SITE INSPECTION REPORT

PROJECT:	Streets Phase 2			REFERENCE:	5449
SITE ADDRESS:	21 Villa Road			CLIENT:	LB Lambeth
MAIN CONTRACTOR:	Mears Group			REPORT NO:	50
INSPECTOR:	[REDACTED]			INSPECTION DATE:	27 February 2019
WEATHER CONDITIONS				Fine	
Enter Temp (if <5 or >30degC):				17	
RESOURCES				Labour (approx. quantity):	0
Trades on site:	No:	Trades on site:	No:	Trades on site:	No:
Comments:	Combination of resident issues and site manager illness has contributed to a temporary stop to works.				
Plant on site:	No:	Plant on site:	No:	Plant on site:	No:
Comments:	Scaffolding onsite, no other plant at time of inspection.

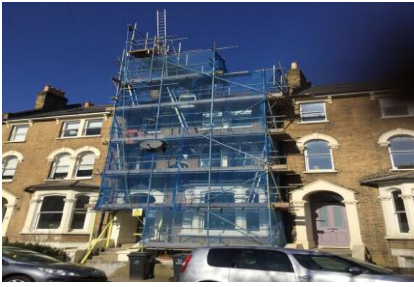
Front of 21 Villa Road, scaffolding in place, satellites moved to exterior.

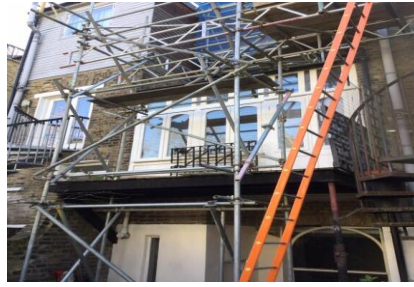
Rear of 21 Villa Road including unsafe balcony structure to rear.

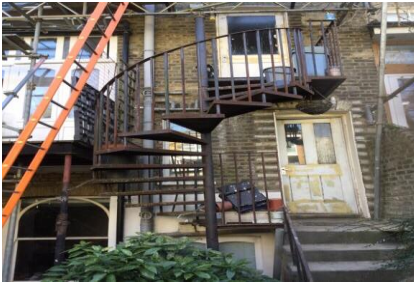
Metal fire escape staircase to rear.

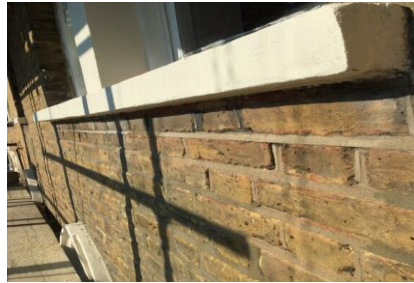
Example concrete repair and external decs, helibar below.

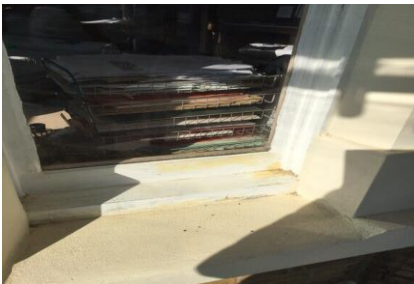
Example window prepared for decoration.

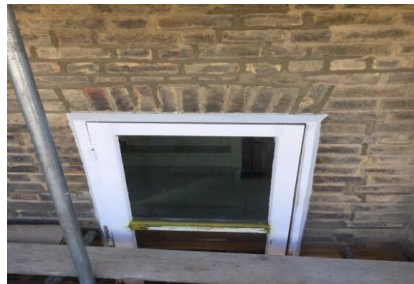
Window showing resin repair to cross piece. Repointing and helibar repair above.
