External Staircase at 21 Villa Road,
Brixton, London, SW9 7ND

Condition Report

9th July 2019

Job number:	5449
Status:	Final
Date:	9 th July 2019

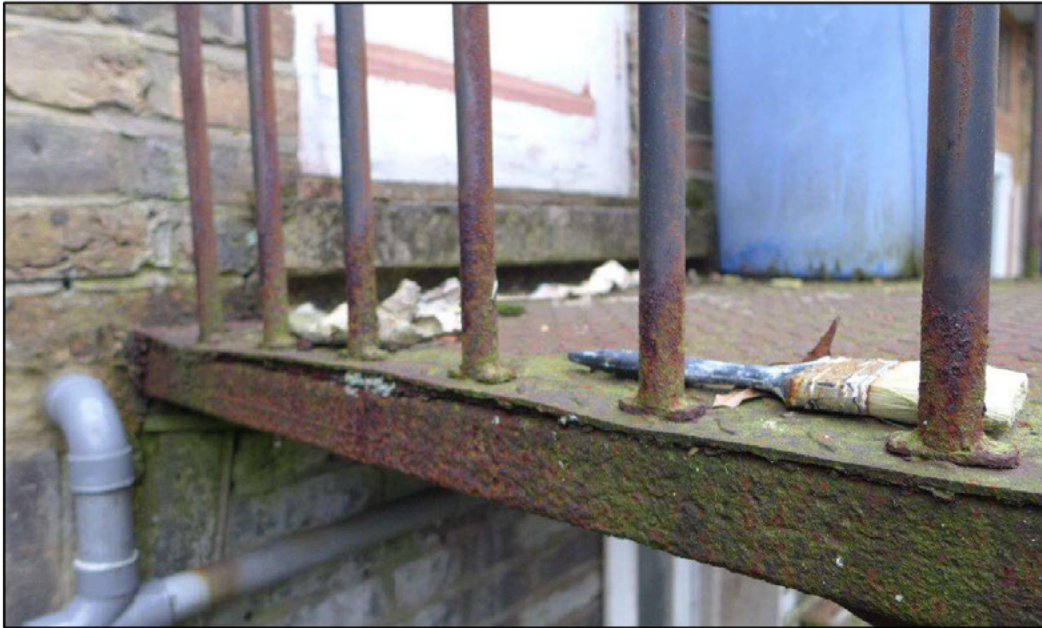
The finish to the staircase is heavily deteriorated and has reached end of life. The finish acts as a protective barrier against oxygen and moisture and therefore prevents the build up of corrosion. Due to the failure of the finish the structure has been able to corrode to a point of advanced deterioration (picture 1). Due to the advanced corrosion it is possible the structural integrity of the staircase has been affected. This can be seen to the lowest landing plate which has rusted through (picture 2).

Photo 1: View of the top landing plate to the external staircase showing the general level of corrosion. Note the distortion to the plate caused by the expansion of the oxidising metal.

As such, we would recommend complete replacement of the structure with a new galvanised, stainless or similar external staircase.

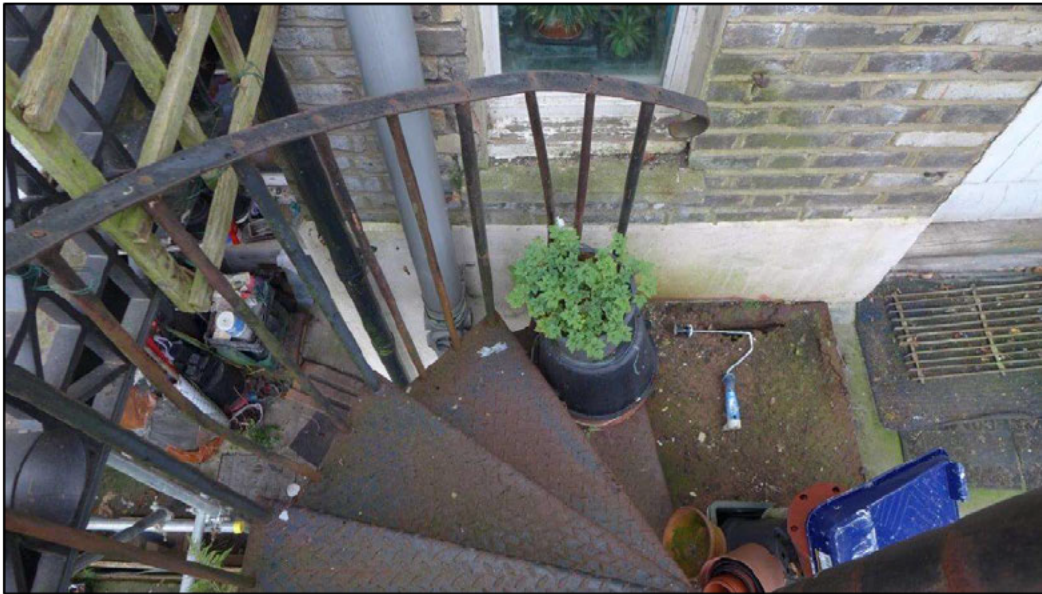
Photo 2: View of the lower treads and landing plate to the external staircase. Note the hole to the landing plate caused by a loss of structural integrity and the bent vertical railing bars.

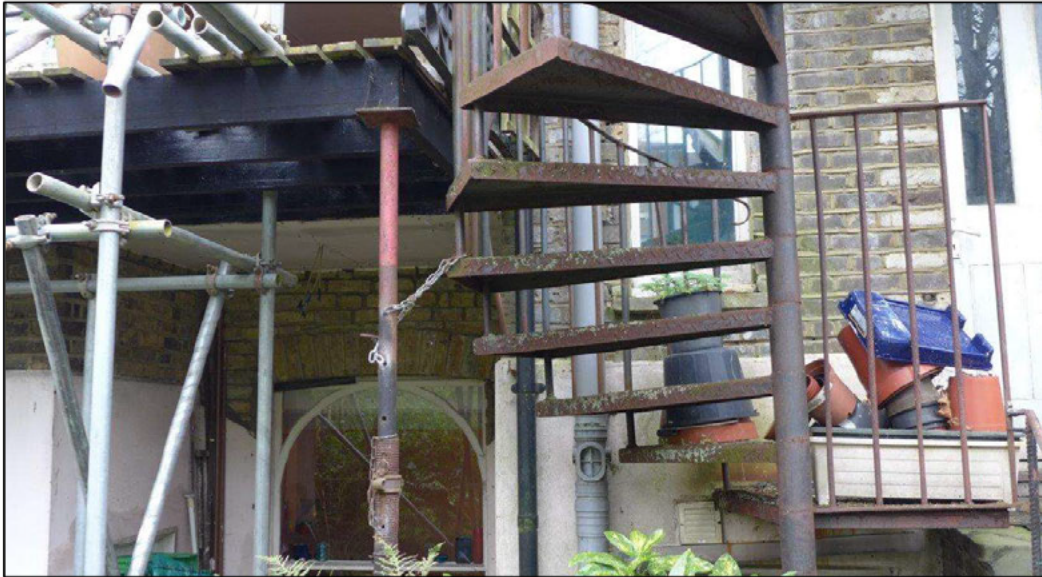
The staircase shows evidence of structural movement. The treads show noticeable downward distortion to the outer edge as the flight turns towards the property (picture 3). This distortion may be due to multiple factors such as the expansion of corrosion, overloading due to the staircase's deteriorated loadbearing capacity or movement of the underlying loadbearing ground.

The structural movement is likely symptomatic of the wider deterioration of the staircase. The distorted treads also pose a trip risk to those ascending or descending the staircase. This is especially true of the use of the staircase as an emergency escape when the likelihood of a trip occurring will be substantially increased.

Photo 3: View of the structurally distorted treads to the external staircase. Note the angle of the treads can be easily seen affecting the potted plant on the staircase. Note the chained strut propping up the adjacent dangerous structure.

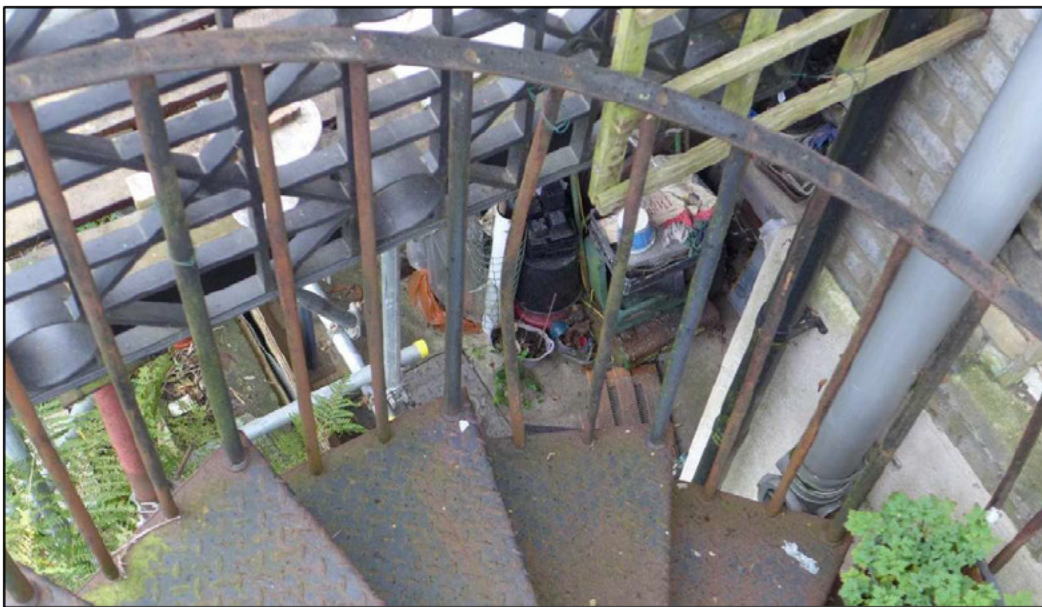
In addition, several of the vertical railing bars have buckled and/or bent (picture 4). This will have brought the railings out of line with the latest Building regulations as below, which require no more than a 100mm gap through the railing. The buckled and/or bent railing bars may be symptomatic of the above described movement. However, it is our opinion that the bars have likely been bent from mechanical action over time, where residents have moved and placed loads against them.

Photo 4: View of the metal tread plates and railings. Note the bent/buckled railings and the level of corrosion to the treads.
