Code: Sgl/05 Tag:	54414	ld: 8		Symbol:	•				
	Location: Herne Hill & Loughborough Junction Site: Dorchester Drive								
Location:	so 2	7 poplar wall	k front/						
Species: Planted Stock Type	Prun	us species ((Cherry)						
Owner:	Envi	ronmental Se	ervices						
Grid Ref:	TQ-3	32345-75094							
Felled:	No	Proposed:	No	TPO:	No				
Freq 1:	No	Poll'd:	No	Freq 2:	No				
Massaria:	No	PksRoad:	No I	Memorial:	No				
CCTV:	No	Epicormic:	No Su l	bsidence:	No

Single tree (54414) - Full tree details	Scale	Unknown	N
ambeth	Full tree details - Single tree (54414)	Date	12/05/2023	W
ambeth	This map is based upon Ordnance Survey material with the permission of Ordnance Survey on behalf of He Crown Copyright. Unauthorised reproduction infringes Crown Copyright and may lead to prosecution or civil 100019338.2008.			S

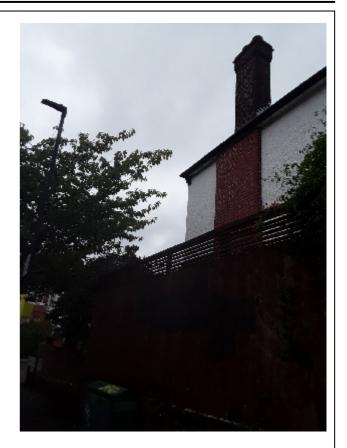
inspection:	09/09/2022	at: 08:21 By: PL	-	Next inspection: September 202
Height: Spread: Trunk: Age:	7.0m 4.0m 31cm Mature	NSEW: -/-/-/-	Access: Damage: Condition: Fair Type: LDF:	Cdbh(Auto): 30 to 39.9 cm FuncVal: No reduction SLE: 20-40 years
Features:	None recorde	ed	Recommendations	:
Conditions:	Stem Damag	oots Basal/trunk sucker e ath or Trip Hazard	over parking bay, 5.4	own lift to 3.5m over ground level 4m over road outside parking bay. Inches to 1.5m away from property, with point
Risk Categ Risk Fac	ory: RA not r ctor:	elevant	Priority: 7 Days (Q	•
Inspection:	09/09/2020	at: 12:26 By: PL	Re-inspect: 36 months	Next inspection: September 202
Height: Spread: Trunk: Age:	31cm	NSEW: -/-/-/-	Access: Damage: Condition: Fair Type: LDF:	Cdbh(Auto): 30 to 39.9 cm FuncVal: No reduction SLE: 20-40 years
Features:	None recorde	ed	Recommendations	:
Conditions:	Stem Damag	oots Basal/trunk sucker e ath or Trip Hazard	None recorded Priority: None	Due:

Tree works:	23/09/2022	at: 14:27	By: C2	Re-inspect:	36 months	Next inspectio	n: September 2026		
Height: Spread: Trunk: Age:	4.0m 31cm	NSEW:	-/-/-	Access: Damage: Condition: Type: LDF:	Fair	FuncVal:	30 to 39.9 cm No reduction 20-40 years		
Features:	None recorde	∍d		Recom	mendations:				
Conditions:	Conditions: Epicormic Shoots Basal/trunk sucker Stem Damage				None recorded Priority: None Due:				
	Lifting Footpa	ath or Trip Ha	azard	Tree works carried out:					
Risk Category: RA not relevant Risk Factor:				Standard Prune - crown lift to 3.5m over ground level over parking bay, 5.4m over road outside parking bay. laterally reduce branches to 1.5m away from property, back to closest growth point.
