Operational Inspection

Kildoran Road

Inspection Ref: 1333011

Inspected: 15 April 2021 at 12:14 Inspector: [REDACTED]

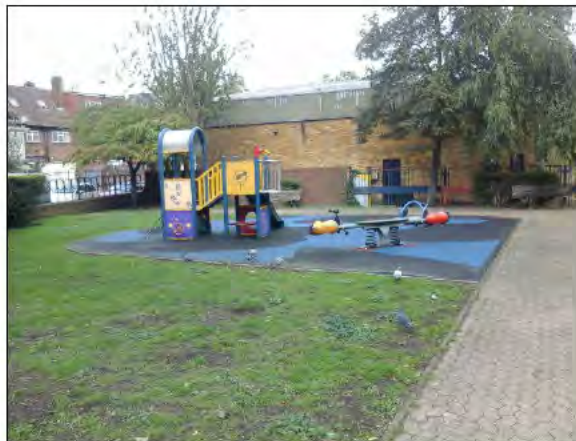
Item: Ancillary Items - Site General
Manufacturer: Owner/Operator
Comments

There are trip hazards at the edges of the surface
Reinstate surrounding surface levels to remove the trip points 20lm

Risk Assessment: 8 - Low Risk

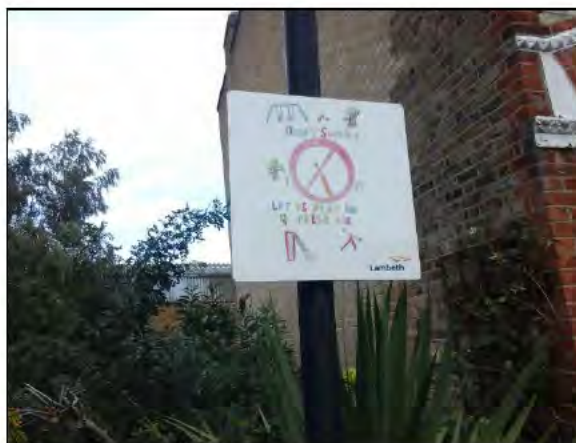
Item: Ancillary Items - Sign
Manufacturer: Not Applicable
Comments

This item is satisfactory - no work required

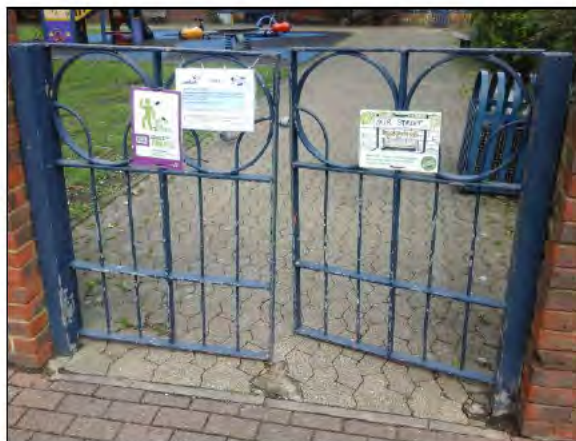
Item: Gates - Gate - Pedestrian
Manufacturer: Unknown
Comments

The gate is loose on its hinges Investigate and take appropriate action to rectify

Risk Assessment: 6 - Low Risk

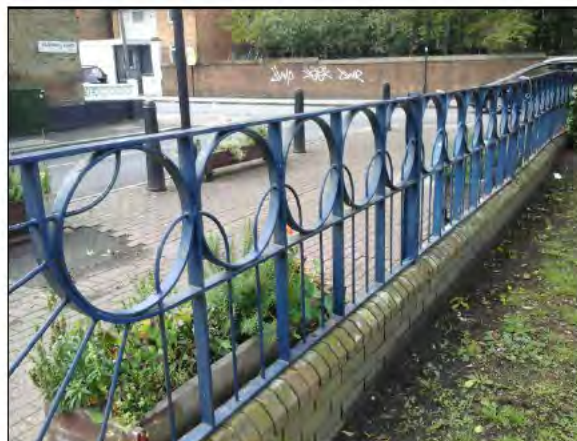
Item: Fences - Fencing - Flat Top
Manufacturer: Unknown
Comments

There is surface corrosion present on the item Consider treating and repainting the item

There is some graffiti present Remove the graffiti

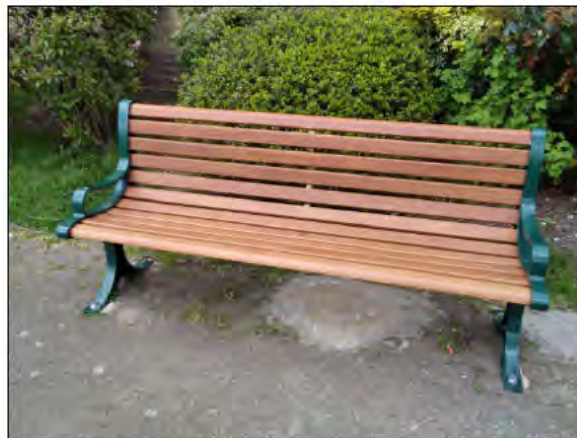
Item: Ancillary Items - Bench
Manufacturer: Unknown
Comments

The timber on this item has severe rot Remove and replace all affected timber sections 24?0031800?00375?00322

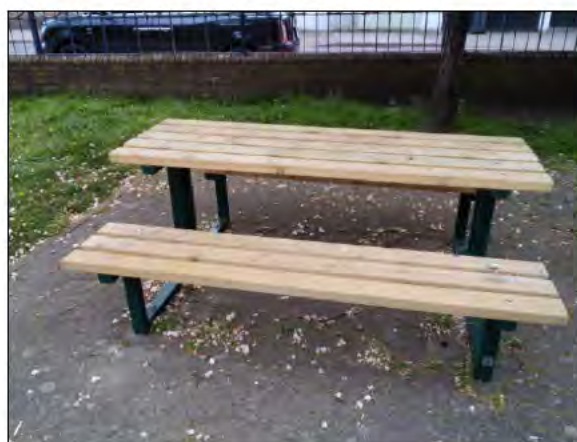
Item: Ancillary Items - Picnic Table
Manufacturer: Unknown
Comments

There are areas or parts of the timber on the structure that have rotted Replace all affected timbers 5?0031800?003120?00350&4?0031800?003100?00350

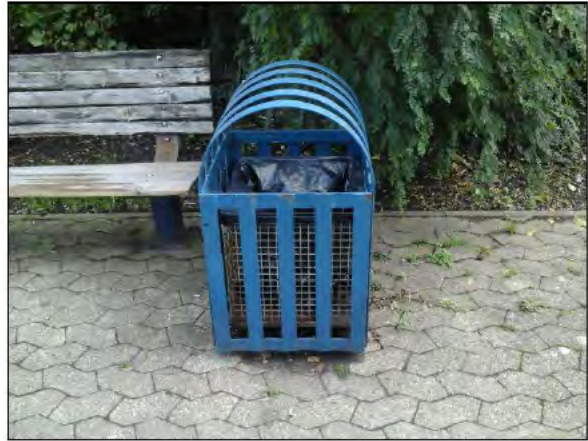
Item: Ancillary Items - Litter Bin
Manufacturer: Unknown
Comments

There is no liner present in the litterbin Provide as required

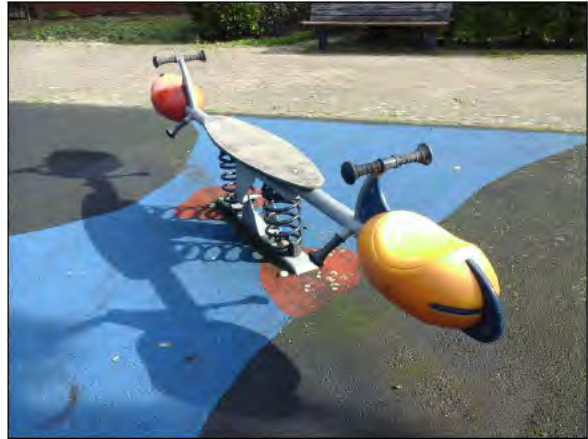
Item: Rocking Equipment - Spring See-Saw
Manufacturer: Kompan Ltd
Comments

Hand/foot rests are wearing Monitor for further wear

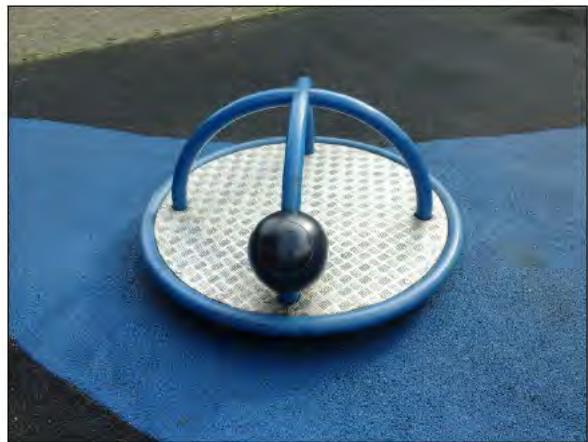
Item: Rotor Play - Roundabout
Manufacturer: Berliner Seil Fabrik
Comments

This item is satisfactory - no work required

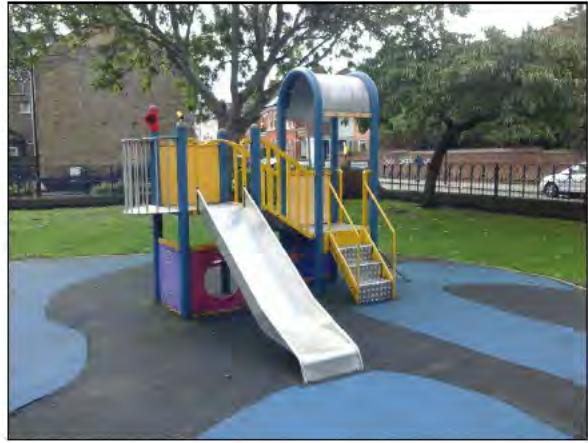
Item: Activity Equipment - Multi Play (Toddler)
Manufacturer: Russell Leisure Ltd
Comments

There is some graffiti present Remove the graffiti

Steering wheel is damaged Replace

The surface is lifting at the edges and creating trip points
Repair perimeter of surfacing to remove trip points 1LM

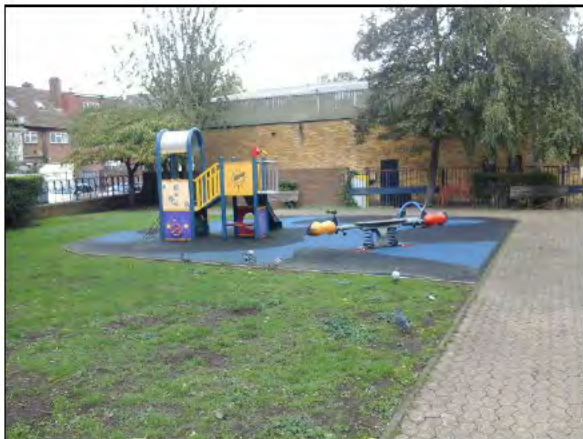
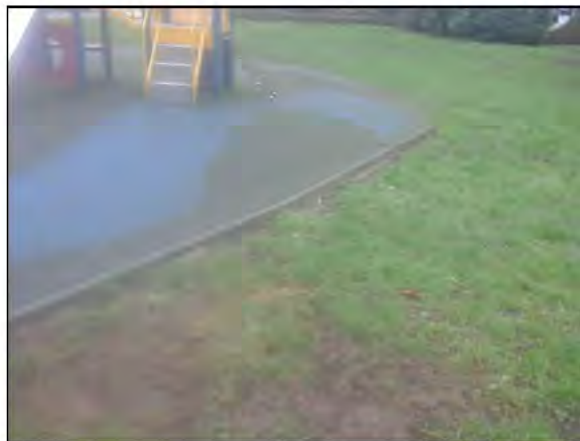
Item: Ancillary Items - Site General
Manufacturer: Owner/Operator

Risk Level: 8 - Low Risk
Surface: N/A

Finding: There are trip hazards at the edges of the surface
Action: Reinstate surrounding surface levels to remove the trip points 20lm

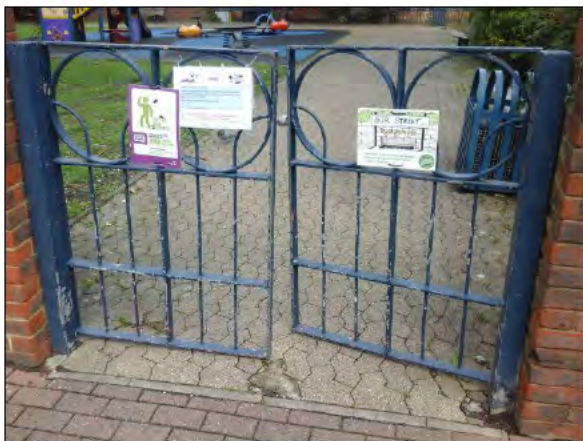
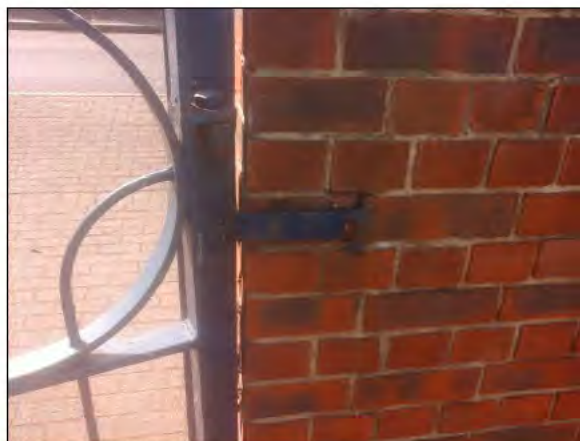
Item: Gates - Gate - Pedestrian
Manufacturer: Unknown

Risk Level: 6 - Low Risk
Surface: All Weather Surface

Finding: The gate is loose on its hinges
Action: Investigate and take appropriate action to rectify

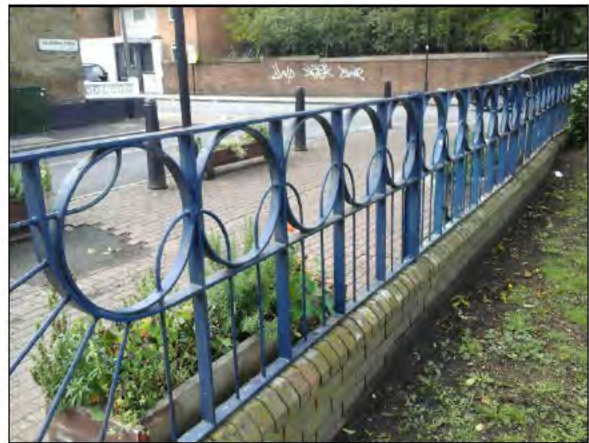
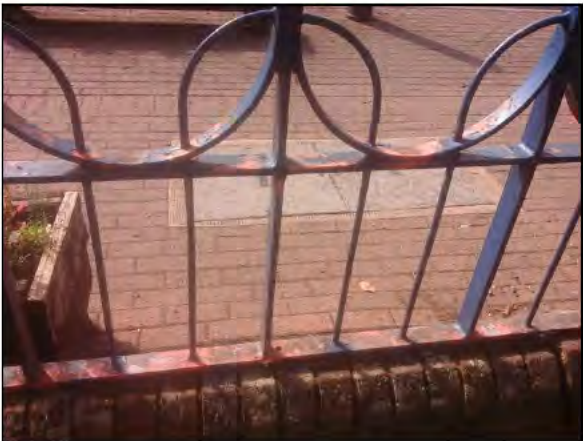
Item: Fences - Fencing - Flat Top
Manufacturer: Unknown

Risk Level: 6 - Low Risk
Surface: Brick Pavers

Finding: There is surface corrosion present on the item
Action: Consider treating and repainting the item

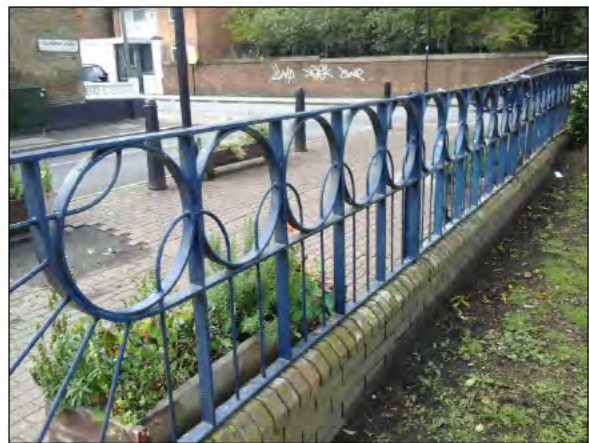
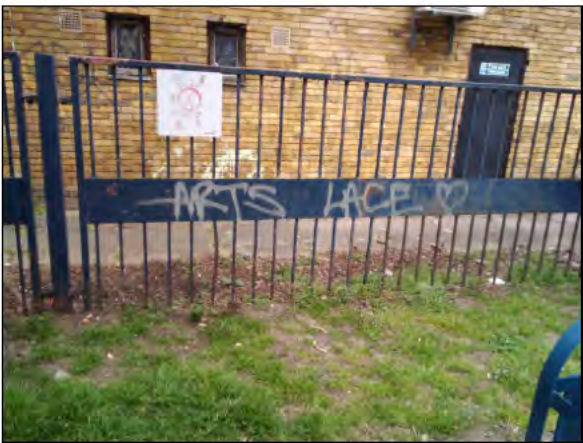
Item: Fences - Fencing - Flat Top
Manufacturer: Unknown

Risk Level: 2 - Very Low Risk
Surface: Brick Pavers

Finding: There is some graffiti present
Action: Remove the graffiti

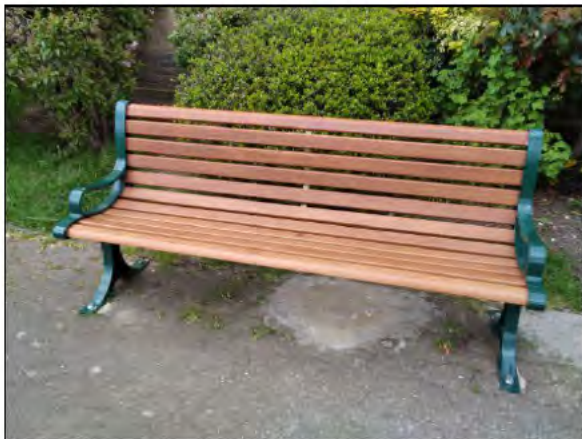
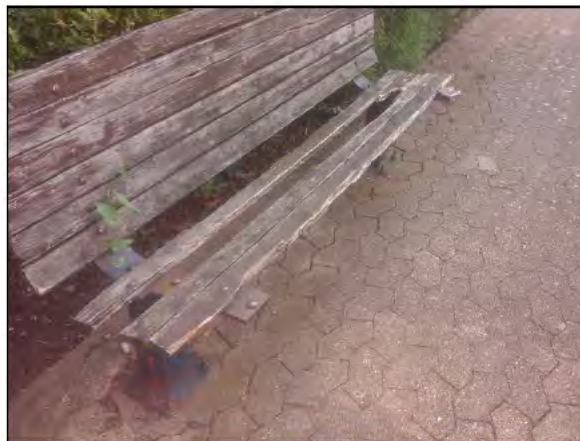
Item: Ancillary Items - Bench
Manufacturer: Unknown

Risk Level: 10 - Low Risk
Surface: Brick Pavers

Finding: The timber on this item has severe rot
Action: Remove and replace all affected timber sections 24?0031800?00375?00322

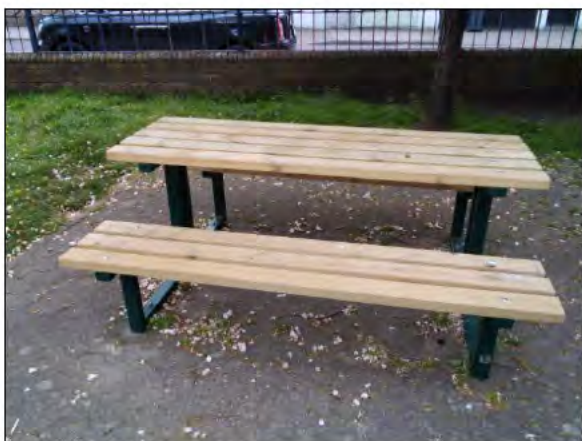
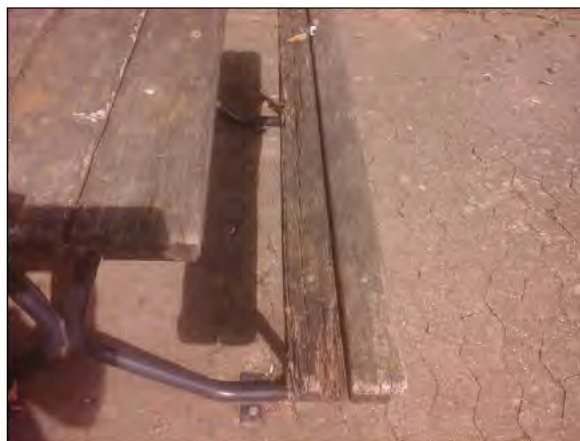
Item: Ancillary Items - Picnic Table
Manufacturer: Unknown

Risk Level: 8 - Low Risk
Surface: Brick Pavers

Finding: There are areas or parts of the timber on the structure that have rotted
Action: Replace all affected timbers 5?0031800?003120?00350&4?0031800?003100?00350

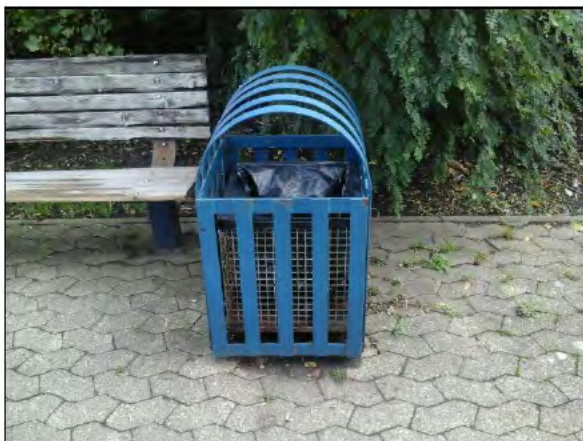
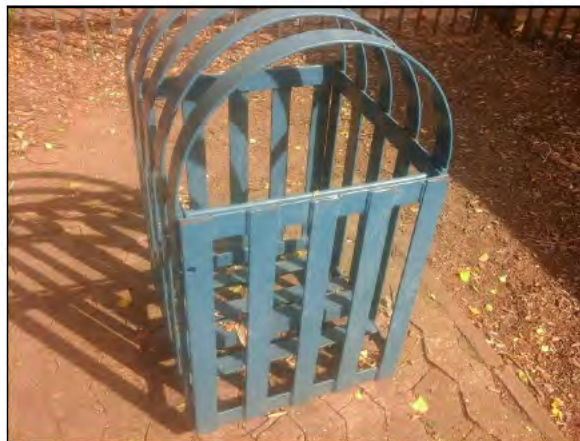
Item: Ancillary Items - Litter Bin
Manufacturer: Unknown

Risk Level: 2 - Very Low Risk
Surface: Brick Pavers

Finding: There is no liner present in the litterbin
Action: Provide as required

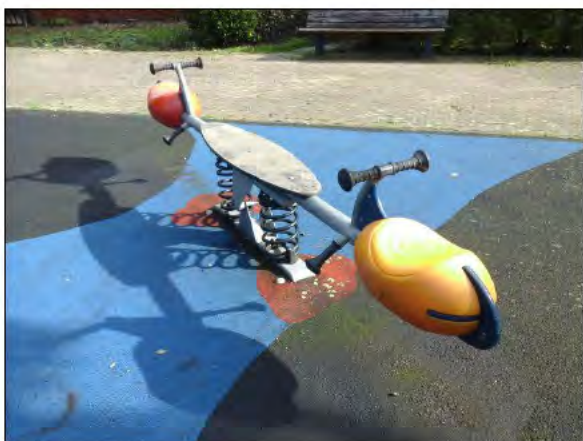
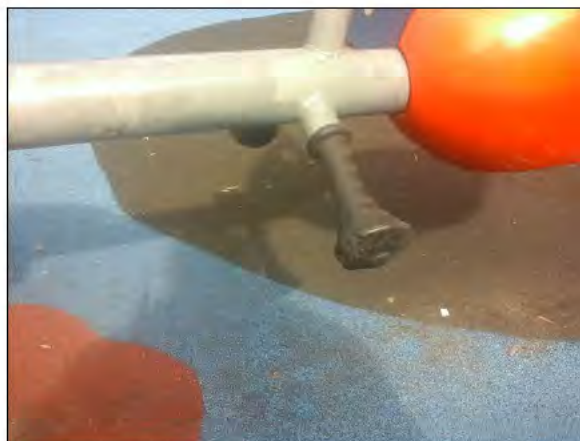
Item: Rocking Equipment - Spring See-Saw
Manufacturer: Kompan Ltd

Risk Level: 5 - Very Low Risk
Surface: Wet Pour

Finding: Hand/foot rests are wearing
Action: Monitor for further wear

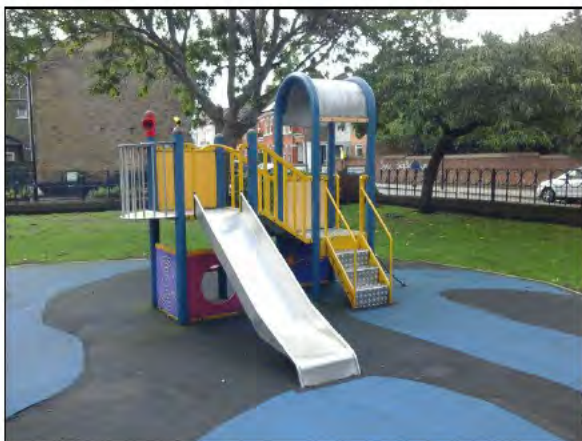
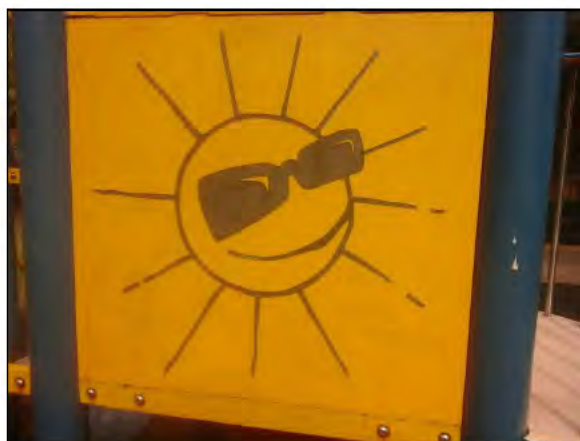
Item: Activity Equipment - Multi Play (Toddler)
Manufacturer: Russell Leisure Ltd

Risk Level: 2 - Very Low Risk
Surface: Wet Pour

Finding: There is some graffiti present
Action: Remove the graffiti

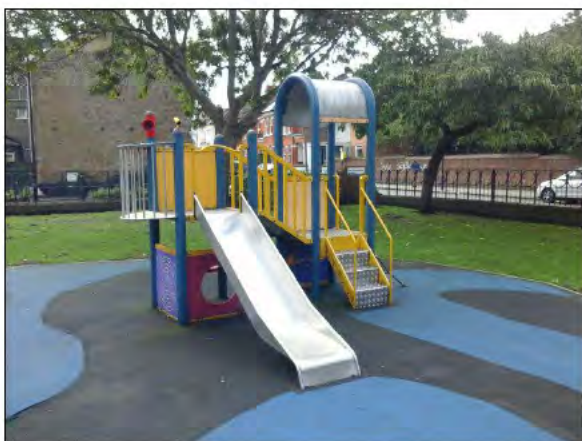
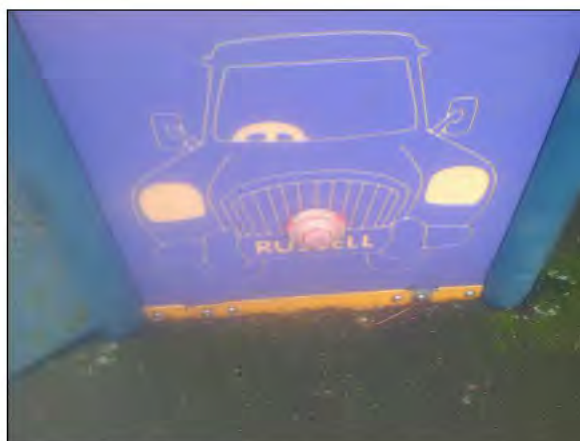
Item: Activity Equipment - Multi Play (Toddler)
Manufacturer: Russell Leisure Ltd

Risk Level: 6 - Low Risk
Surface: Wet Pour

Finding: Steering wheel is damaged
Action: Replace

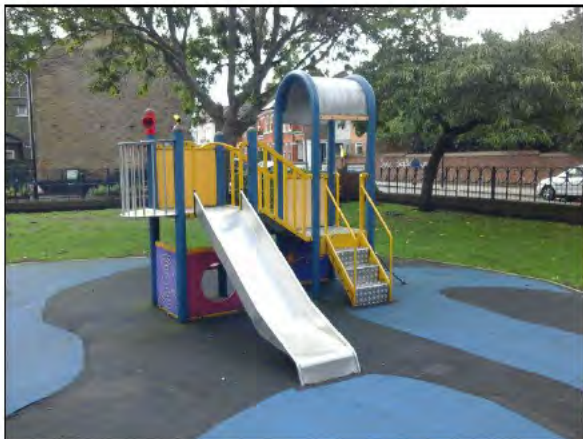
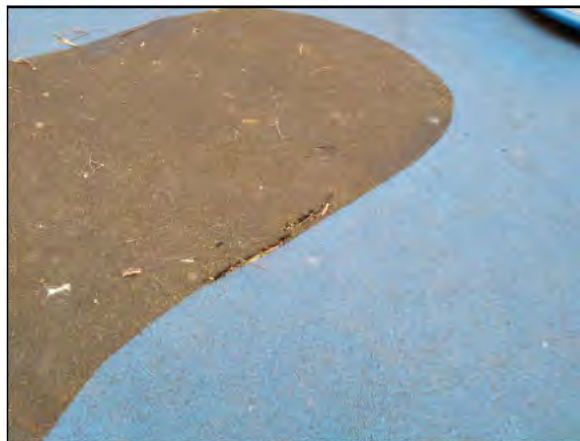
Item: Activity Equipment - Multi Play (Toddler)
Manufacturer: Russell Leisure Ltd

Risk Level: 8 - Low Risk
Surface: Wet Pour

Finding: The surface is lifting at the edges and creating trip points
Action: Repair perimeter of surfacing to remove trip points 1LM
