## Operational Inspection

### Kildoran Road

Inspection Ref: 1648812

Inspected: 27 April 2022 at 12:25 Inspector: [REDACTED]

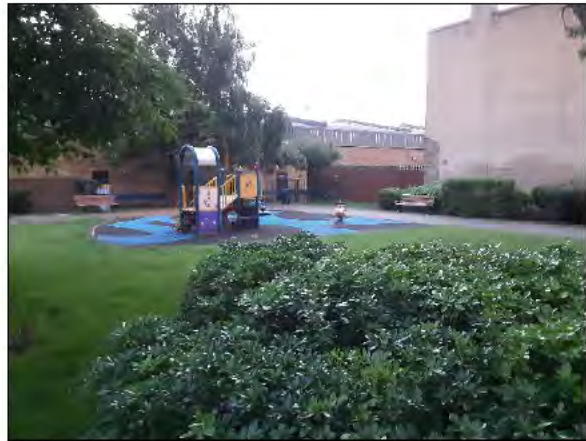
There are trip hazards at the edges of the surface  
Reinstate surrounding surface levels to remove the trip points 20lm

There is algae or moss growth on the surface resulting in slippery conditions Clean and treat appropriately

**Risk Assessment:** 8 - Low Risk

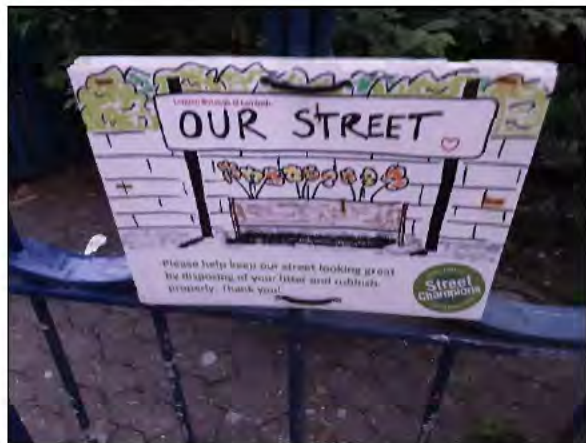
This item is satisfactory - no work required

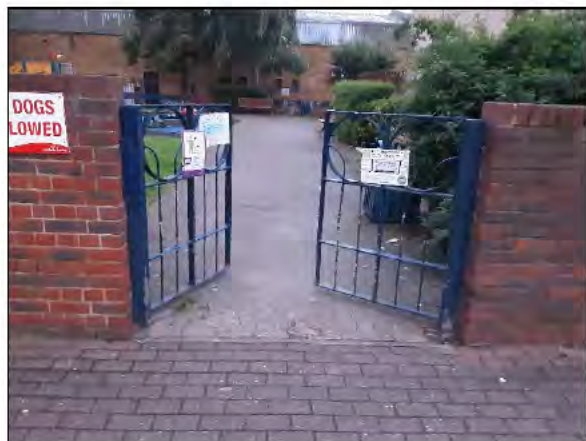
The gate is loose on its hinges Investigate and take appropriate action to rectify

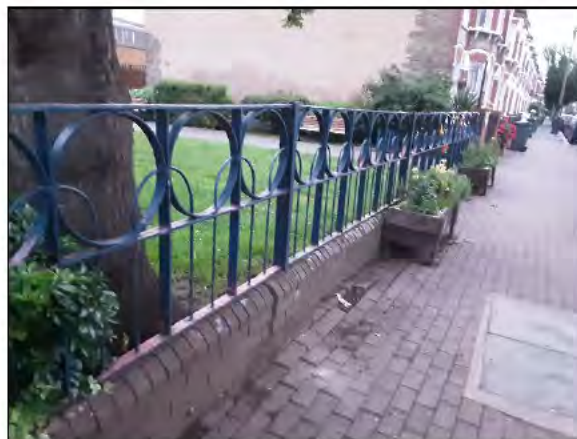
There is surface corrosion present on the item Consider treating and repainting the item

There is some graffiti present Remove the graffiti

Section of railing is missing Replace as required

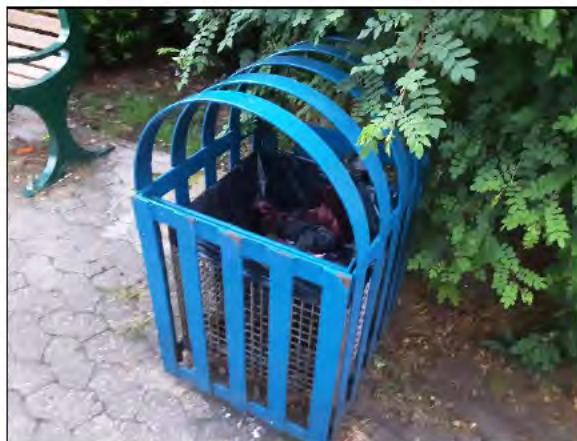
There is no liner present in the litterbin Provide as required

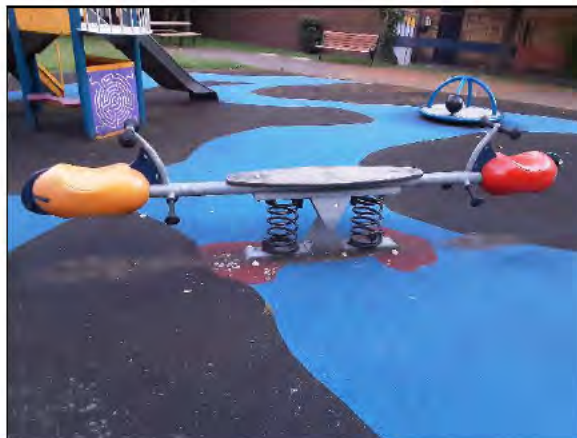
Hand/foot rests are wearing Monitor for further wear

Evidence of vandalism, dog bites Monitor for deterioration and consider replacing

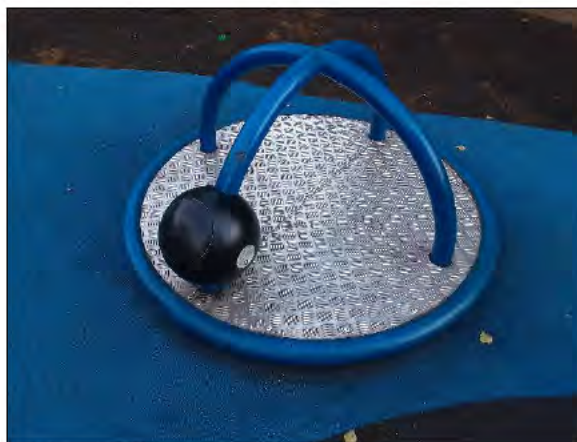
There is surface corrosion present on the item Consider treating and repainting the item

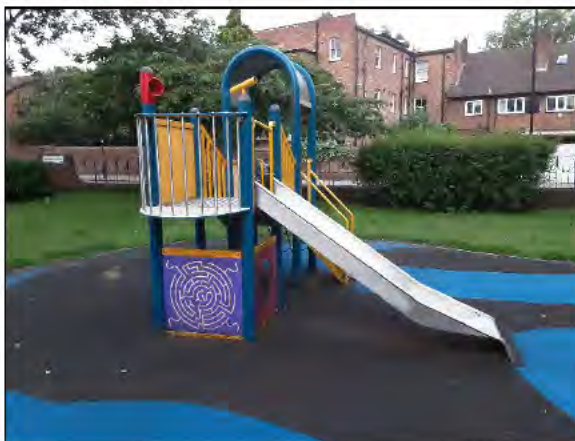
There is some graffiti present Remove the graffiti

Steering wheel is damaged Replace

There are gaps opening between the surfacing and the edging surround or between the joints in the surfacing Monitor for any further deterioration and repair as required, 2 Lm

The paintwork on this item has been damaged or worn exposing the metal underneath which is rusting Treat any rusting components and repaint

There are a number of dents in the slide surface, sharp surface Arrange to sand down any burrs on surface

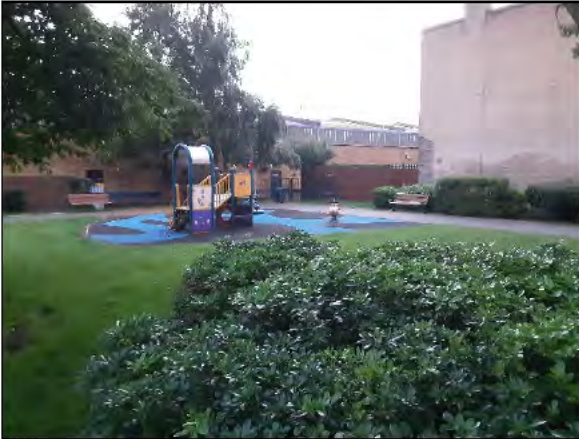
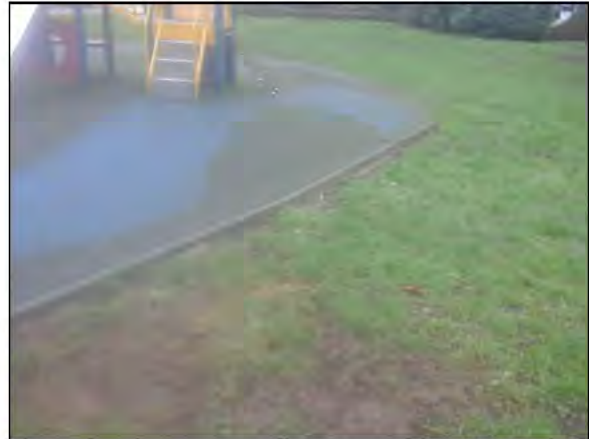
**Item:** Ancillary Items - Site General  
**Manufacturer:** Owner/Operator

**Finding:** There are trip hazards at the edges of the surface  
**Action:** Reinstate surrounding surface levels to remove the trip points 20lm

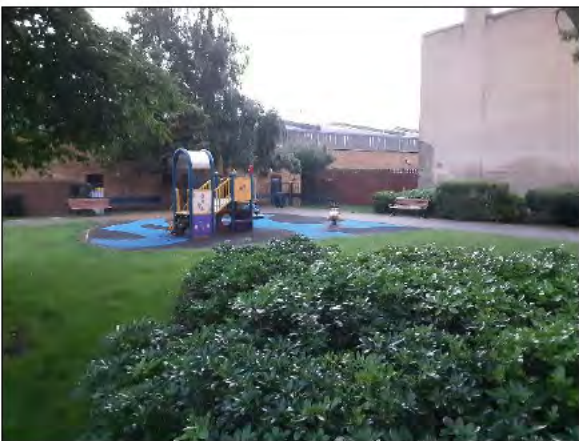
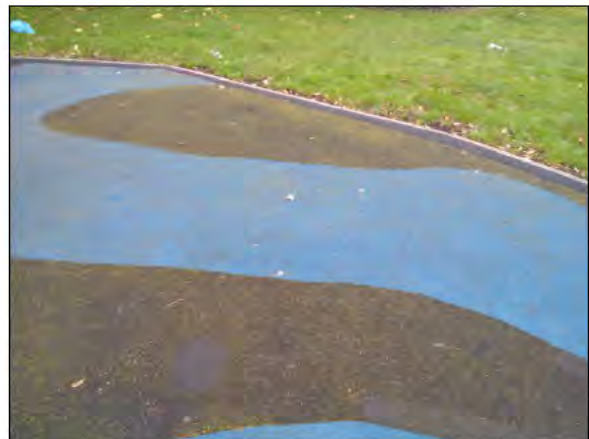
**Item:** Ancillary Items - Site General  
**Manufacturer:** Owner/Operator

**Finding:** There is algae or moss growth on the surface resulting in slippery conditions  
**Action:** Clean and treat appropriately

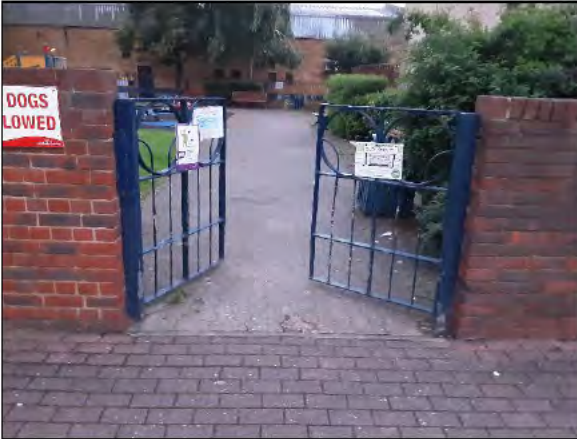
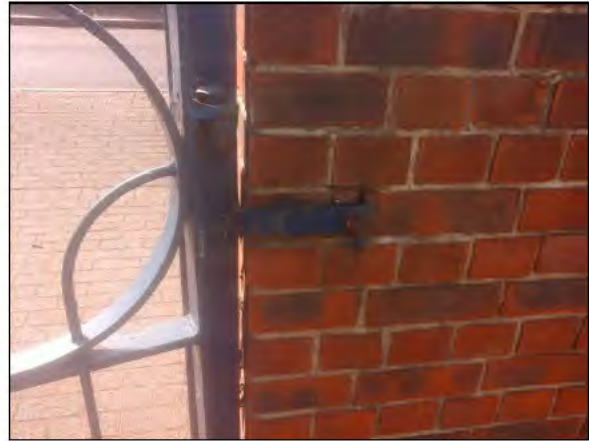
**Item:** Gates - Gate - Pedestrian  
**Manufacturer:** Unknown

**Finding:** The gate is loose on its hinges  
**Action:** Investigate and take appropriate action to rectify

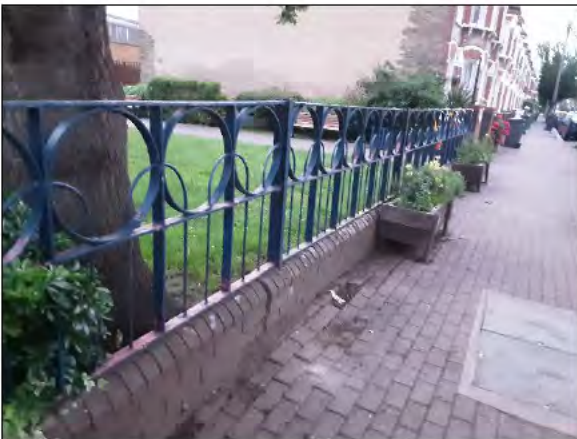
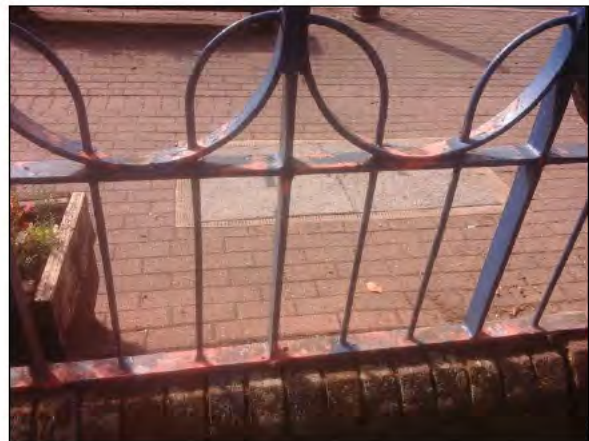
**Item:** Fences - Fencing - Flat Top  
**Manufacturer:** Unknown

**Finding:** There is surface corrosion present on the item  
**Action:** Consider treating and repainting the item

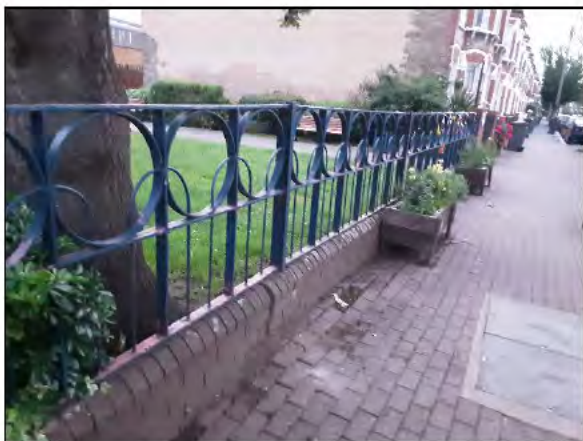
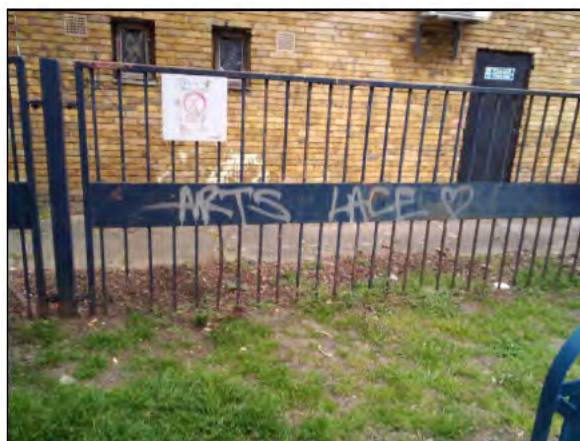
**Item:** Fences - Fencing - Flat Top  
**Manufacturer:** Unknown

**Finding:** There is some graffiti present  
**Action:** Remove the graffiti

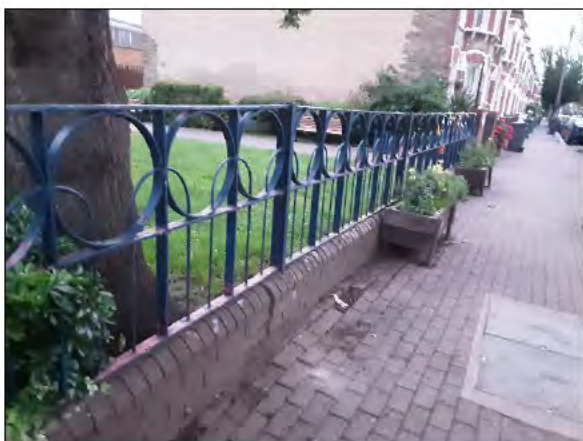
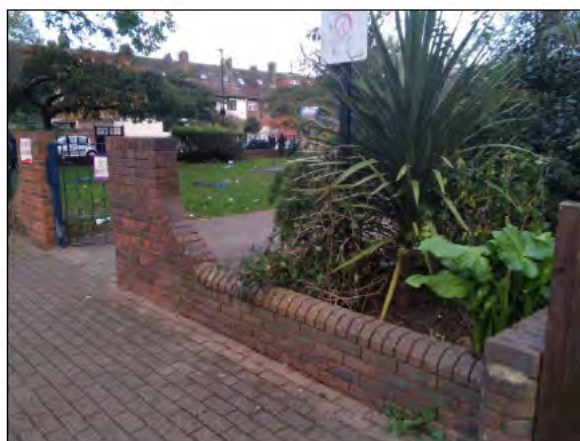
**Item:** Fences - Fencing - Flat Top  
**Manufacturer:** Unknown

**Finding:** Section of railing is missing  
**Action:** Replace as required

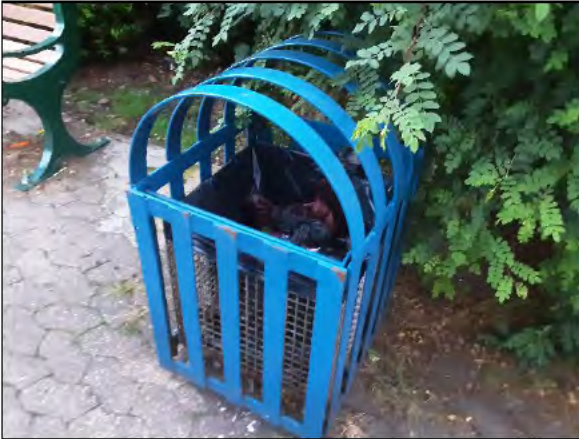
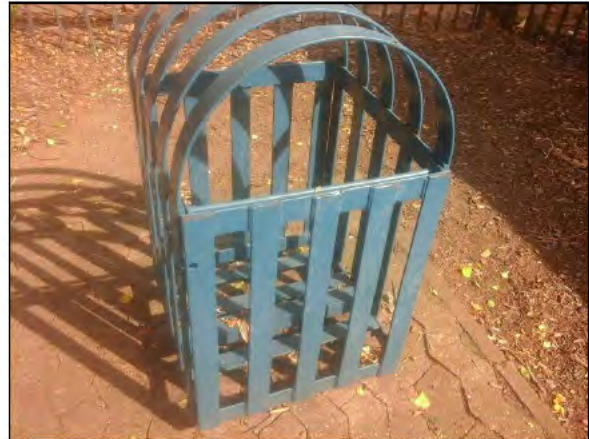
**Item:** Ancillary Items - Litter Bin  
**Manufacturer:** Unknown

**Finding:** There is no liner present in the litterbin  
**Action:** Provide as required

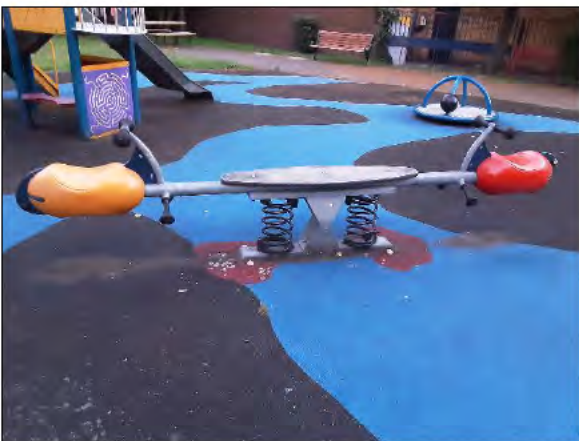
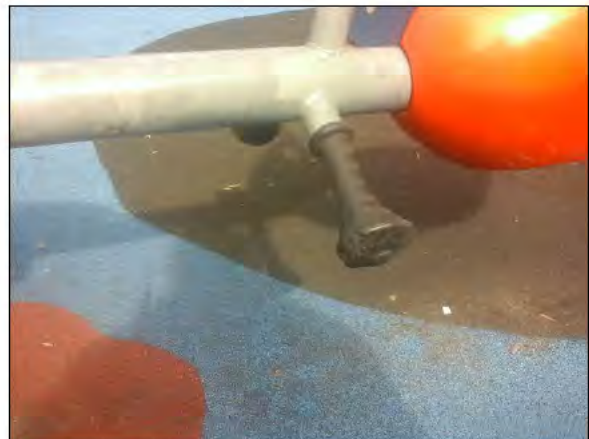
**Item:** Rocking Equipment - Spring See-Saw  
**Manufacturer:** Kompan Ltd

**Finding:** Hand/foot rests are wearing  
**Action:** Monitor for further wear

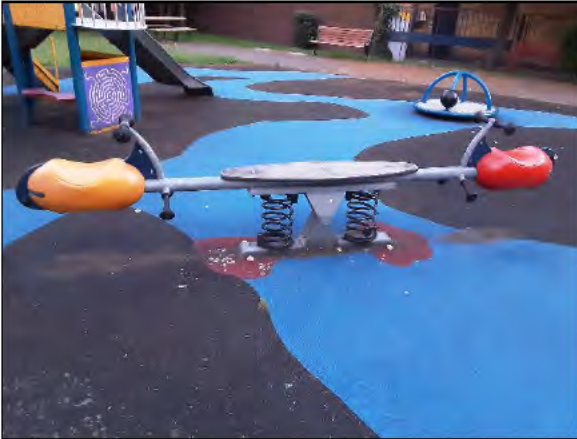
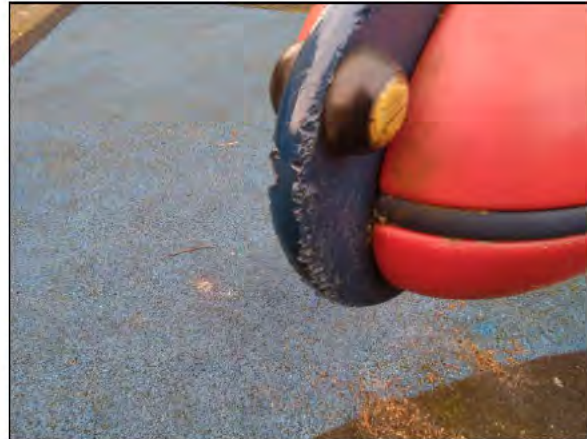
**Item:** Rocking Equipment - Spring See-Saw  
**Manufacturer:** Kompan Ltd

**Finding:** Evidence of vandalism, dog bites  
**Action:** Monitor for deterioration and consider replacing

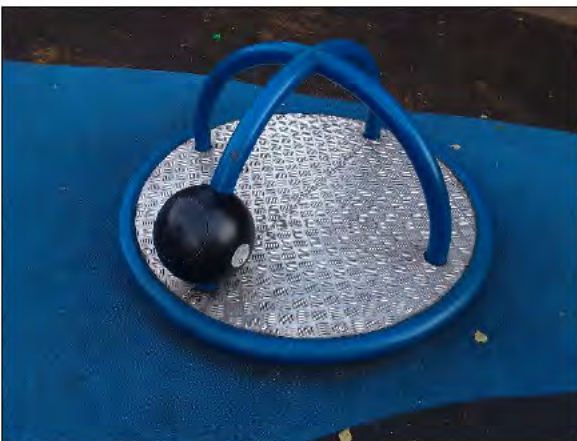
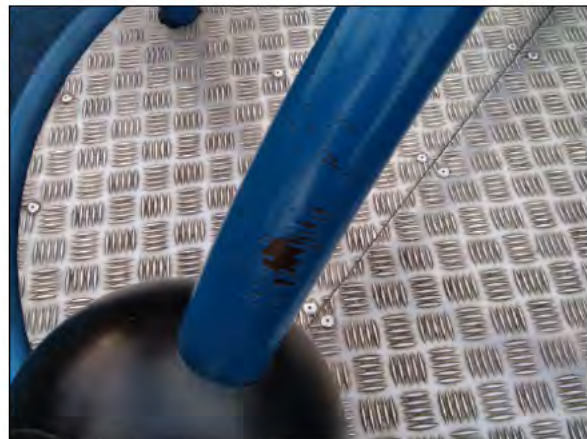
**Item:** Rotor Play - Roundabout  
**Manufacturer:** Berliner Seil Fabrik

**Finding:** There is surface corrosion present on the item  
**Action:** Consider treating and repainting the item

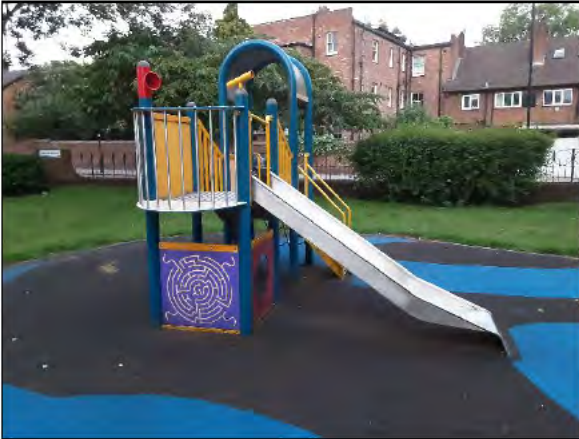
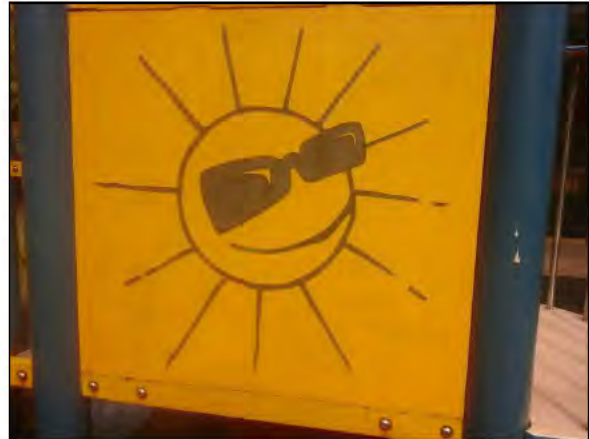
**Item:** Activity Equipment - Multi Play (Toddler)  
**Manufacturer:** Russell Leisure Ltd

**Finding:** There is some graffiti present  
**Action:** Remove the graffiti

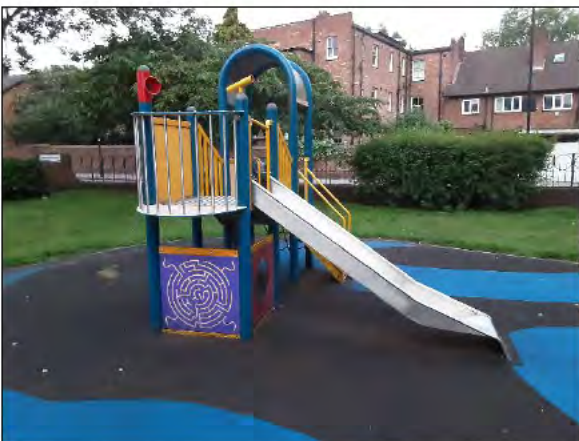
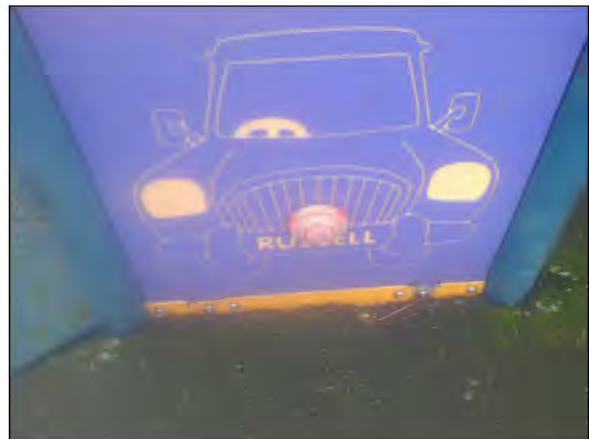
**Item:** Activity Equipment - Multi Play (Toddler)  
**Manufacturer:** Russell Leisure Ltd

**Finding:** Steering wheel is damaged  
**Action:** Replace

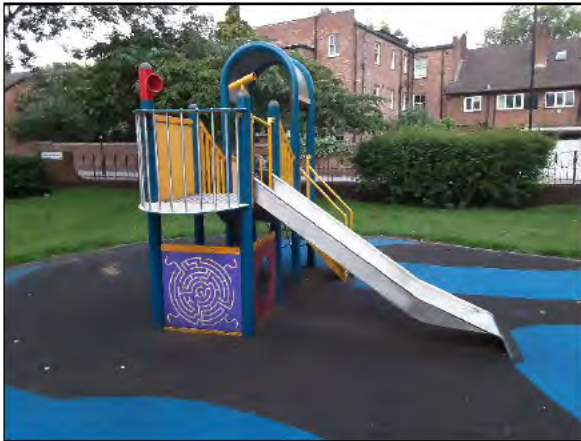
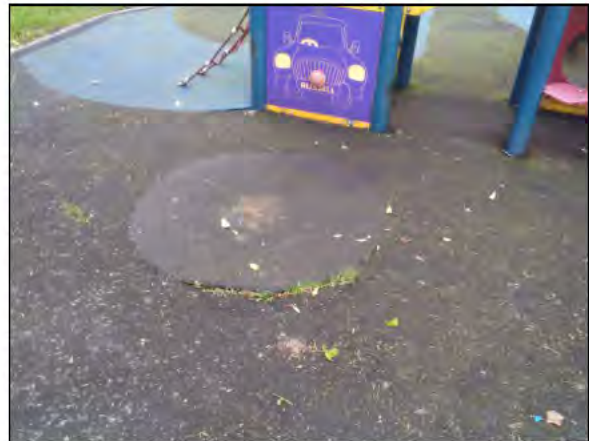
**Item:** Activity Equipment - Multi Play (Toddler)  
**Manufacturer:** Russell Leisure Ltd

**Finding:** There are gaps opening between the surfacing and the edging surround or between the joints in the surfacing  
**Action:** Monitor for any further deterioration and repair as required, 2 Lm

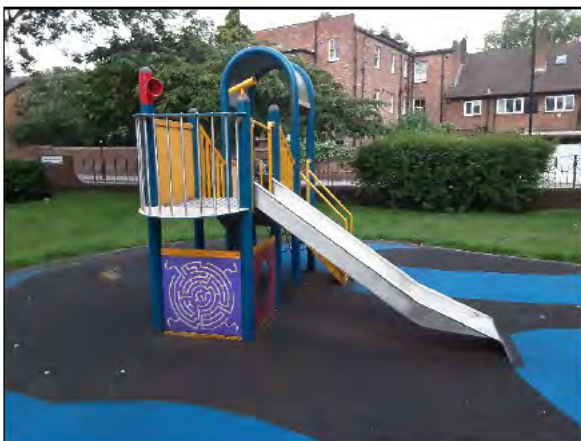
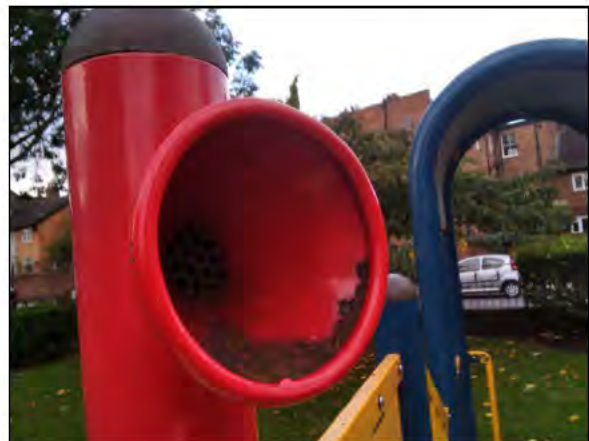
**Item:** Activity Equipment - Multi Play (Toddler)  
**Manufacturer:** Russell Leisure Ltd

**Finding:** The paintwork on this item has been damaged or worn exposing the metal underneath which is rusting  
**Action:** Treat any rusting components and repaint

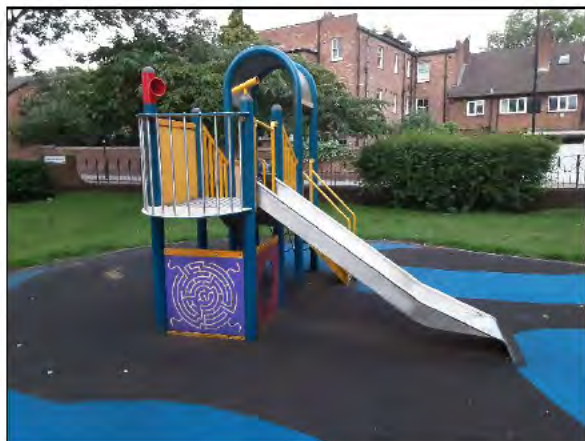
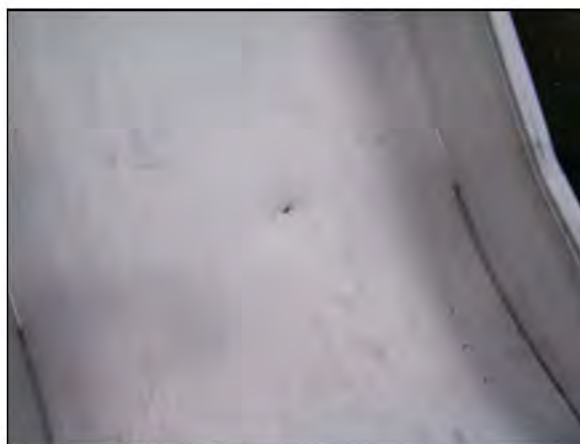
**Item:** Activity Equipment - Multi Play (Toddler)  
**Manufacturer:** Russell Leisure Ltd

**Finding:** There are a number of dents in the slide surface, sharp surface  
**Action:** Arrange to sand down any burrs on surface
