## Annual Inspection

### Kildoran Road

Inspection Ref: 1737494

Inspected: 21 August 2022 at 14:02 Inspector: [REDACTED]

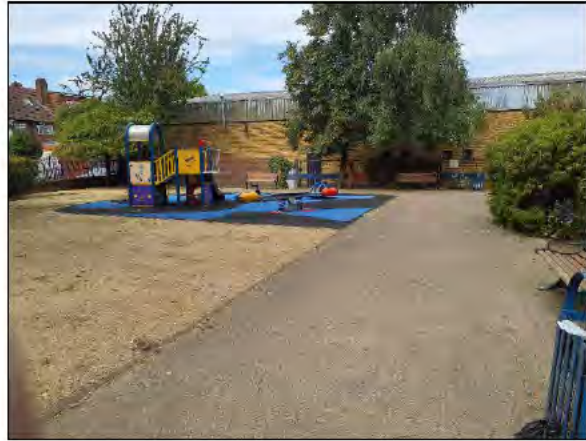
**Item:** Ancillary Items - Site General  
**Manufacturer:** Owner/Operator  
**Comments**

The paved surface has subsided in some areas Monitor for any further deterioration and repair as required

There is weed / vegetation growth on, between, or around the edges of the paved surfacing Remove weed / vegetation growth

There are trip hazards at the edges of the surface Reinstall surrounding surface levels to remove the trip points

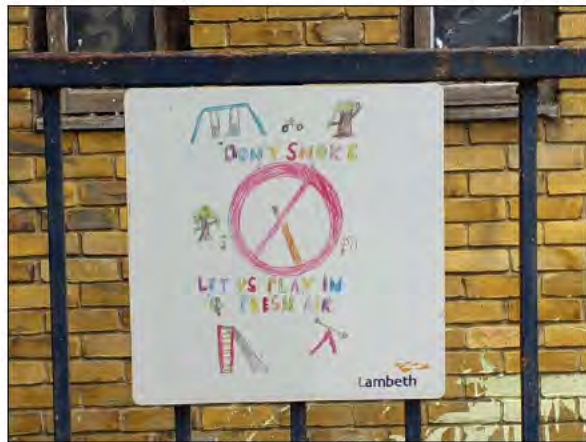
**Item:** Ancillary Items - Sign  
**Manufacturer:** Not Applicable  
**Comments**

It is recommended that signage, with information including the site address, contact information for maintenance issues and emergency contact details are provided for the facility Provide in accordance with the recommendations

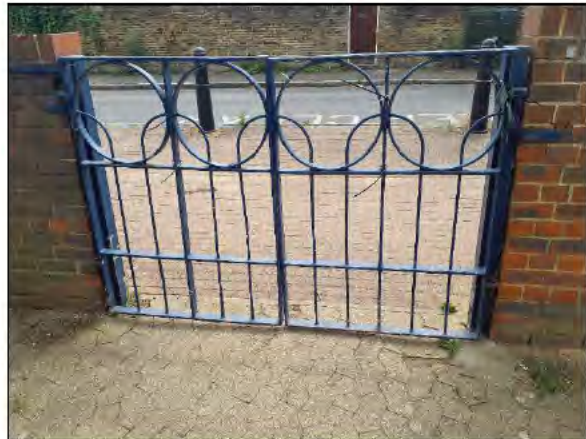
**Item:** Gates - Gate - Pedestrian  
**Manufacturer:** Unknown  
**Comments**

The gate has no drop bolt sleeves and/or drop bolts fitted Provide drop bolt sleeves and/or drop bolts

There is no padlock on the maintenance gate Provide a padlock to secure the gate

There are openings that are less than 12mm that could trap or crush fingers Where possible a 12mm gap should be maintained on both sides or between the gate leaves

There is no slamming plate on the gate Provide a slamming plate

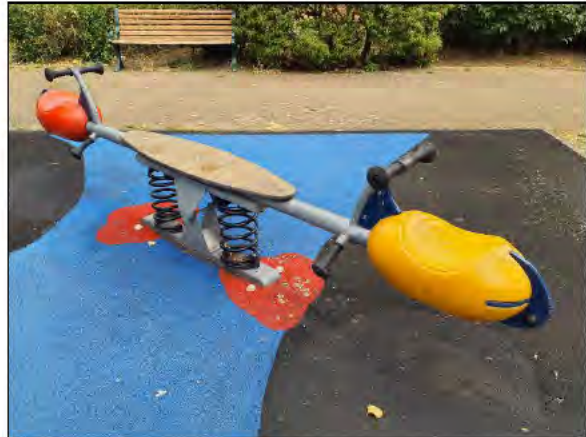
**Item:** Rocking Equipment - Spring See-Saw  
**Manufacturer:** Kompan Ltd  
**Comments**

There is some minor damage to the surface Monitor for any further deterioration and repair as required

There is minor damage to the handgrips/footrests Monitor and replace if required

There is minor vandalism damage to the body Remove the sharp protrusions

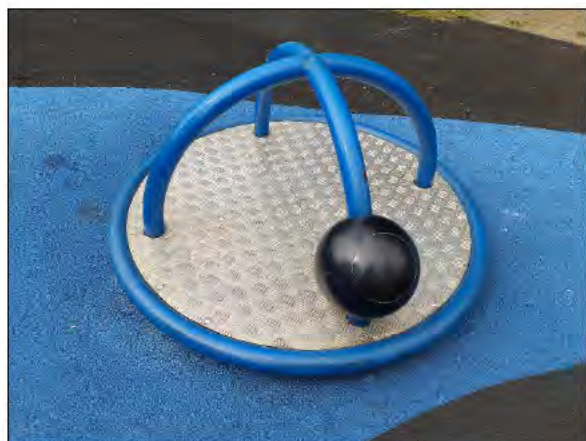
**Item:** Rotor Play - Roundabout  
**Manufacturer:** Berliner Seil Fabrik  
**Comments**

The paintwork on this item has been damaged or worn exposing the metal underneath which is rusting Treat any rusting components and repaint

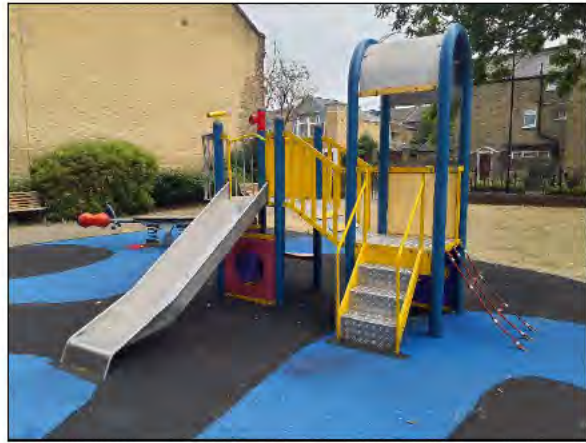
**Item:** Activity Equipment - Multi Play (Toddler)  
**Manufacturer:** Russell Leisure Ltd  
**Comments**

The equipment item does not comply with the requirements of the current applicable standard.

There are a number of dents in the slide surface Monitor for any further deterioration and repair as required

The paintwork on this item has been damaged or worn exposing the metal underneath which is rusting Treat any rusting components and repaint

The bushes are worn or missing Replace worn or missing bushes

There is damage to the surface Repair the damaged areas of surfacing

The design of the barriers encourages standing or sitting and fails the requirements of BS EN 1176 Monitor - No remedial work recommended

There is some graffiti present Remove the graffiti

There is/are finger entrapment/s in the structure and the item fails to meet the requirements of BS EN 1176 Part 1 4.2.7.6 Entrapment of fingers Monitor - No remedial work recommended

The item has damaged/missing component(s) Consider replacing damaged/missing components

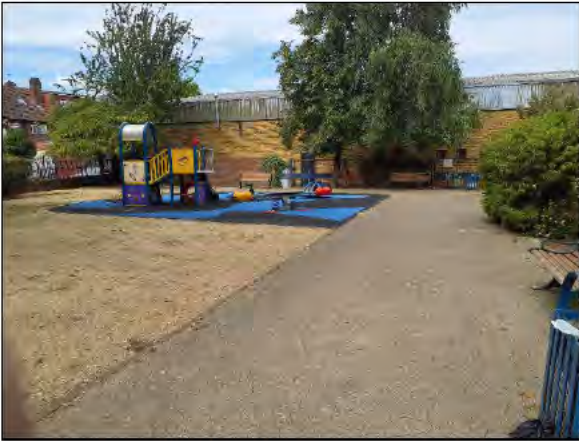
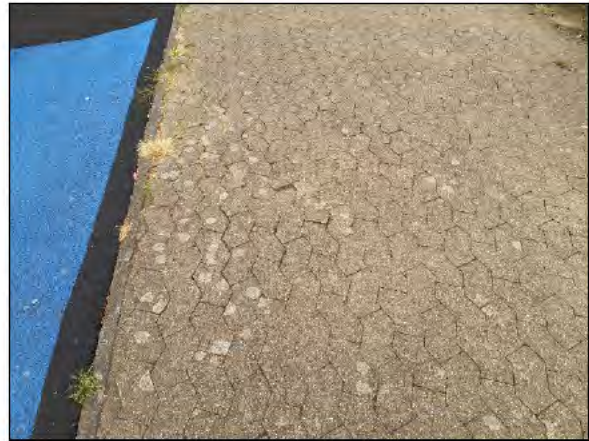
**Item:** Ancillary Items - Site General  
**Manufacturer:** Owner/Operator

**Finding:** The paved surface has subsided in some areas  
**Action:** Monitor for any further deterioration and repair as required

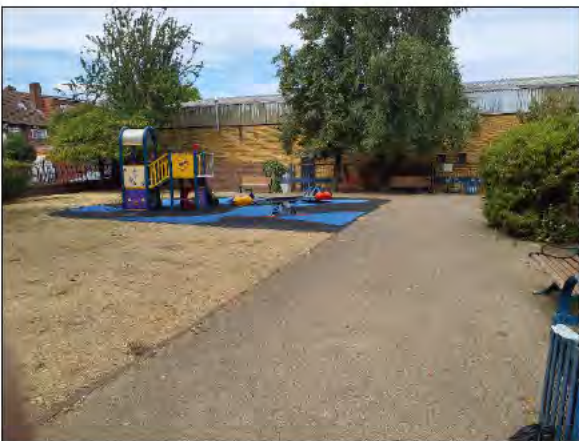
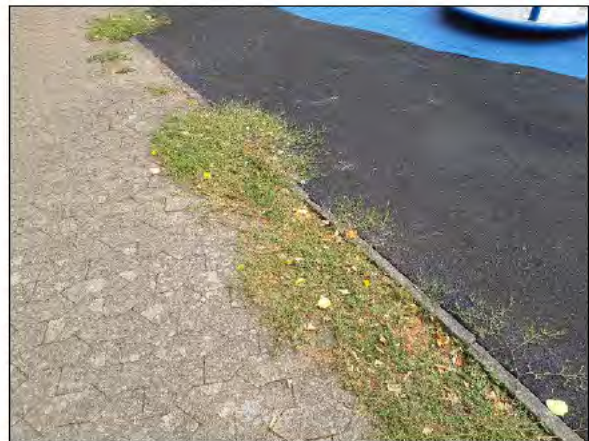
**Item:** Ancillary Items - Site General  
**Manufacturer:** Owner/Operator

**Finding:** There is weed / vegetation growth on, between, or around the edges of the paved surfacing  
**Action:** Remove weed / vegetation growth

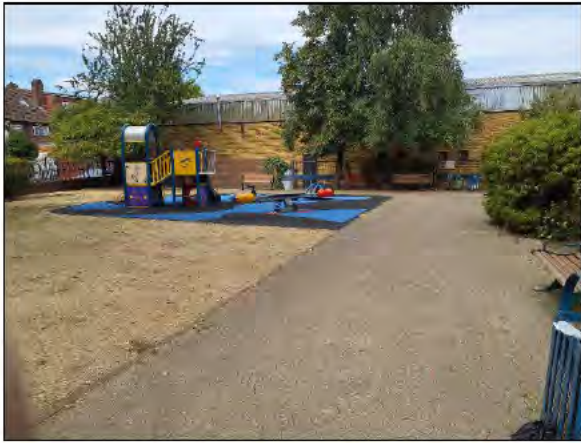
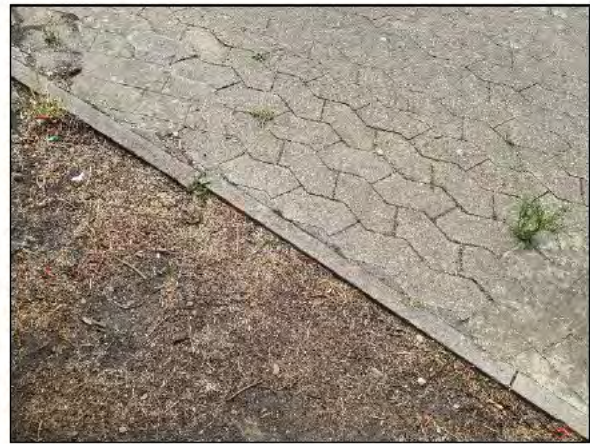
<b>Item:</b>	Ancillary Items - Site General	<b>Risk Level:</b>	8 - Low Risk
<b>Manufacturer:</b>	Owner/Operator	<b>Surface:</b>	N/A

**Finding:** There are trip hazards at the edges of the surface  
**Action:** Reinstate surrounding surface levels to remove the trip points

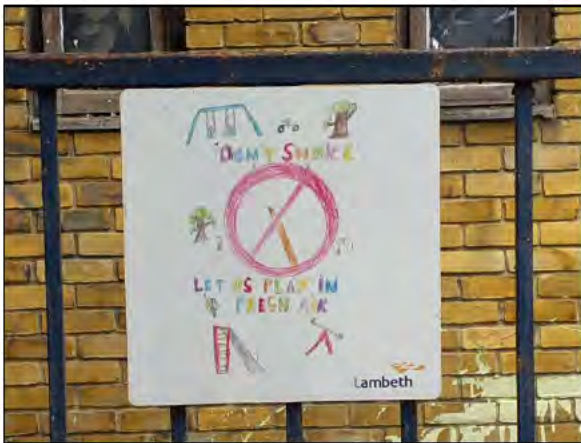
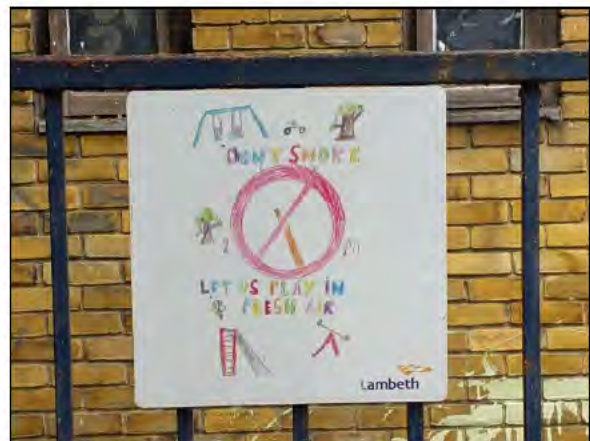
<b>Item:</b>	Ancillary Items - Sign	<b>Risk Level:</b>	5 - Very Low Risk
<b>Manufacturer:</b>	Not Applicable	<b>Surface:</b>	N/A

**Finding:** It is recommended that signage, with information including the site address, contact information for maintenance issues and emergency contact details are provided for the facility  
**Action:** Provide in accordance with the recommendations

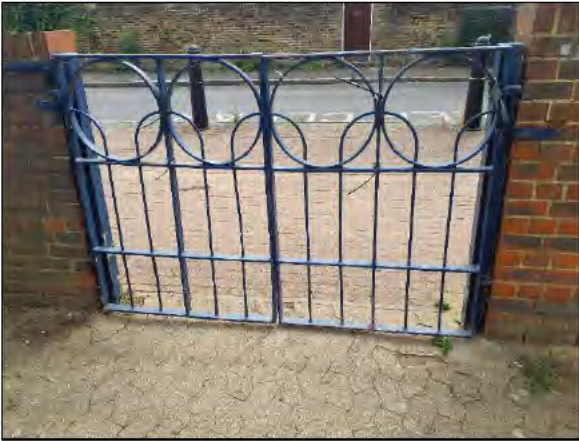
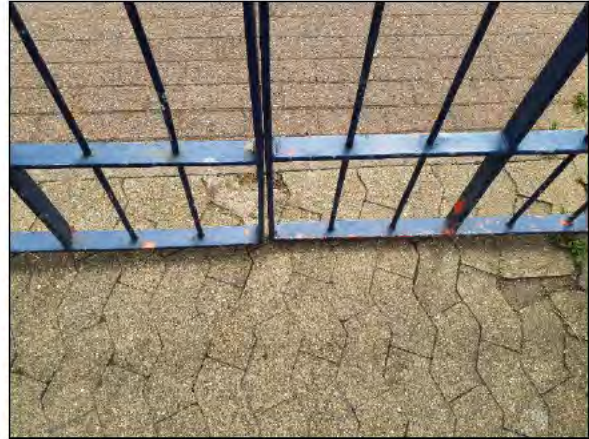
**Item:** Gates - Gate - Pedestrian  
**Manufacturer:** Unknown

**Finding:** The gate has no drop bolt sleeves and/or drop bolts fitted  
**Action:** Provide drop bolt sleeves and/or drop bolts

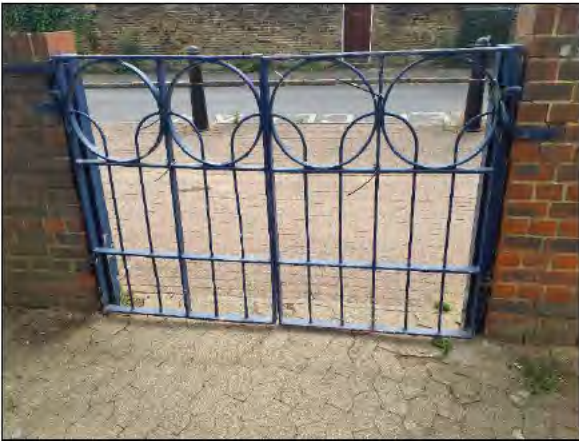
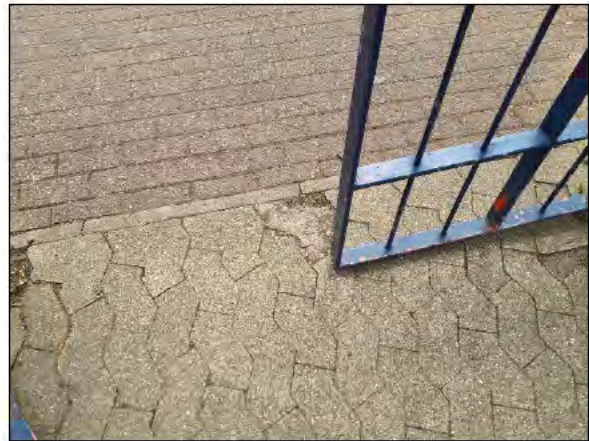
**Item:** Gates - Gate - Pedestrian  
**Manufacturer:** Unknown

**Finding:** There is no padlock on the maintenance gate  
**Action:** Provide a padlock to secure the gate

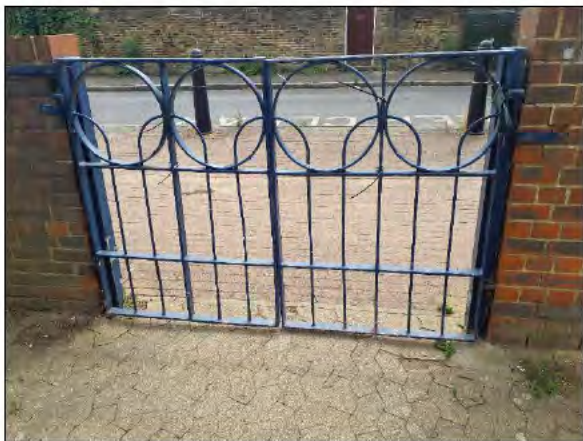
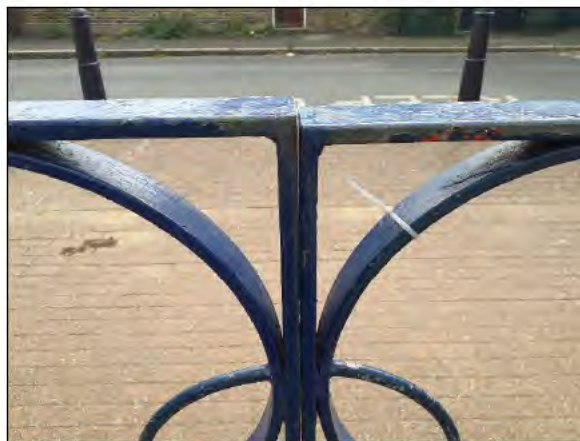
**Item:** Gates - Gate - Pedestrian  
**Manufacturer:** Unknown

**Finding:** There are openings that are less than 12mm that could trap or crush fingers  
**Action:** Where possible a 12mm gap should be maintained on both sides or between the gate leaves

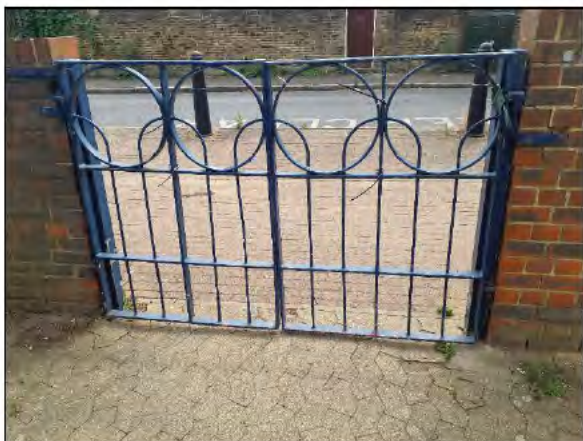
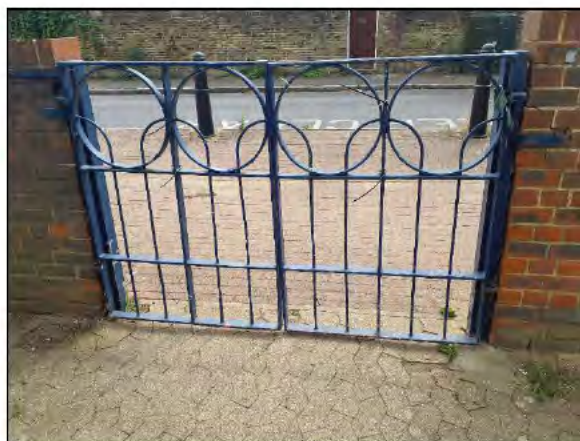
**Item:** Gates - Gate - Pedestrian  
**Manufacturer:** Unknown

**Finding:** There is no slamming plate on the gate  
**Action:** Provide a slamming plate

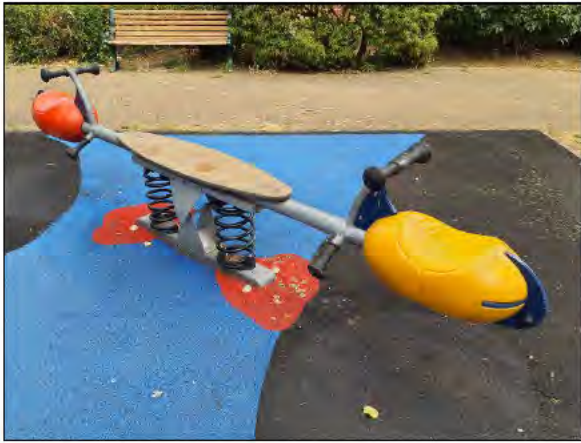
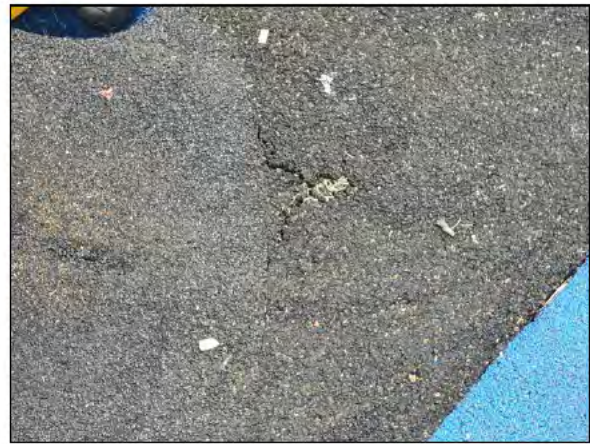
**Item:** Rocking Equipment - Spring See-Saw  
**Manufacturer:** Kompan Ltd

**Finding:** There is some minor damage to the surface  
**Action:** Monitor for any further deterioration and repair as required

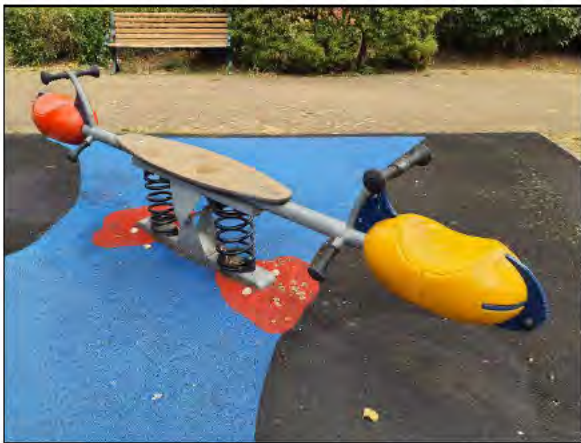
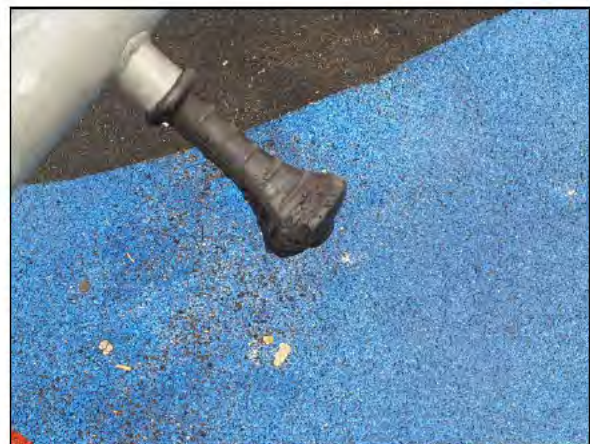
**Item:** Rocking Equipment - Spring See-Saw  
**Manufacturer:** Kompan Ltd

**Finding:** There is minor damage to the handgrips/footrests  
**Action:** Monitor and replace if required

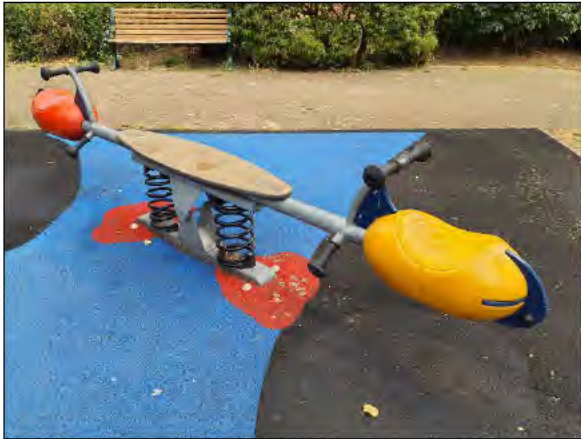
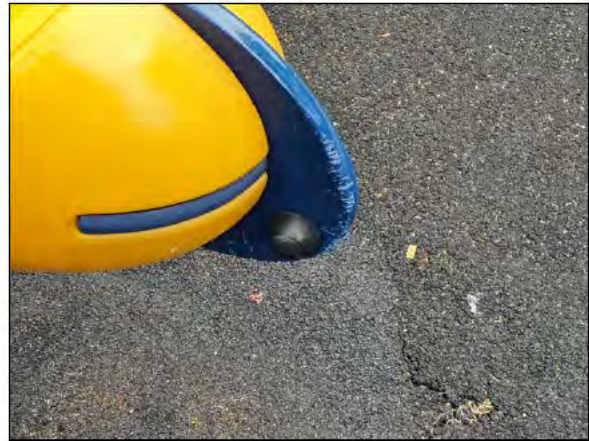
**Item:** Rocking Equipment - Spring See-Saw  
**Manufacturer:** Kompan Ltd

**Finding:** There is minor vandalism damage to the body  
**Action:** Remove the sharp protrusions

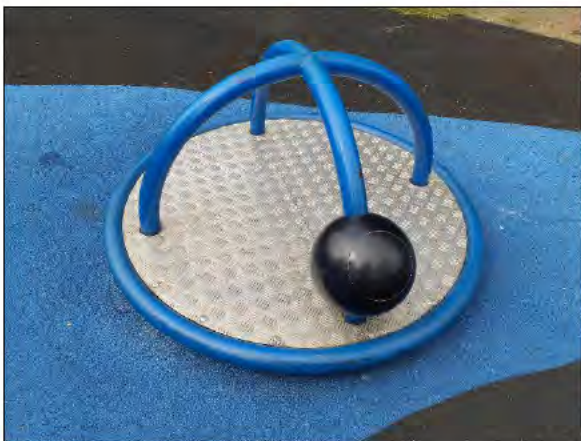
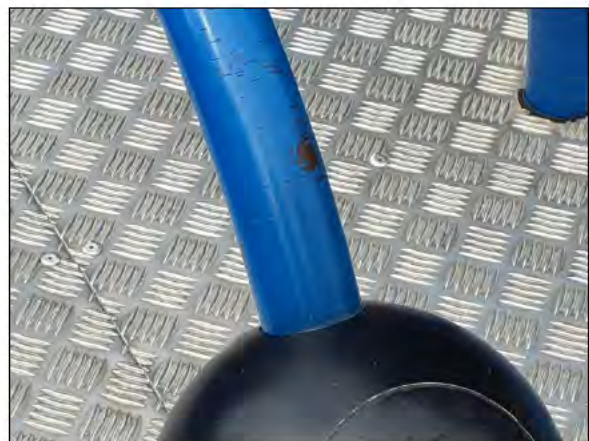
**Item:** Rotor Play - Roundabout  
**Manufacturer:** Berliner Seil Fabrik

**Finding:** The paintwork on this item has been damaged or worn exposing the metal underneath which is rusting  
**Action:** Treat any rusting components and repaint

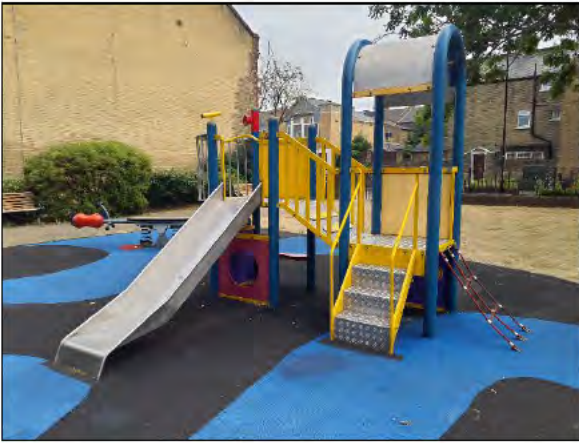
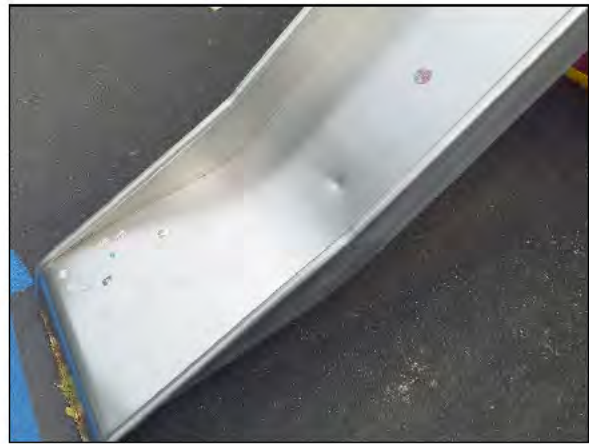
<b>Item:</b>	Activity Equipment - Multi Play (Toddler)	<b>Risk Level:</b>	4 - Very Low Risk
<b>Manufacturer:</b>	Russell Leisure Ltd	<b>Surface:</b>	Wet Pour

**Finding:** There are a number of dents in the slide surface  
**Action:** Monitor for any further deterioration and repair as required

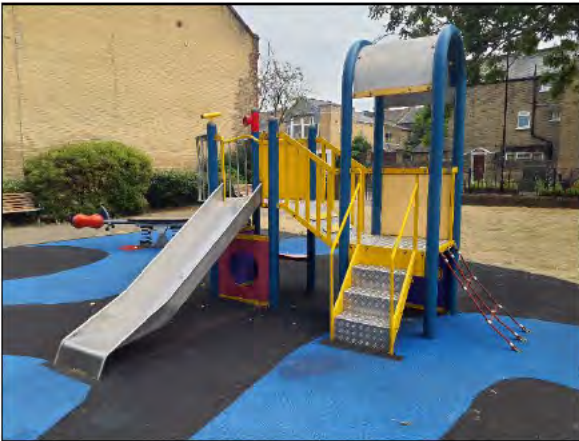
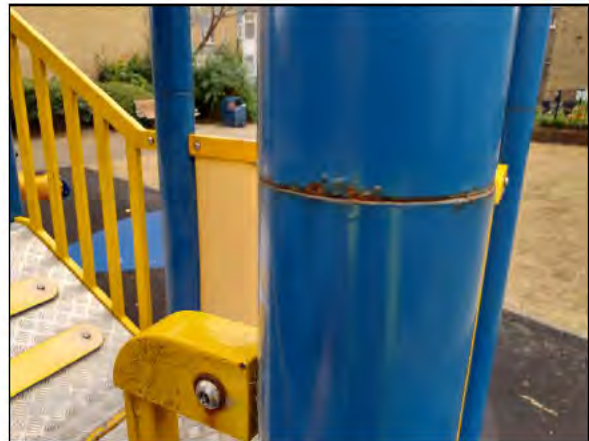
<b>Item:</b>	Activity Equipment - Multi Play (Toddler)	<b>Risk Level:</b>	6 - Low Risk
<b>Manufacturer:</b>	Russell Leisure Ltd	<b>Surface:</b>	Wet Pour

**Finding:** The paintwork on this item has been damaged or worn exposing the metal underneath which is rusting  
**Action:** Treat any rusting components and repaint

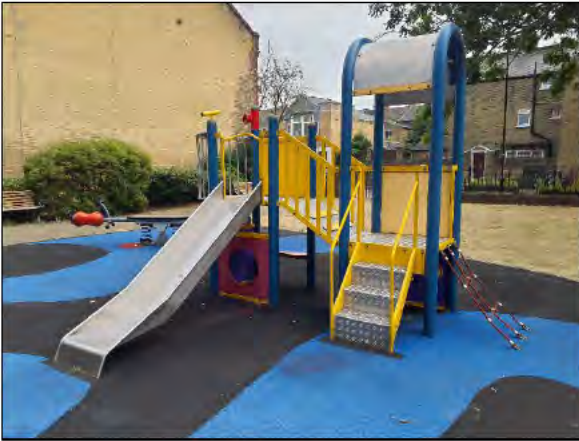
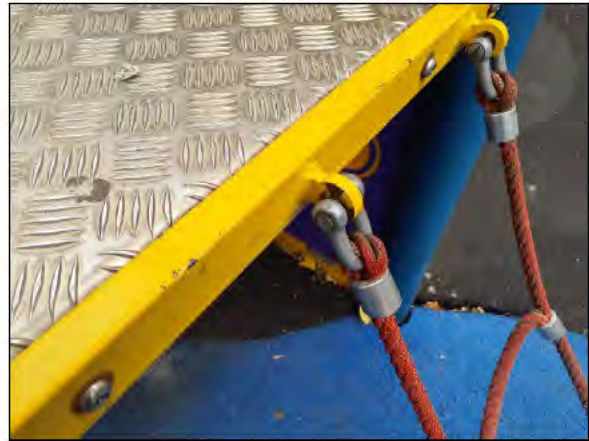
**Item:** Activity Equipment - Multi Play (Toddler)  
**Manufacturer:** Russell Leisure Ltd

**Finding:** The bushes are worn or missing  
**Action:** Replace worn or missing bushes

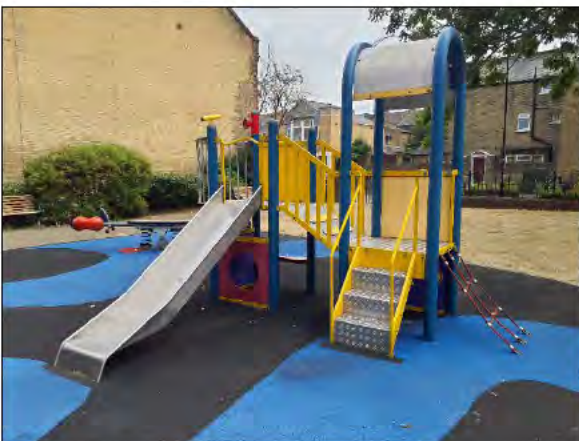
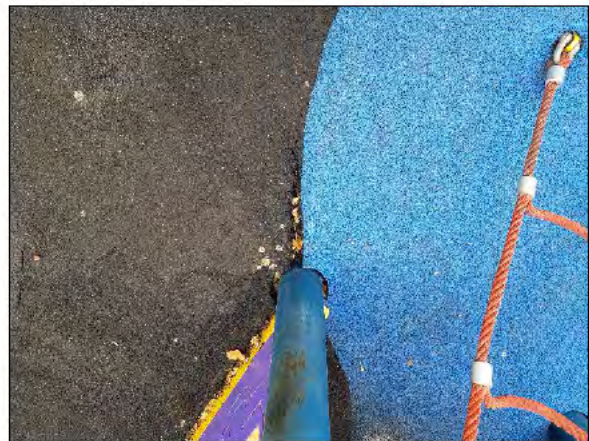
**Item:** Activity Equipment - Multi Play (Toddler)  
**Manufacturer:** Russell Leisure Ltd

**Finding:** There is damage to the surface  
**Action:** Repair the damaged areas of surfacing

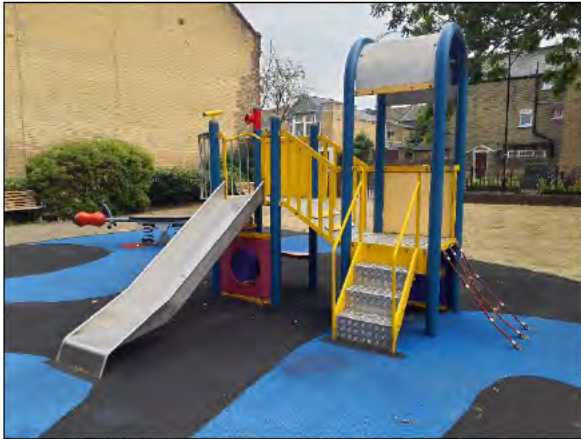
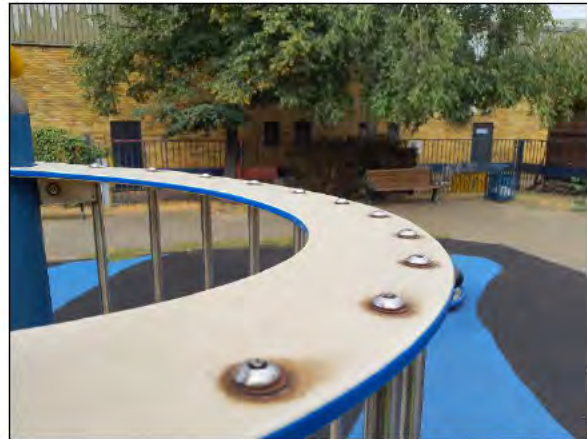
**Item:** Activity Equipment - Multi Play (Toddler)  
**Manufacturer:** Russell Leisure Ltd

**Finding:** The design of the barriers encourages standing or sitting and fails the requirements of BS EN 1176  
**Action:** Monitor - No remedial work recommended

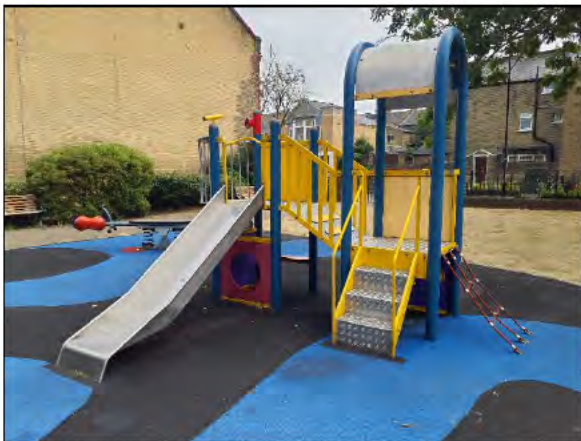
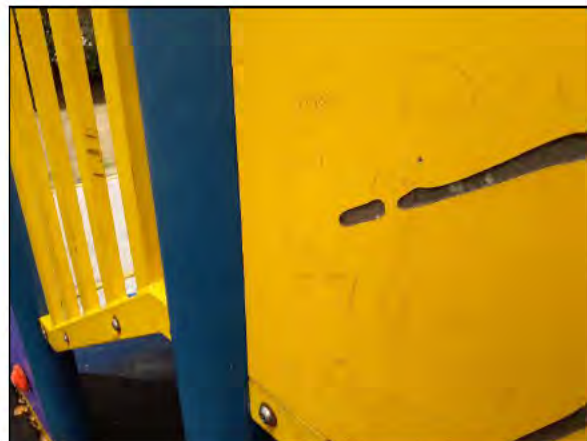
**Item:** Activity Equipment - Multi Play (Toddler)  
**Manufacturer:** Russell Leisure Ltd

**Finding:** There is some graffiti present  
**Action:** Remove the graffiti

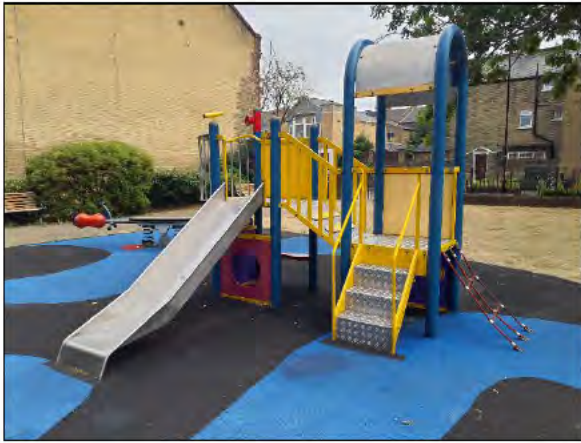
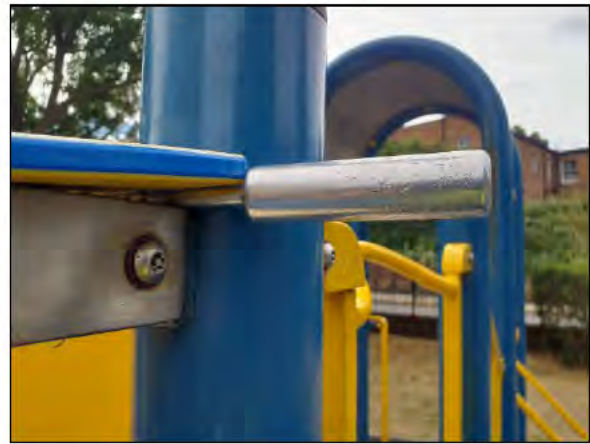
<b>Item:</b>	Activity Equipment - Multi Play (Toddler)	<b>Risk Level:</b>	5 - Very Low Risk
<b>Manufacturer:</b>	Russell Leisure Ltd	<b>Surface:</b>	Wet Pour

**Finding:** There is/are finger entrapment/s in the structure and the item fails to meet the requirements of BS EN 1176 Part 1 4.2.7.6 Entrapment of fingers

**Action:** Monitor - No remedial work recommended

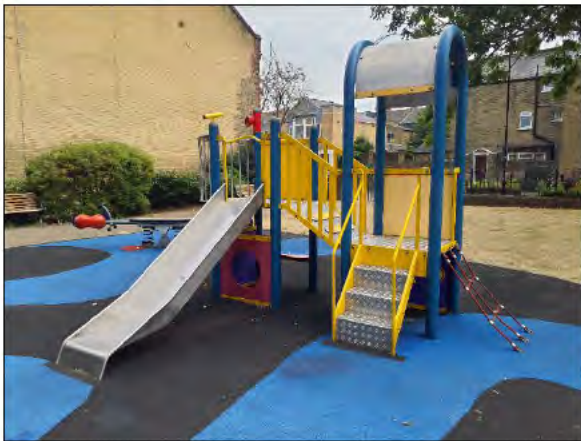
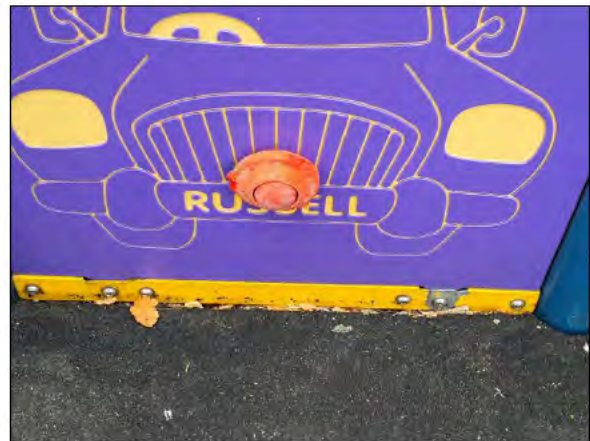
<b>Item:</b>	Activity Equipment - Multi Play (Toddler)	<b>Risk Level:</b>	6 - Low Risk
<b>Manufacturer:</b>	Russell Leisure Ltd	<b>Surface:</b>	Wet Pour

**Finding:** The item has damaged/missing component(s)

**Action:** Consider replacing damaged/missing components
