123 Knights Hill, West Norwood,  
London, SE27 0SP

## Structural Engineer's Crack Monitoring Report

**Lambeth Housing**

September 2022

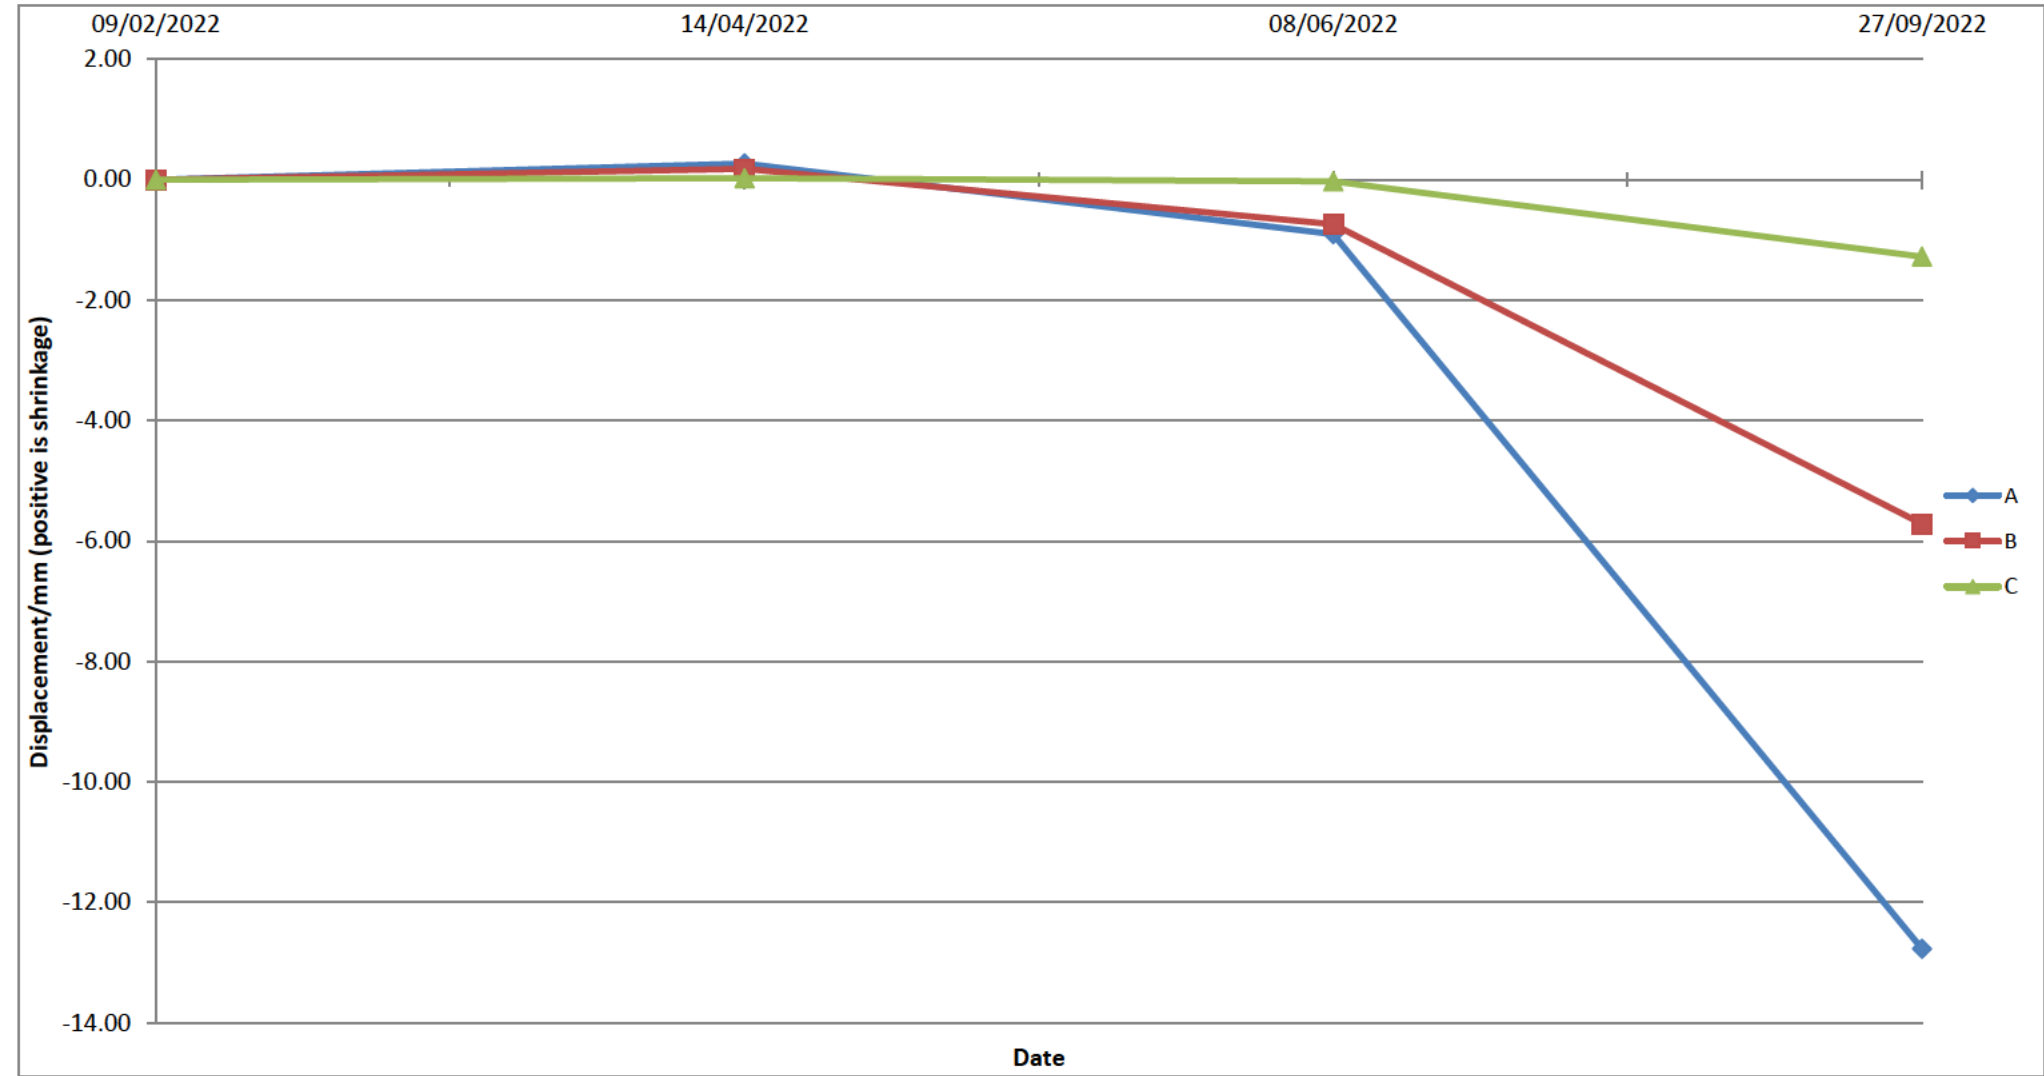
Change From Start				
	09/02/2022	14/04/2022	08/06/2022	27/09/2022
A	0.00	0.27	-0.90	-12.77
B	0.00	0.18	-0.74	-5.71
C	0.00	0.03	-0.03	-1.28
Neg = Wider				
Pos = Shrink

- 3.4 It is possible that recent weather in the UK has exacerbated ground movements. This year has seen five consecutive months of below average rainfall across all regions in England and above average temperatures. According to the Environment Agency, river flows, groundwater levels and reservoir stocks all decreased during July. It is thought possible that the lack of rainfall has caused movements to become more extreme resulting in the degree of cracking present and the significant movement recorded in the recent crack monitoring exercise.

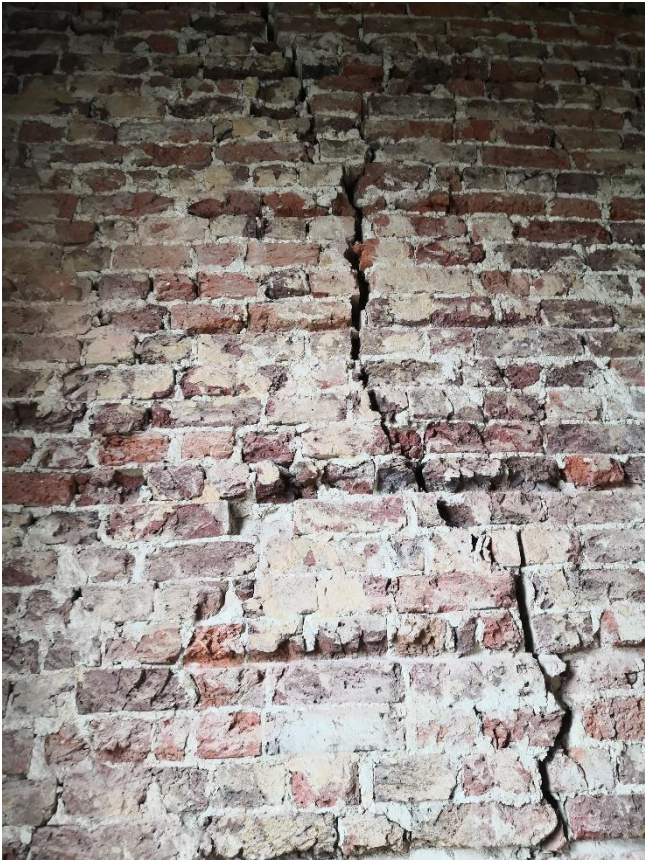
- 3.1 Stud group A is located internally in the stair area on the internal wall adjacent to the upper switchback of the stairs, across an approximately vertical crack that has moved considerably over the period of monitoring. Initially the crack remained relatively stable, before a trend of horizontal expansion started. This expansion became more extreme towards the conclusion of the crack monitoring exercise. The crack has expanded by 12.77mm by the end of the monitoring period, although most of this movement occurred in June-September period.

- 4.1 Crack A, internally in the stair area in the internal wall adjacent to the upper switchback of the stairs (left)
- 4.2 Crack B, internally in the ground floor hallway in the internal wall below the upper switchback of the stairs (right)

- 3.11 It is not thought that movement has ceased sufficiently for remedial repairs to be successfully implemented at this time, and any remedial repairs carried out are likely to fail as movement continues.

- 3.12 We recommend that once trees and dense foliage have been removed, as per recommendation 5.7 of SFSP report, dated July 2022, crack monitoring is continued and once it has been determined that significant progressive movements have ceased (and only then), that repairs are undertaken.

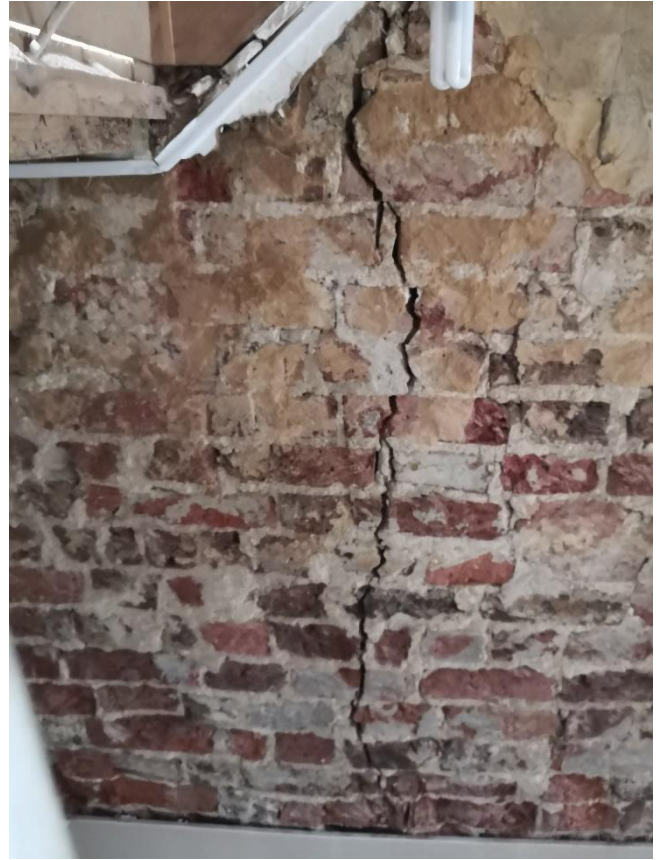
- 3.2 Stud group B is located internally in the ground floor hallway on the internal wall below the upper switchback of the stairs across an approximately vertical crack. This is a continuation of crack A, but at a lower level. The crack has expanded over the period of monitoring. A similar pattern is seen in the magnitude of movement as that at A, with the initial period having only slight movements and more significant movement occurring in the June-September period.

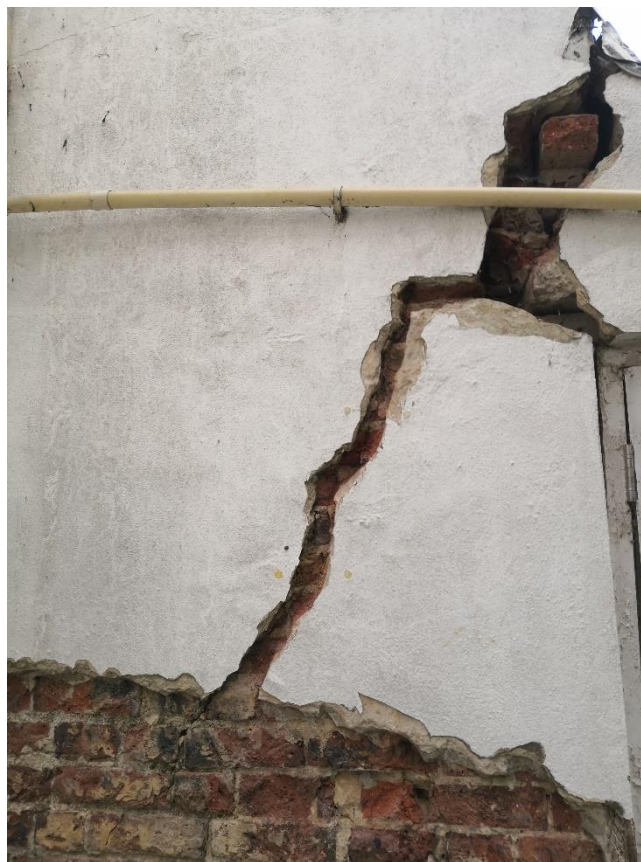
- 3.3 Stud group C, which is situated externally on the side of the one storey section of the property, has shown the least significant movement, on a diagonal crack that has expanded over the period of monitoring. Initially this cracked showed little to no movement before expansion began in the June-September period.

- 3.5 It is observed that the rear door was found to have become very stiff on the last crack monitoring visit, and considerable gaps were present around the frame. It is possible that more extreme movement in the wall with crack C is being facilitated by this gap and crack A and B on the same wall further into the property. Therefore, Crack C shows relatively small movements compared to other cracks monitored.

4.3 Crack C, externally on the side of the one storey section of the property

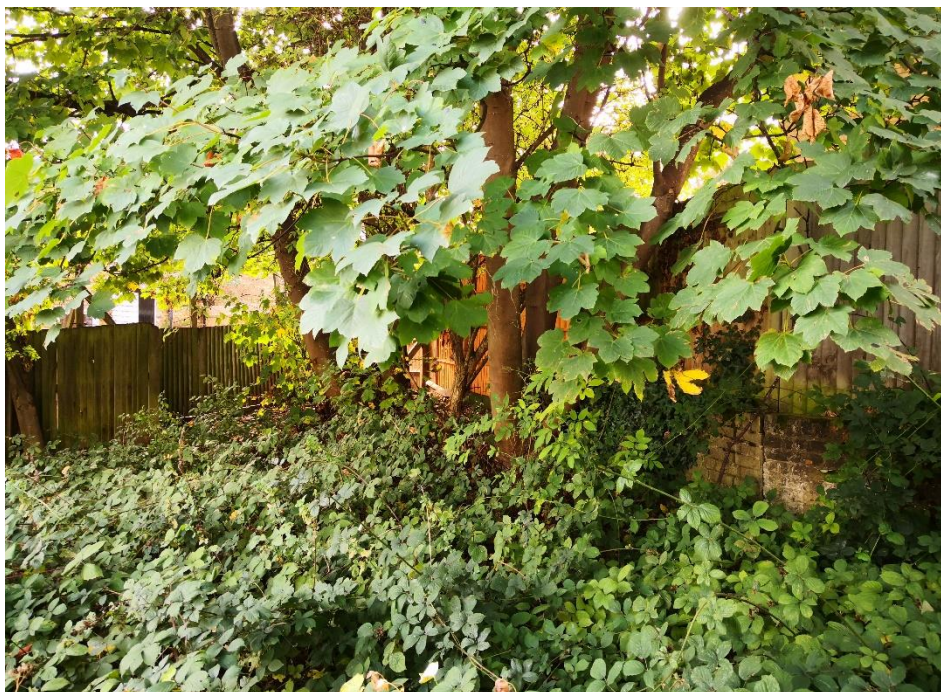
- 3.6 Two mature trees which have previously been determined by NHBC (Chapter 4.2 Building Near Trees) guidance to be too close to the property, especially with the shallow nature of the foundation at the property, remain in place (see photograph 4.4). Furthermore, dense foliage has also returned in the rear garden (see photograph 4.5). It is thought likely that trees and foliage have continued to remove moisture from the soils over the period of monitoring. The extreme movement occurring during the June-September period of monitoring is likely the result of the period of drought experienced in the region at this time.

4.4 General view of trees along southern boundary of rear garden

- 3.10 We recommend that, as per SFSP's Final Report recommendation 7.2, the two mature trees along the southern boundary of the garden are removed and dense foliage is removed. The garden should be maintained so that it is not overgrown, in order to reduce the influence of vegetation on soil moisture contents and to expose excavations in order to reduce fall risk.

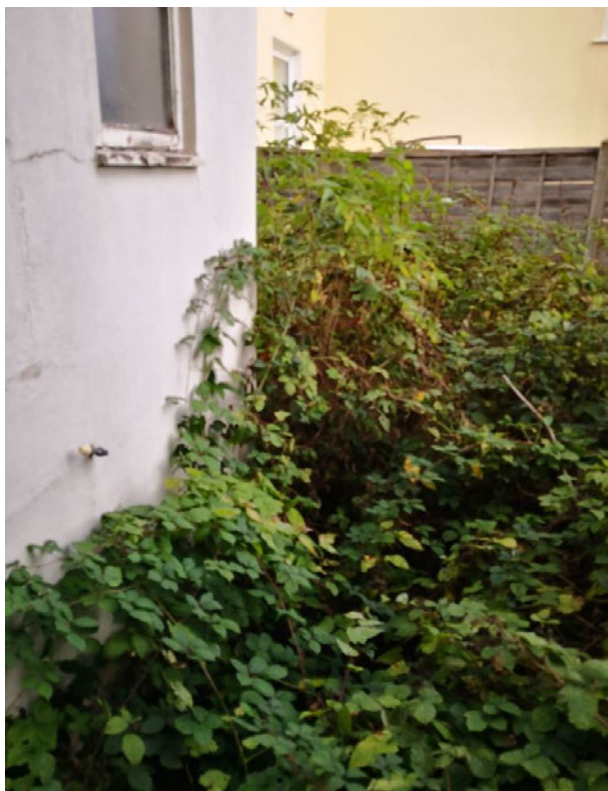
4.5 General view of the rear garden area (left)

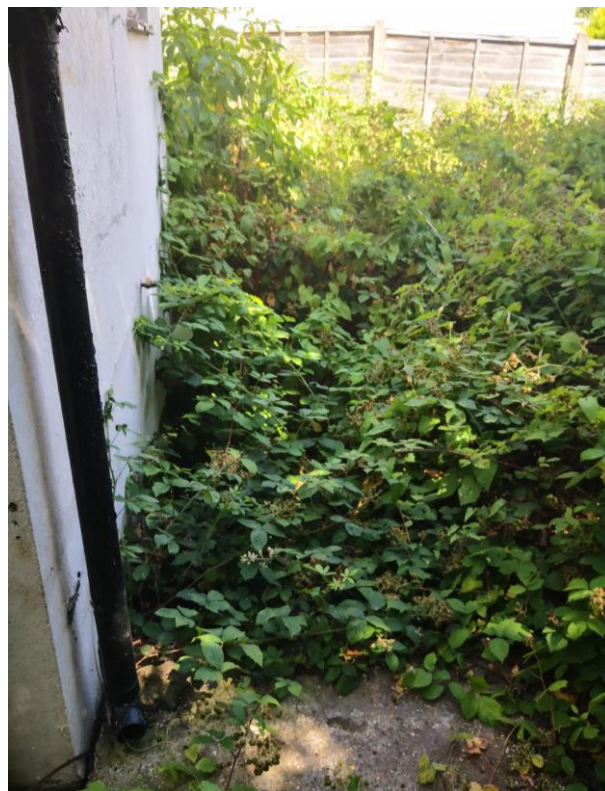
- 
- 3.7 The dense foliage in the rear garden has grown to such an extent that large foundation exposure excavations are concealed and present a danger to anyone attending the site (see photograph 4.6 and 4.7).

4.6 General view of the concealed foundation exposure excavations (right)

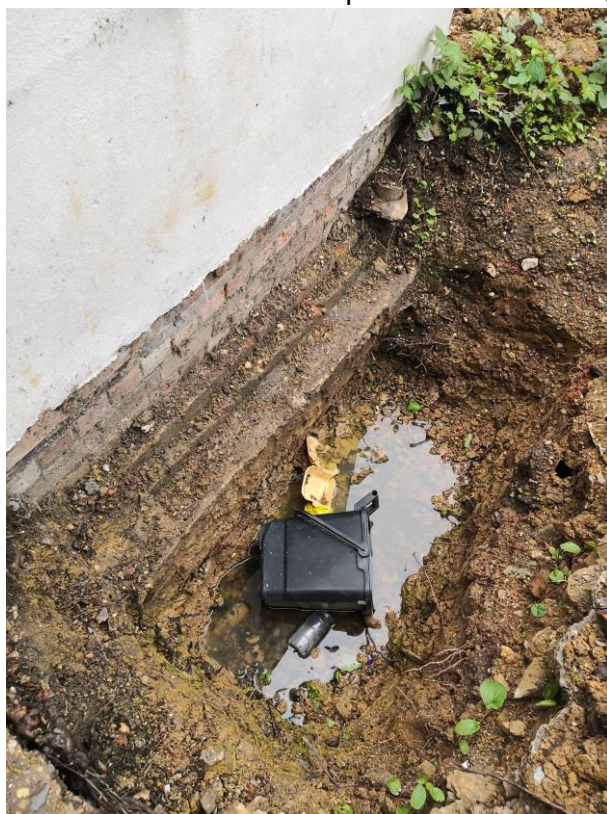
4.7 General view of excavation in photograph 4.5 prior to growth of foliage
