123 Knights Hill, West Norwood,  
London, SE27 0SP

## Structural Engineer's Report

**Prepared for:**  
**Lambeth Housing Management**  
**on the Instruction of Savills (UK) Ltd**

July 2022

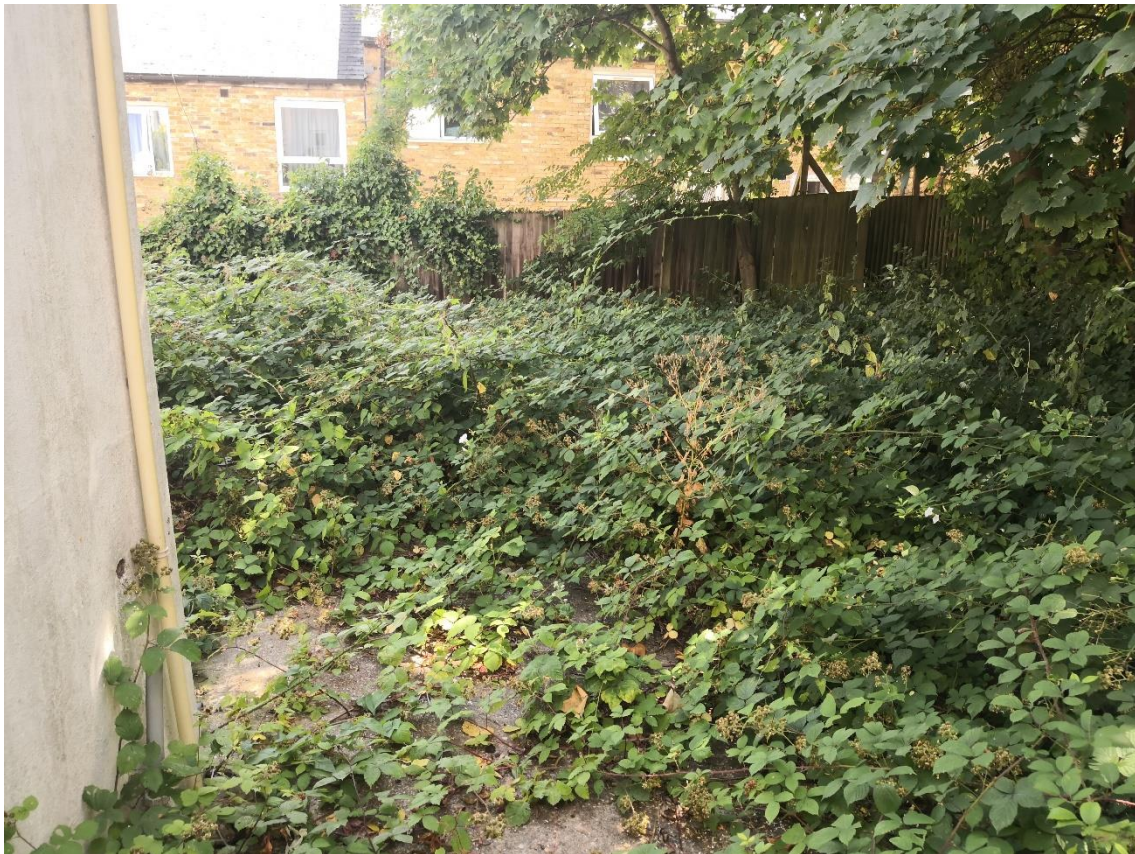
- 4.6 The dense foliage in the rear garden has grown to such an extent that large foundation exposure excavations are concealed and present a danger to anyone attending the site.

6.2 General view of the rear garden of 123 Knights Hill. Note extensive foliage

- 5.2 We recommend that, as per SFSP's Final Report recommendation 7.2, the two mature trees along the southern boundary of the garden are removed and dense foliage is removed. The garden should be maintained so that it is not overgrown, in order to reduce the influence of vegetation on soil moisture contents and to expose excavations in order to reduce fall risk.

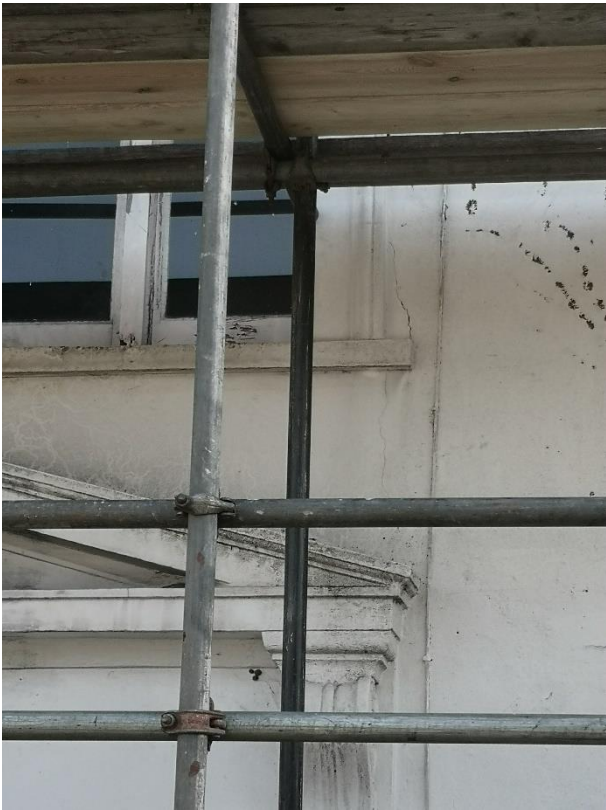
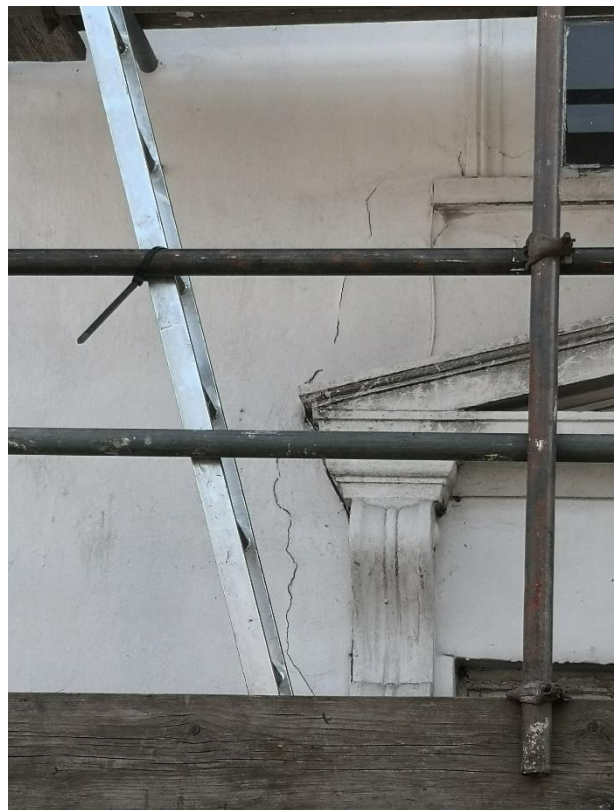
- 3.1.1 A hairline crack was seen at the bottom right-hand corner of the first-floor right-hand window (see photograph 6.3).
- 3.1.2 1-2mm wide cracks were noted at the top right and left-hand corners of the of the left-hand ground floor window (see photographs 6.4 and 6.5).
- 3.1.3 A 1-2mm wide crack was observed at the top right-hand corner of the first-floor left-hand window (see photograph 6.6).

- 6.3 Hairline crack in the front elevation at the bottom right-hand corner of the first-floor right-hand window (left)
- 6.4 1-2mm wide crack in the front elevation at the top right-hand corner of the left-hand ground floor window (right)

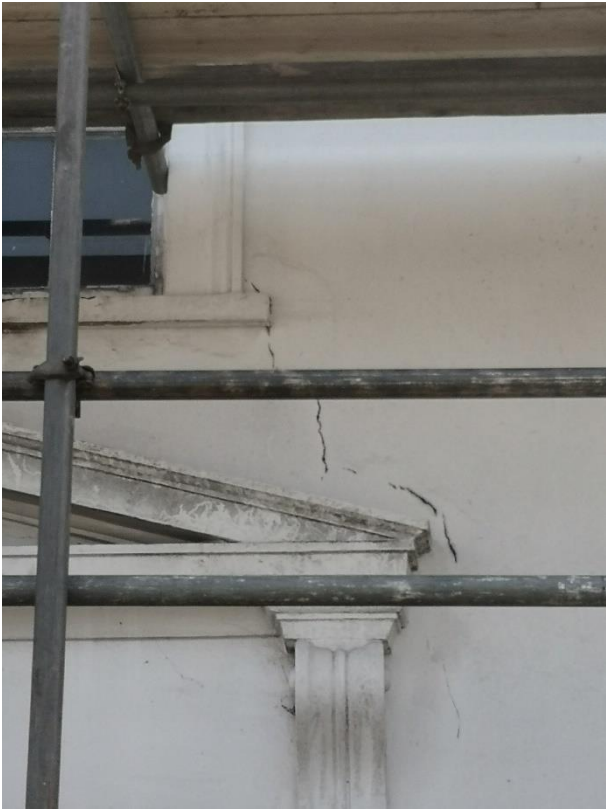
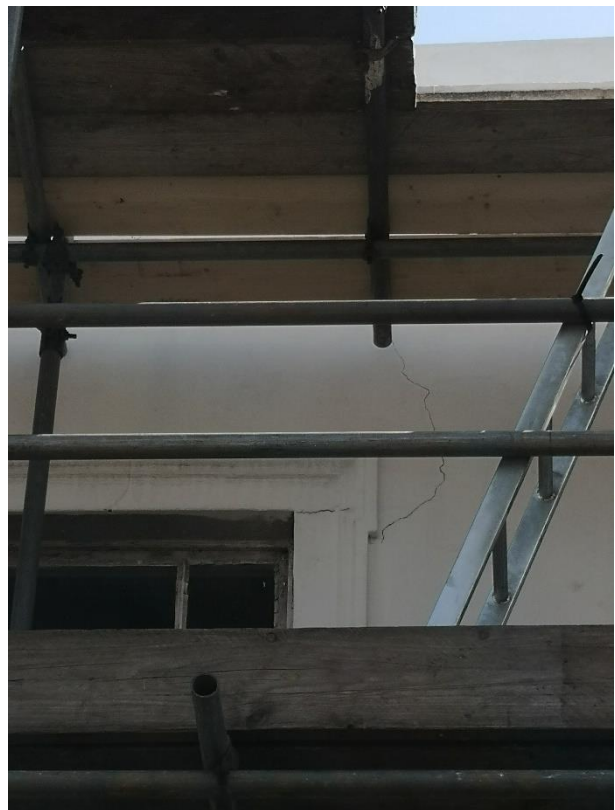
- 6.5 1-2mm wide crack in the front elevation at the top right-hand corner of the left-hand ground floor window (left)
- 6.6 1-2mm wide crack in the front elevation at the top right-hand corner of the first-floor left-hand window (right)

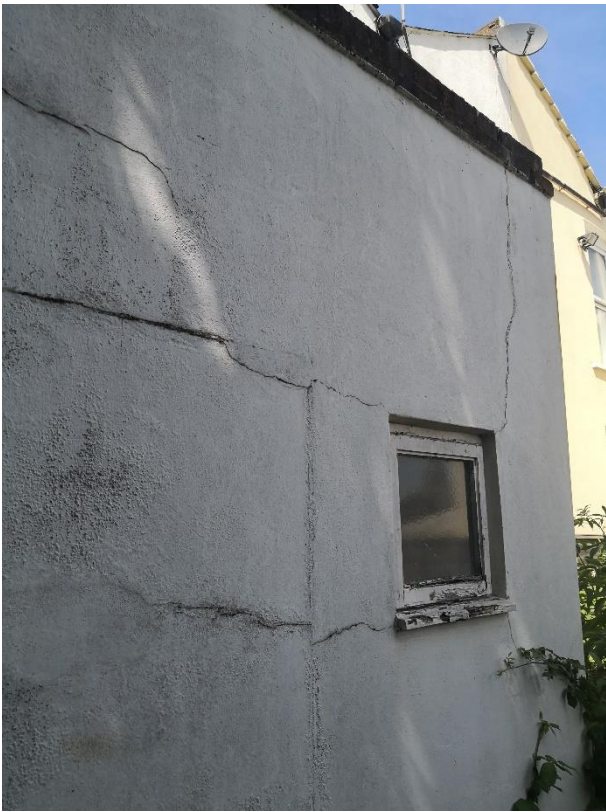
- 3.2.1 Numerous 1-3mm wide cracks were noted on the rear wall of the one storey section of the property (see photograph 6.7).
- 3.2.2 Significant cracks were observed at the top right and left-hand corners of the stair window (see photograph 6.8). It was noted that the wall above the window between these cracks appears to have moved outwards (see photograph 6.9).
- 3.2.3 A 5-15mm wide crack was observed on the left-hand side of the rear door on the side of the one storey section of the property (see photograph 6.10).
- 3.2.4 A 1-2mm wide crack was observed in the back of the parapet wall of the rear elevation of the one storey section (see photograph 6.11).

6.7 Numerous 1-3mm wide cracks in the rear elevation of the one storey section of the property (left)

- 5.7.3 The narrower cracks in the rear elevation should be injected with Fosroc Nitofill LV to maintain weather tightness of the property.
- 5.7.4 Helifix Helibar/CemTies reinforcement should be installed around joints between internal/party walls and the rear elevation wall, in accordance with manufacturer's instructions and Helifix repair details RW03 and RW04, then the cracks should be made good using an appropriate Helifix bonding agent depending on the width of the crack, in accordance with the manufacturer's instructions.

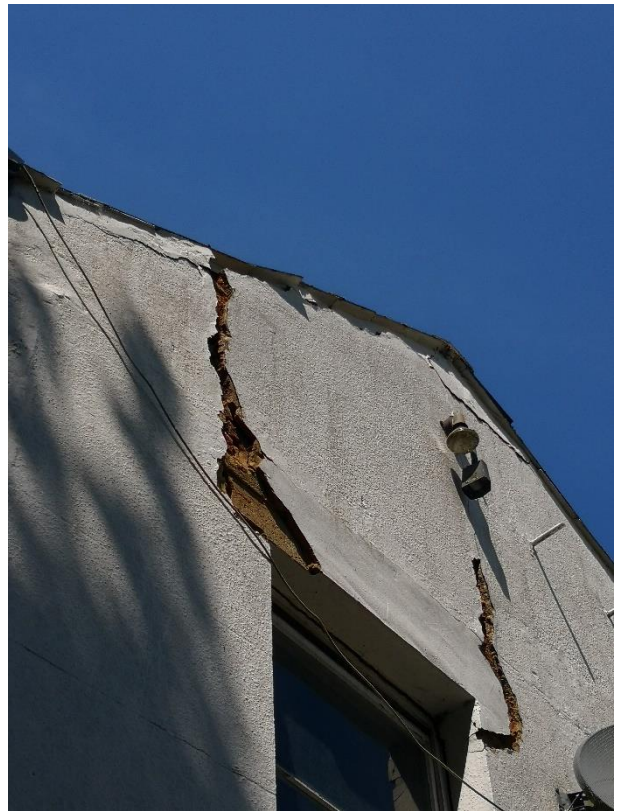
6.8 Significant cracks in the rear elevation at the top right and left-hand corners of the stair window. Note that the wall above the window appears to have moved outwards (right)

- 5.7.2 Bed joint reinforcement, such as Helifix Helibar, should be installed horizontally across the large cracks at the corners of the rear windows in accordance with manufacturer's

instructions and Helifix repair detail LR08, then the cracks be injected with Crackbond TE3 or similar, in accordance with the manufacturer's instructions.

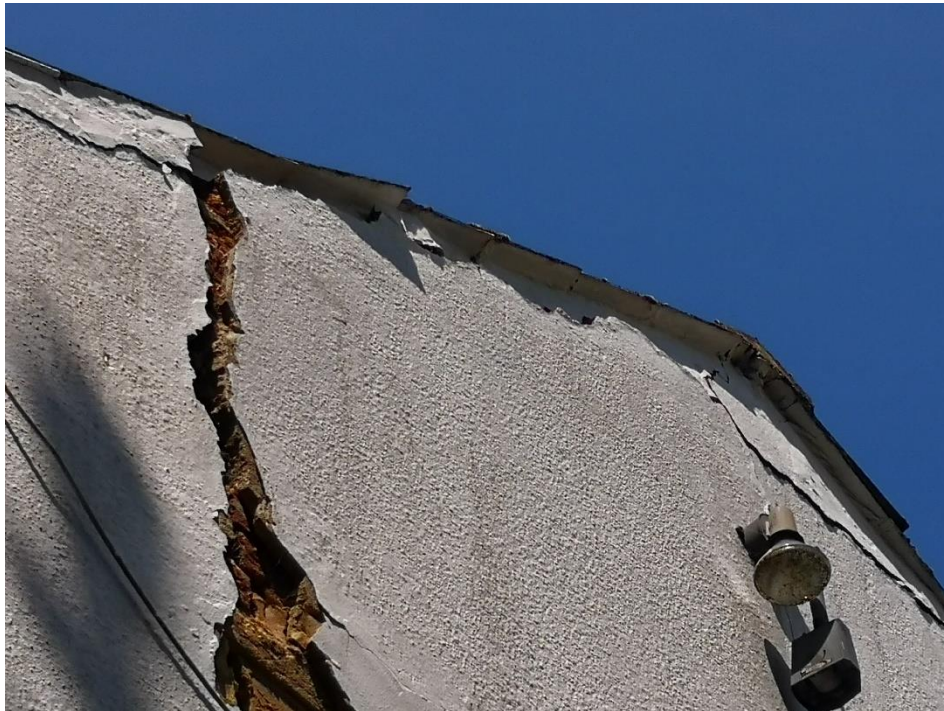
6.9 Section of wall above the stair window that appears to have moved outwards

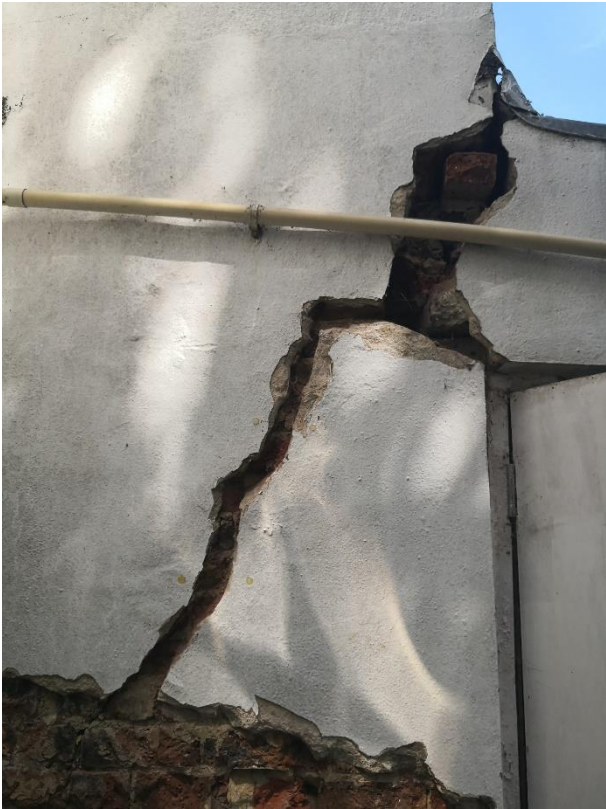
6.10 5-15mm wide crack on the left-hand side of the rear door on the side of the one storey section of the property (left)

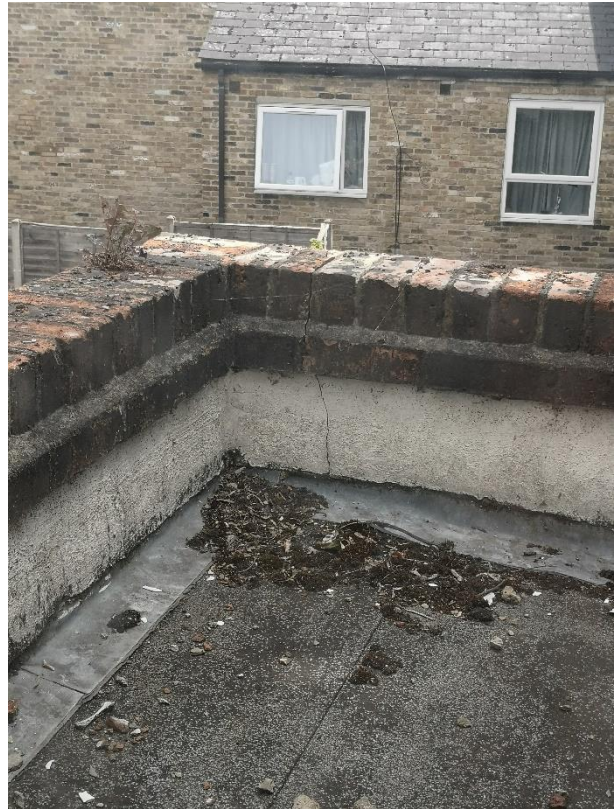
6.11 1-2mm wide crack was observed in the back of the parapet wall of the rear elevation of the one storey section (right)

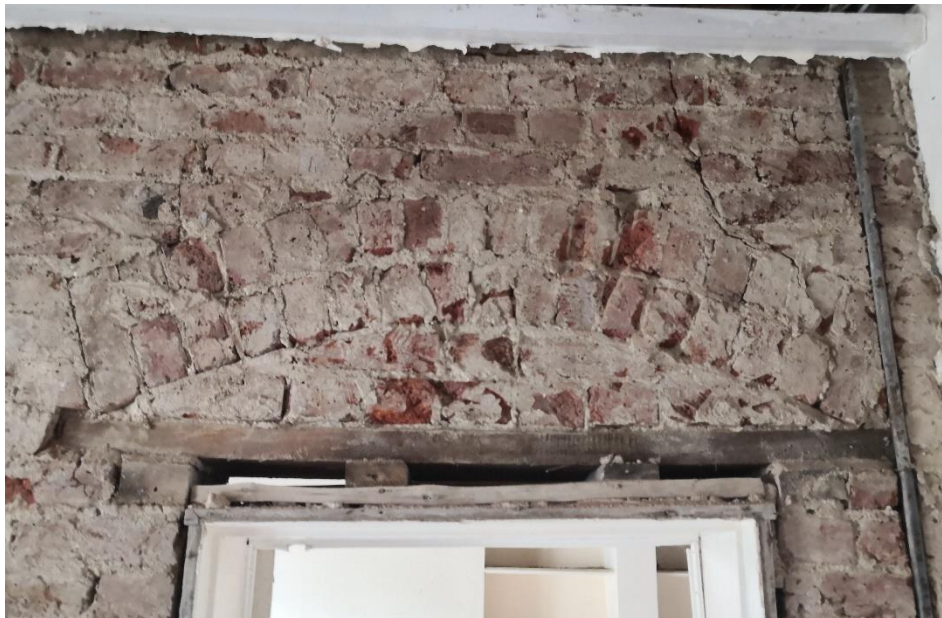
- 3.3.1 A 3-4mm wide crack was seen at the top right-hand corner of the front-most door to the large room (see photograph 6.12).
- 3.3.2 2-10mm wide cracks were seen at the top right and left-hand corners of the rear-most door to the large room (see photographs 6.13 and 6.14).
- 3.3.3 Significant areas of the internal masonry walls were observed to have deteriorated and masonry unit faces have broken away (see photographs 6.15 and 6.16).
- 3.3.4 A 4-6mm wide crack was noted below the stair landing in the external wall (see photograph 6.17).
- 3.3.5 A 10-15mm wide gap was seen down the right-hand side of the rear door (see photograph 6.18).
- 3.3.6 A 5-8mm wide gap was observed down the left-hand side of the rear door.

6.12 3-4mm wide crack in the ground floor hallway at the top right-hand corner of the front-most door to the large room

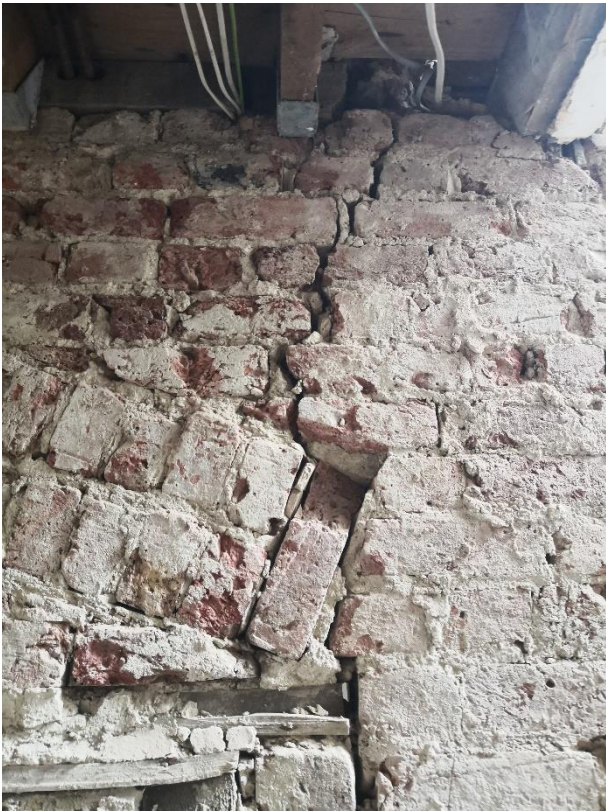
6.13 2-10mm wide crack in the ground floor hallway at the top right-hand corner of the rear-most door to the large room (left)

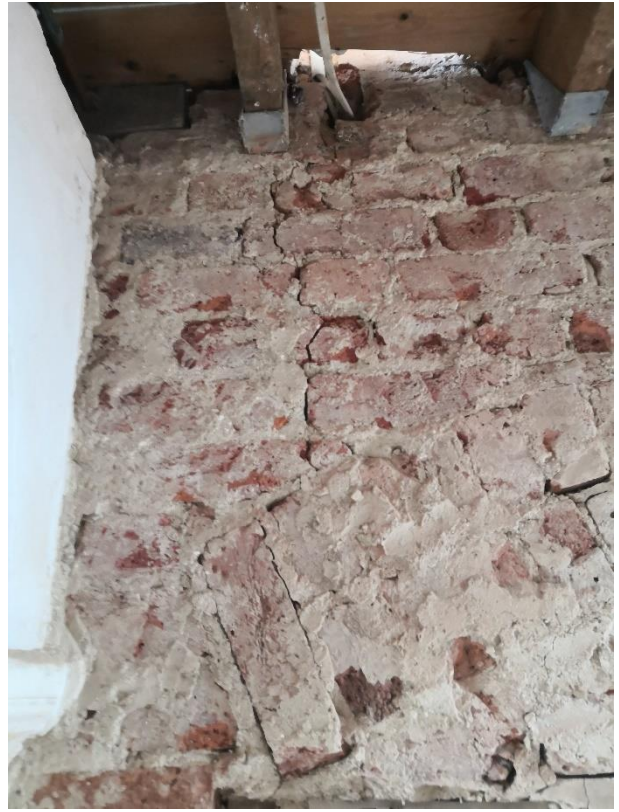
6.14 2-10mm wide crack in the ground floor hallway at the top left-hand corner of the rear-most door to the large room (right)

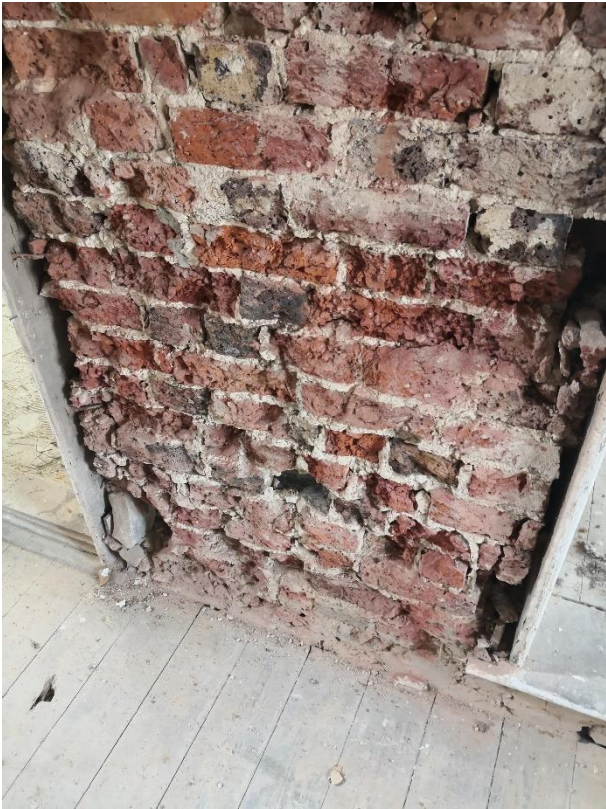
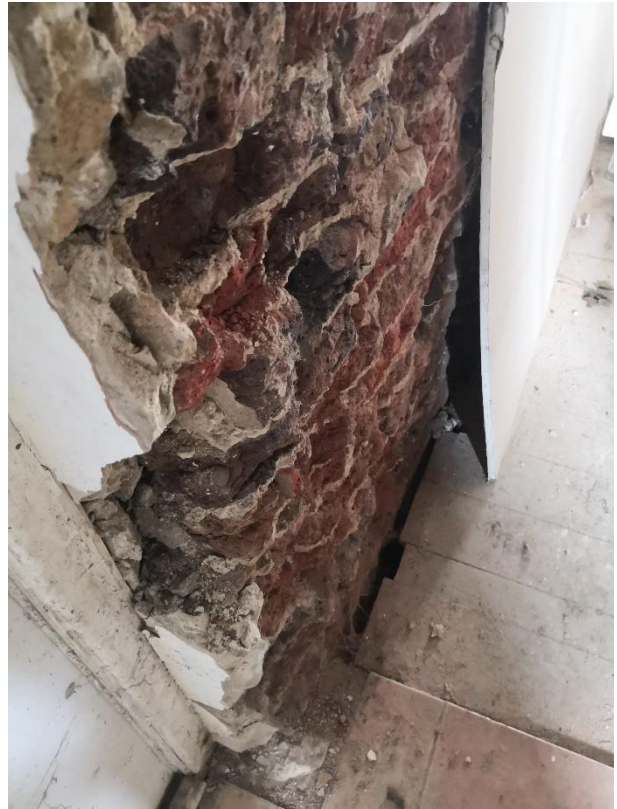
- 6.15 Area of the ground floor hallway internal masonry wall that has deteriorated. Note masonry unit faces have broken away (left)
- 6.16 Area of the ground floor hallway internal masonry wall that has deteriorated. Note masonry unit faces have broken away (right)

- 5.6 We recommend that in the internal wall where it is apparent that significant portions of masonry units have been lost, remaining sections of masonry units are carefully cut out and removed and replaced to match existing.

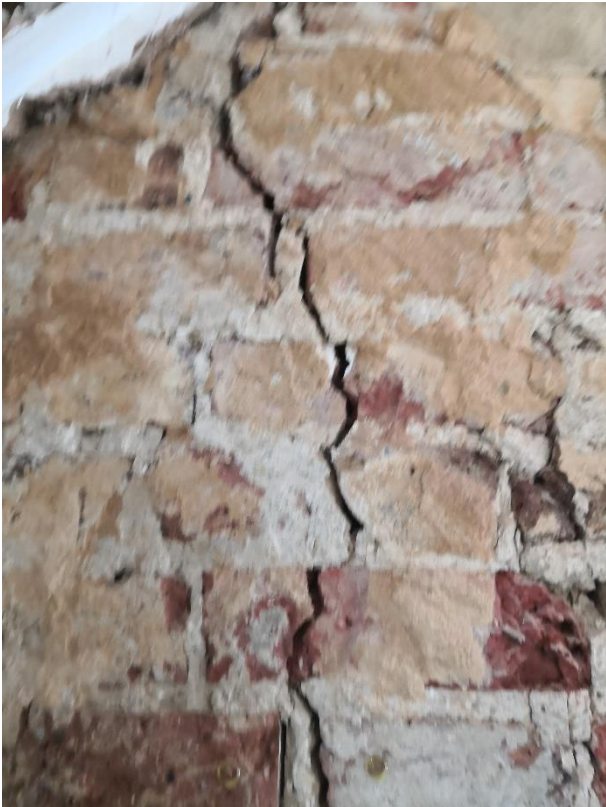
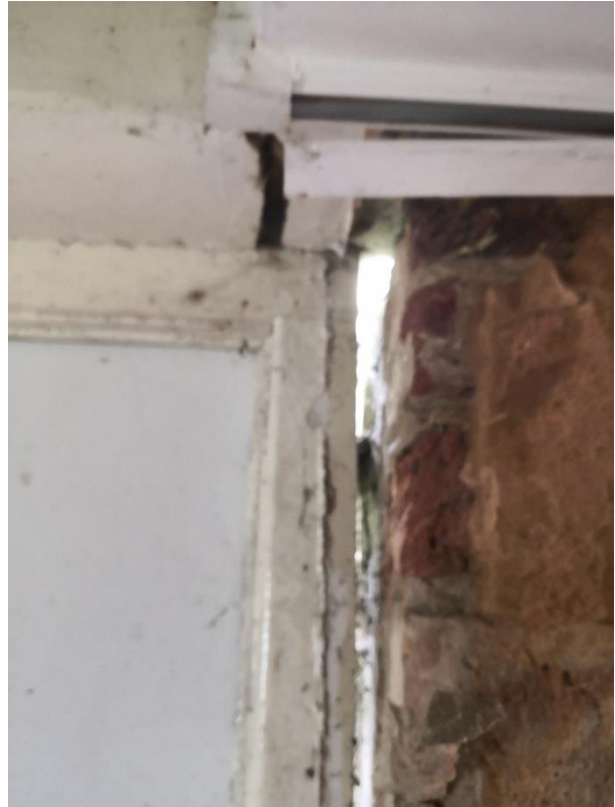
- 6.17 4-6mm wide crack in the ground floor hallway below the stair landing in the external wall (left)
- 6.18 10-15mm wide gap in the ground floor hallway down the right-hand side of the rear door (right)

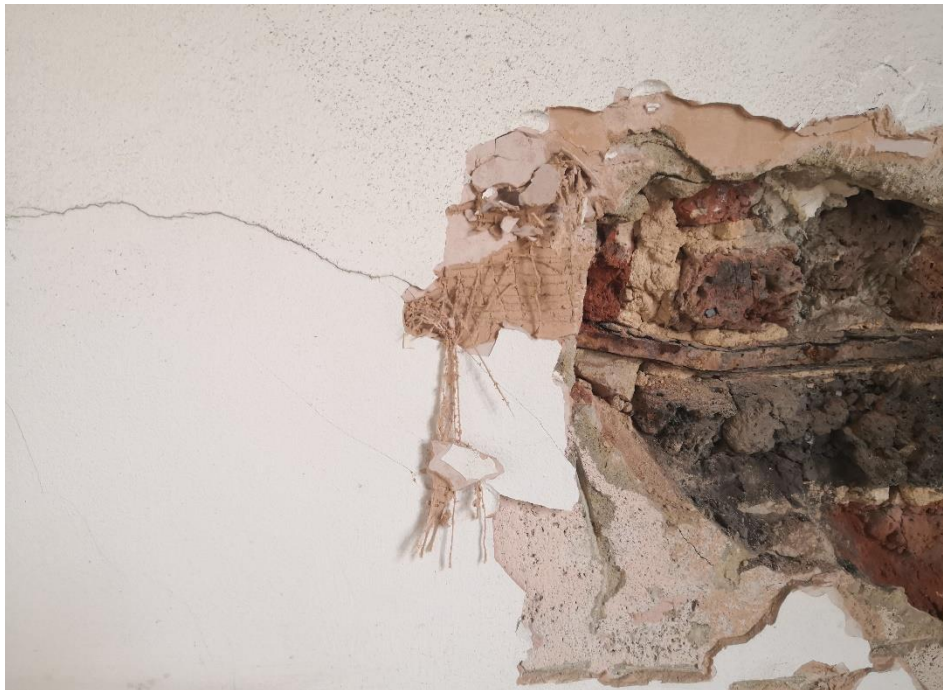
- 3.4.1     A hairline to 1mm wide crack was seen in the chimney breast (see photograph 6.19). It was noted that, where an area of plaster has been removed, a metal plate is embedded in chimney approximately level with the crack. The plate was observed to be rusted.
- 3.4.2     A 2-3mm wide crack was observed in the internal wall with the ground floor back left-hand room (see photograph 6.20).
- 3.4.3     1-2mm wide cracks were seen at the top right and left-hand corners of the door (see photograph 6.21).
- 3.4.4     Efflorescent staining was noted on the underside of the first-floor floorboards (see photograph 6.22).
- 3.4.5     A 1-2mm wide crack was observed in the internal wall with the downstairs hallway (see photograph 6.23).

- 6.19 Hairline to 1mm wide crack in the ground floor front left-hand room in the chimney breast, note exposed rusted metal plate

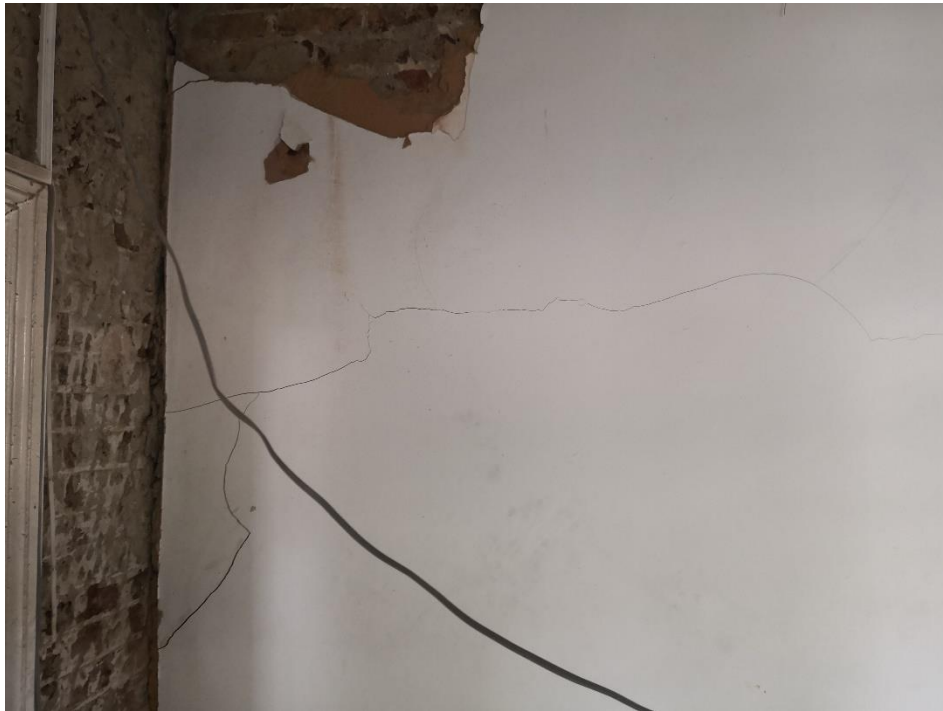
6.20 2-3mm wide crack in the ground floor front left-hand room in the internal wall with the ground floor back left-hand room

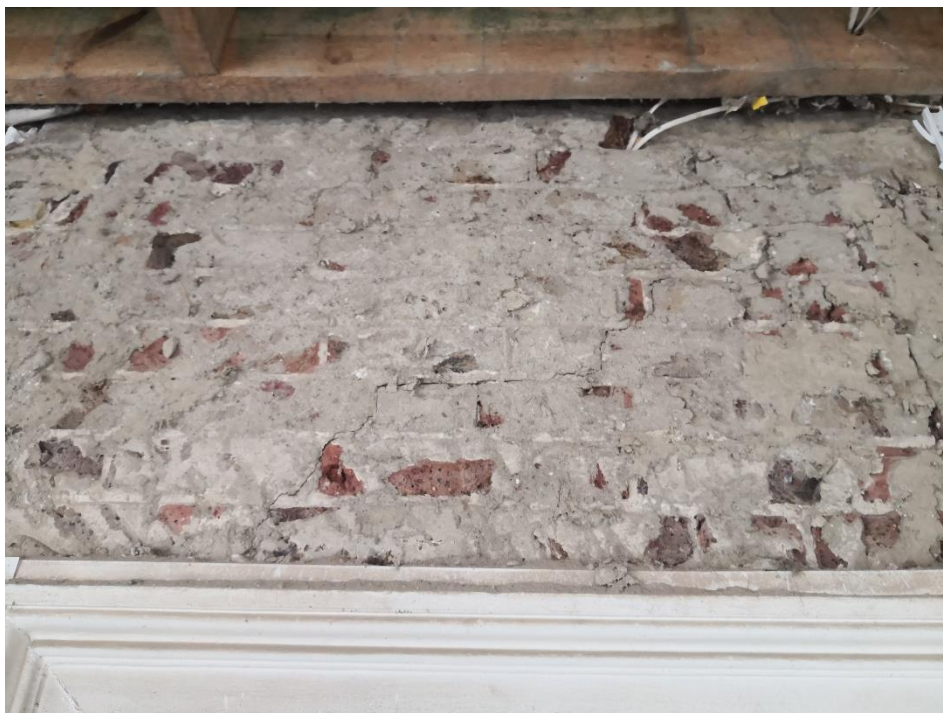
6.21 1-2mm wide cracks in the ground floor front left-hand room at the top left and right-hand corners of the door

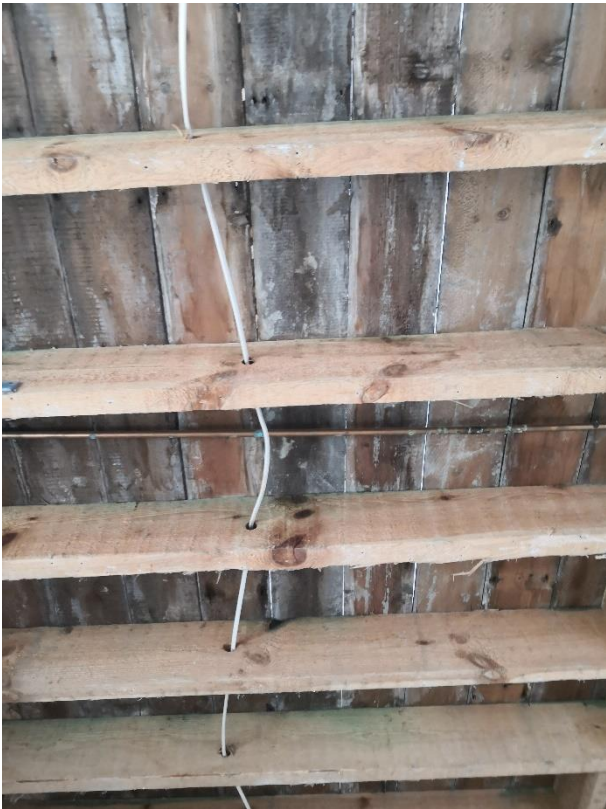
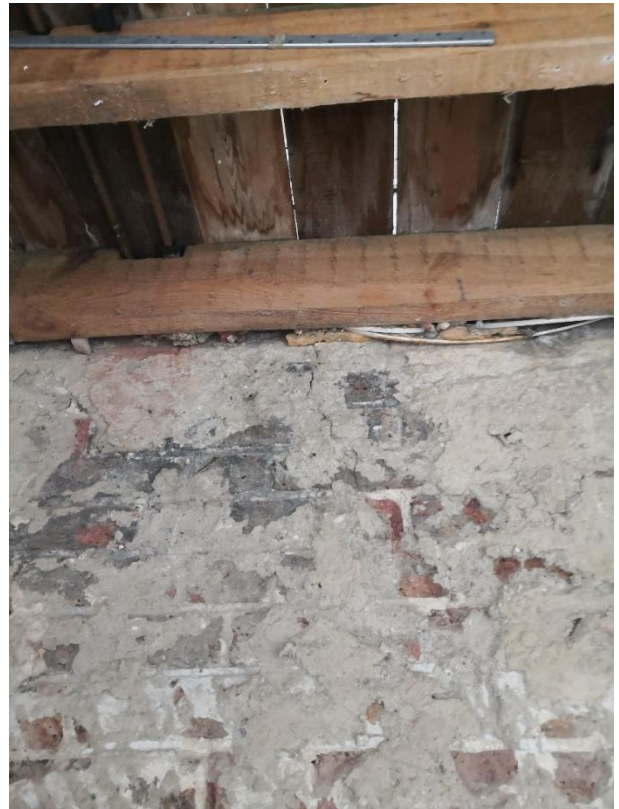
- 6.22 Efflorescent staining in the ground floor front left-hand room on the underside of the first-floor floorboards (left)
- 6.23 1-2mm wide crack in the ground floor front left-hand room in the internal wall with the hallway (right)

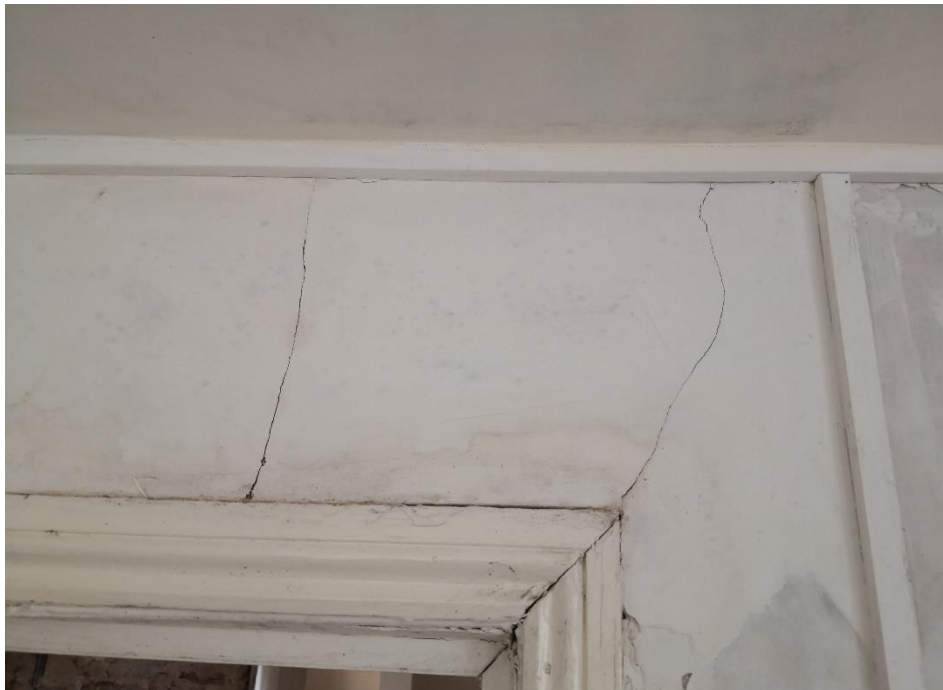
- 3.5.1     Two 1-2mm wide cracks were seen at the top right-hand corner of the door (see photograph 6.24).
- 3.5.2     A 1-2mm wide crack was noted in the internal wall with the hallway (see photograph 6.25).
- 3.5.3     A 2-3mm wide crack was seen in the top reveal of the left-hand window (see photograph 6.26).
- 3.5.4     A hairline to 1mm wide crack was observed in the right-hand window reveal (see photograph 6.27).

- 6.24 Two 1-2mm wide cracks in the ground floor back left-hand room at the top right-hand corner of the door

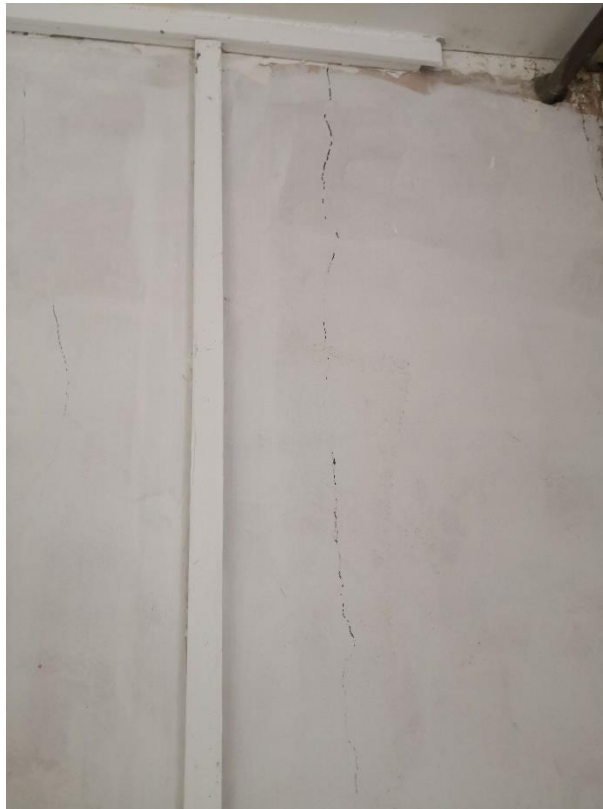
6.25 1-2mm wide crack in the ground floor back left-hand room in the internal wall with the hallway

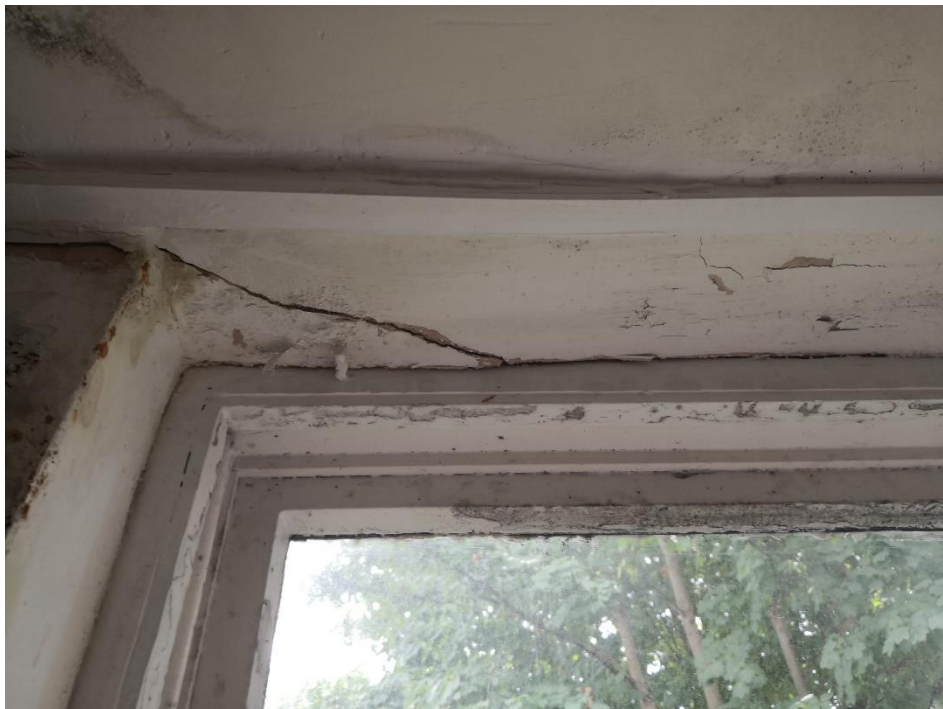
6.26 2-3mm wide crack in the ground floor back left-hand room in the top reveal of the left-hand window

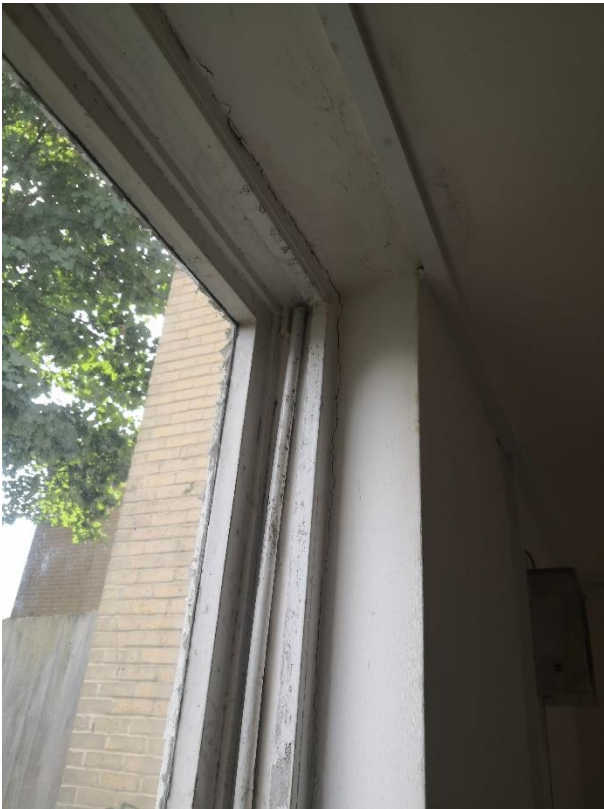
6.27 Hairline to 1mm wide crack in the ground floor back left-hand room in the right-hand window reveal (left)

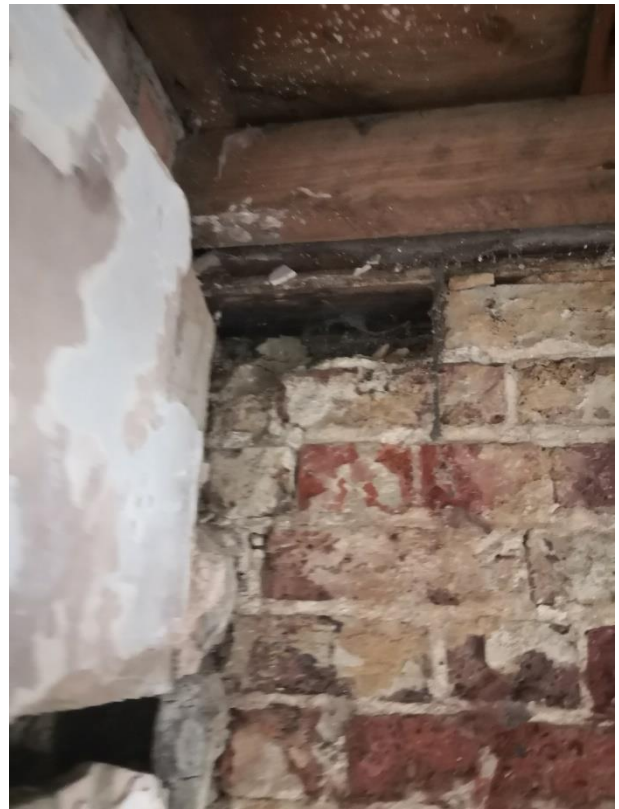
- 3.6.1     It was noted that a brick appears to be missing from high level of the wall, in the corner (see photograph 6.28).

6.28 Missing brick at high level of the wall in the corner of the ground floor bathroom (right)

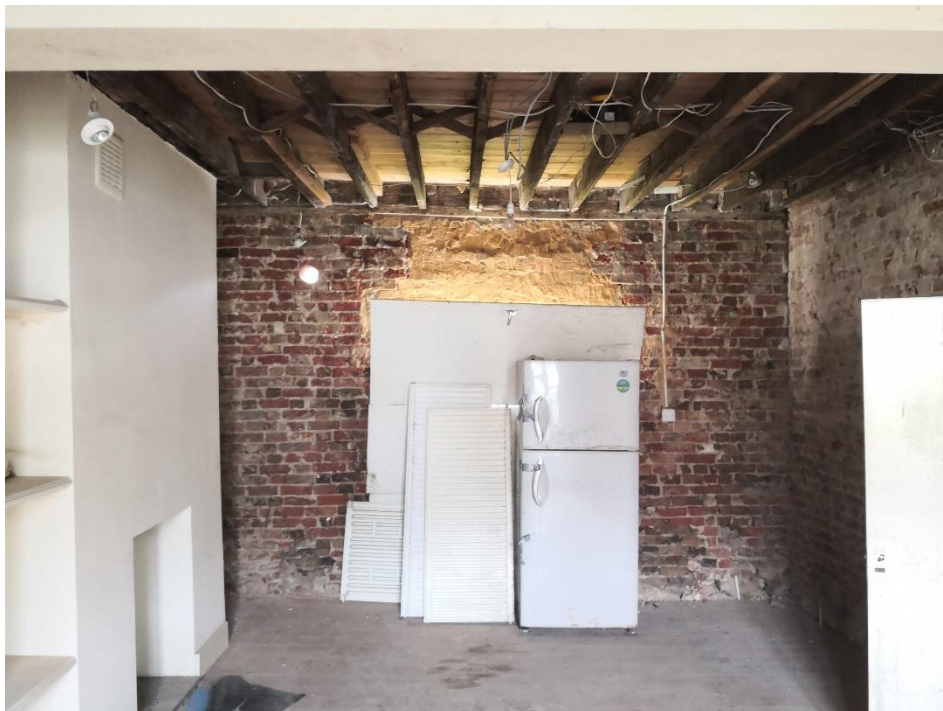
- 3.7.1     It was noted that the rear door opening is a void with no door or doorframe present (see photograph 6.29).
- 3.7.2     Efflorescent staining was observed on the underside of the first-floor floorboards (see photograph 6.30).

6.29 General view of rear door opening in the ground floor right-hand room. Note masonry above the door is distorted

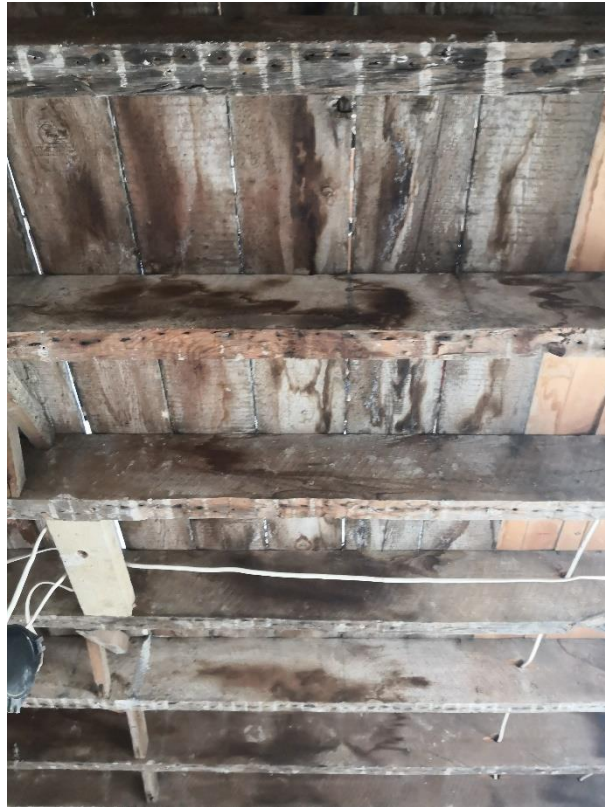
- 4.1 Areas in the ground floor front left-hand room that had been identified as visibly wet/damp in the second final report dated July 2021 appear to have dried, leaving efflorescent staining on floorboards and joists. The roof boards in the first-floor front left-hand room also appeared to have dried. It is not thought that joists or rafters in these areas have deteriorated due to water exposure.

6.30 Efflorescent staining in the ground floor right-hand room on the underside of the first-floor floorboards

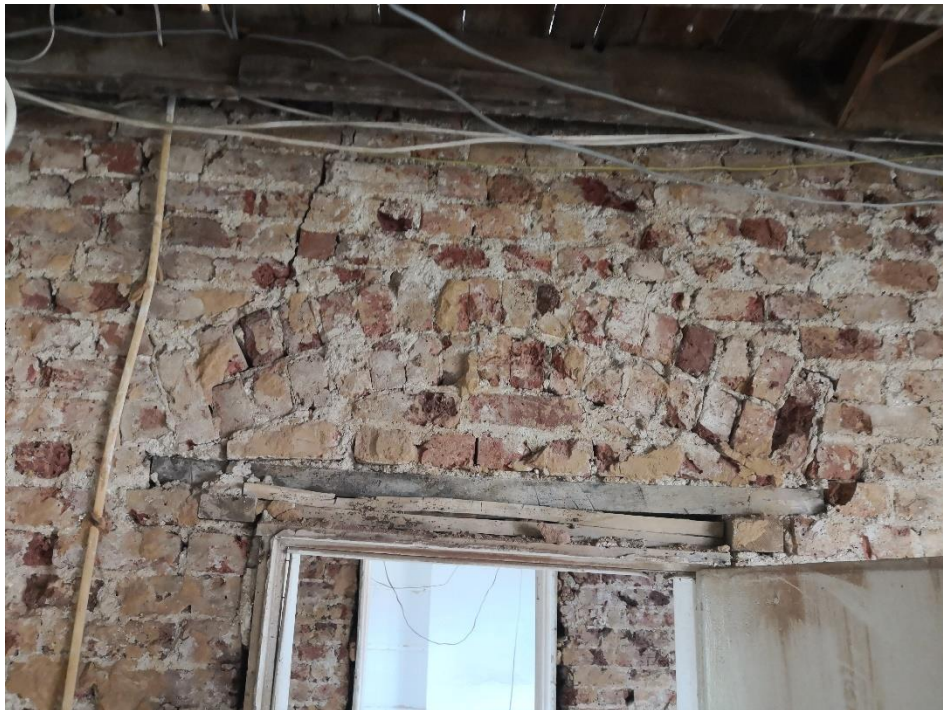
- 3.7.3 A 3-5mm wide crack was seen at the top left-hand corner of the front-most door to the hallway (see photograph 6.31).
- 3.7.4 A 10-15mm wide crack was noted at the top left-hand corner of the rear-most door to the hallway (see photograph 6.32).

6.31 3-5mm wide crack in the ground floor right-hand room at the top left-hand corner of the front-most door to the hallway

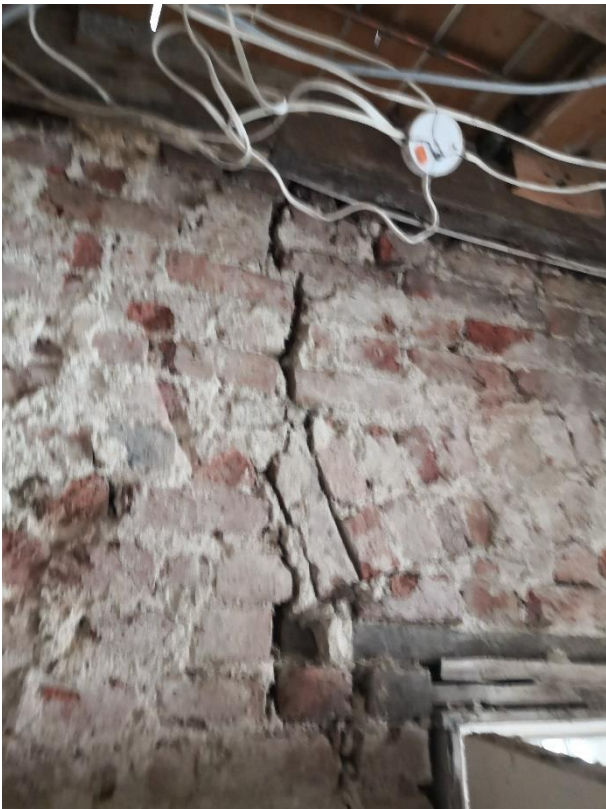
6.32 10-15mm wide crack in the ground floor right hand room at the top left-hand corner of the rear-most door to the hallway (left)

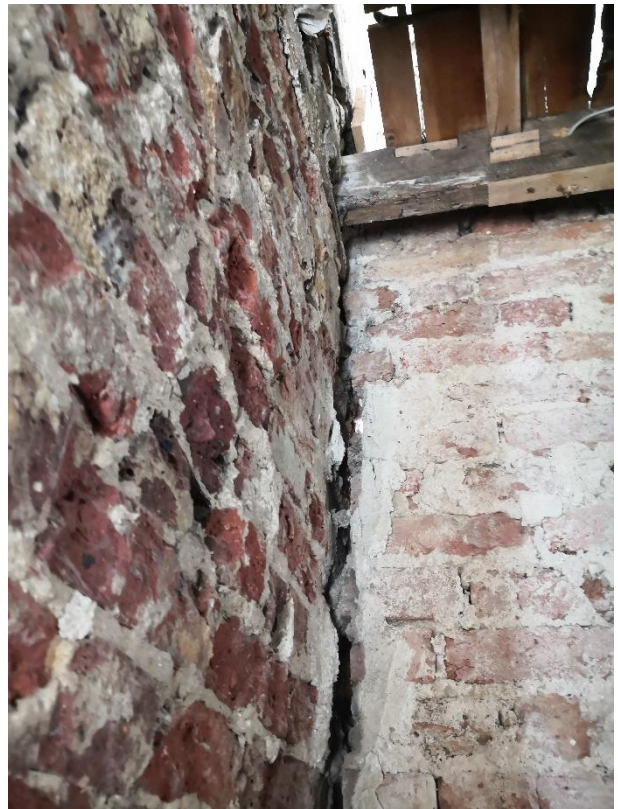
- 3.7.5 A 10-20mm wide gap was observed in the corner between the rear elevation wall and the internal wall with the stairs (see photograph 6.33).
- 3.7.6 It was noted that the rear elevation wall is slightly distorted above the rear door opening (see photographs 6.34 and 6.28).

6.33 10-20mm wide gap in the ground floor right-hand room in the corner between the rear elevation wall and internal wall with the stairs (right)

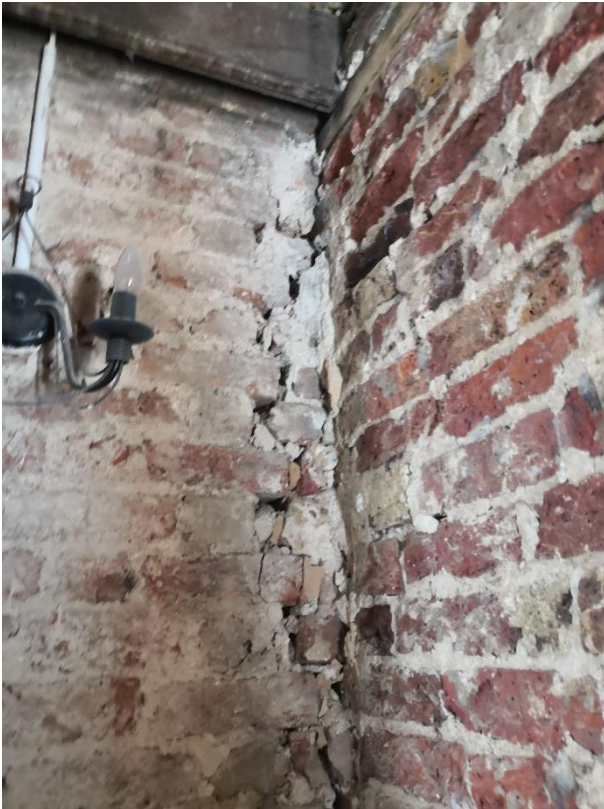
- 3.7.7 A 15-25mm wide crack was seen in the corner between the rear elevation and party wall (see photograph 6.35).
- 3.7.8 It was noted that areas of masonry at low level on the right and left-hand sides of the rear door opening are missing (see photographs 6.36 and 6.37).

6.35 15-25mm wide crack in the ground floor right-hand room in the corner between the rear elevation and party wall (left)

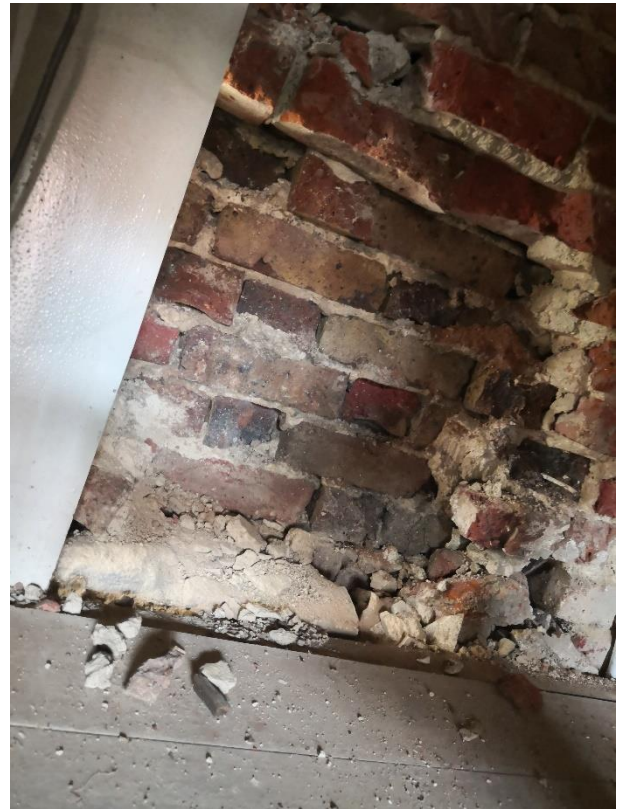
6.36 Area of masonry in the ground floor right hand room at low level on the right-hand side of the rear door opening that is missing (right)

- 5.5 We recommend that defective masonry internally around rear door in the ground floor right hand room is carefully removed. Once defective masonry has been removed, new masonry should be constructed to match existing where wall has lost thickness, to reinstate the stability of this section of the property. It is noted that these repairs are likely to crack as movements continue.

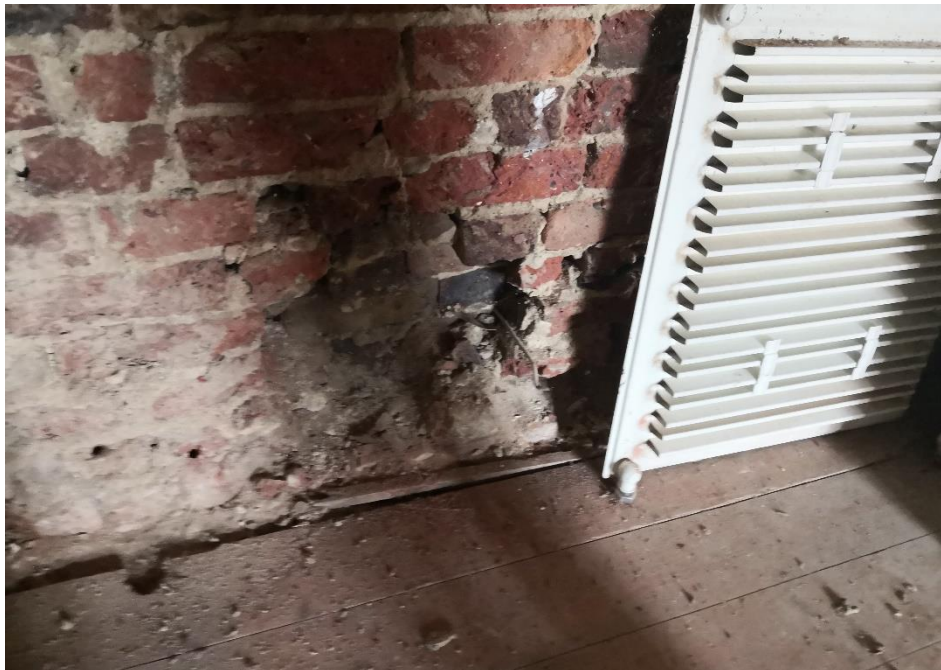
6.37 Area of masonry in the ground floor right hand room at low level on the left-hand side of the rear door opening that is missing
