123 Knights Hill, West Norwood,  
London, SE27 0SP

## Structural Engineer's Report

**Prepared for:**  
**Lambeth Housing Management**  
**on the Instruction of Savills (UK) Ltd**

July 2022

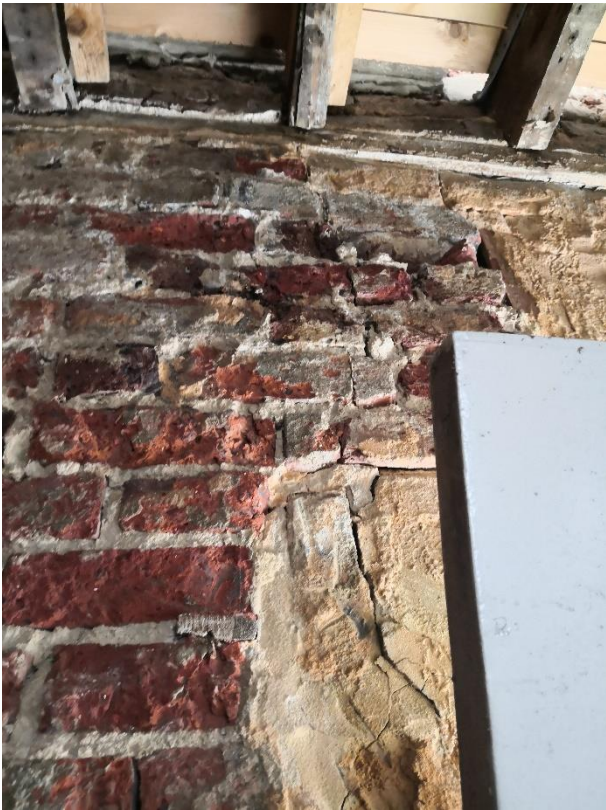
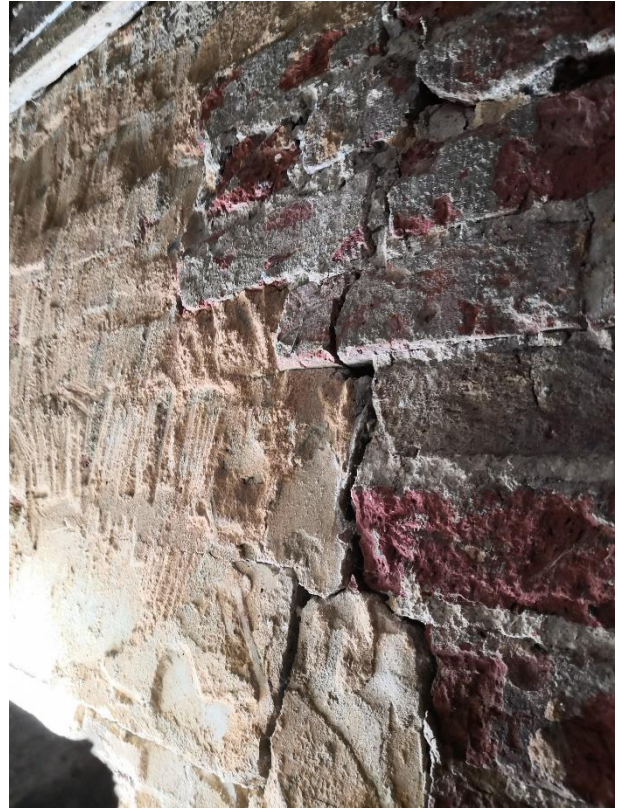
- 3.7.9 4-5mm wide cracks were seen at the top left and right-hand corners of the rear door opening (see photographs 6.38 and 6.39).

- 6.38 4-5mm wide cracks in the ground floor right hand room at the top left-hand corner of the rear door opening (left)
- 6.39 4-5mm wide cracks in the ground floor right hand room at the top right-hand corner of the rear door opening (right)

- 5.7.1 The section of masonry above the rear door should be carefully removed/deconstructed, a new lintel be provided and the masonry above reinstated to match existing. Bed joint reinforcement, such as Helifix Helibar, should also be installed in this new section of masonry, in accordance with manufacturer's instructions and Helifix repair detail CS05, with bars projecting 1 metre into the existing masonry on each side of the re-built area.

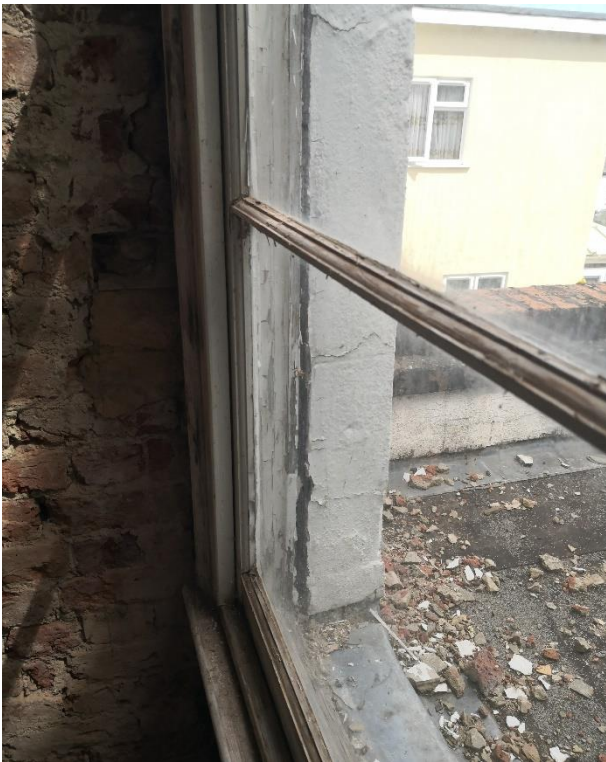
- 3.8.1 A 10-15mm wide gap was noted around the window reveal (see photograph 6.40).
- 3.8.2 A 10-20mm wide gap was seen in the corner between the rear elevation wall and internal wall with the large ground floor room (see photograph 6.41).
- 3.8.3 A 4-5mm wide crack was observed at high level in the internal wall with the back left room (see photograph 6.42).
- 3.8.4 A 10-15mm wide crack was seen in the external wall forming the return on the rear elevation. The crack is approximately at the connection between the rear elevation and the return (see photograph 6.43).
- 3.8.5 It was noted that light was visible through the corner in the external wall and a 2-4mm wide crack is present (see photograph 6.44).
- 3.8.6 It was observed that areas of the masonry have deteriorated (see photograph 6.45).

6.40 10-15mm wide gap around the stair window reveal (left)

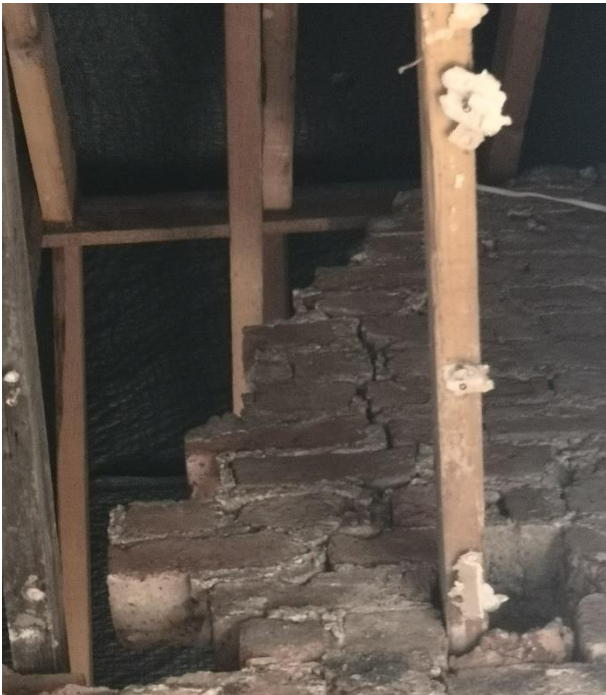
6.42 4-5mm wide crack in the stair area at high level on the internal wall with the back left room (left)

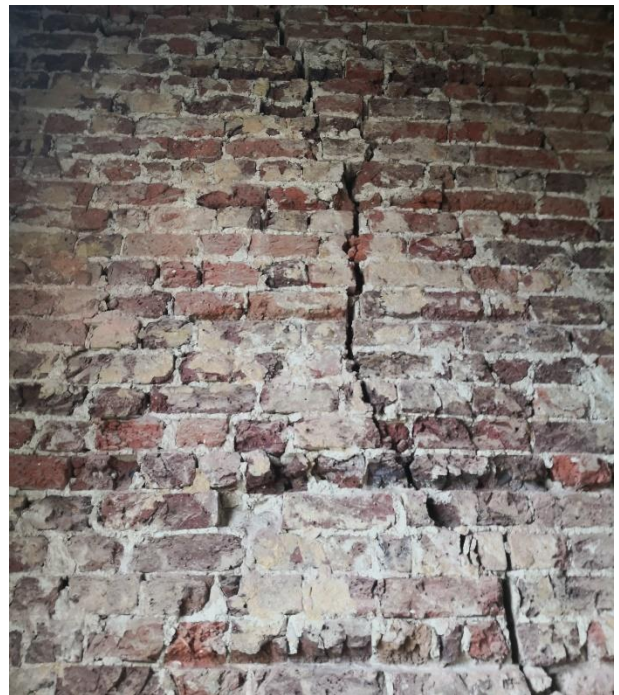
6.43 10-15mm wide crack in the stair area in the external wall forming the return on the rear of the property (right)

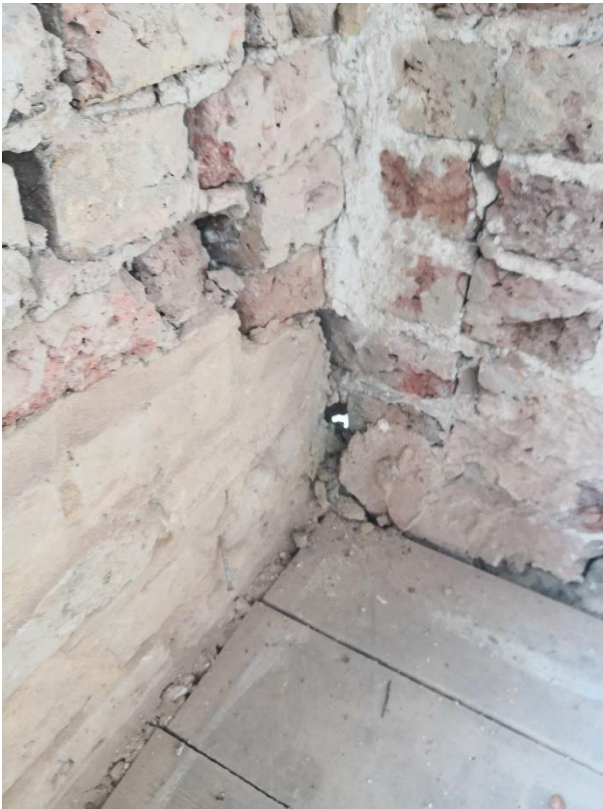
6.44 Visible light through the corner of the stair landing in the external wall. Note 2-4mm wide crack (left)

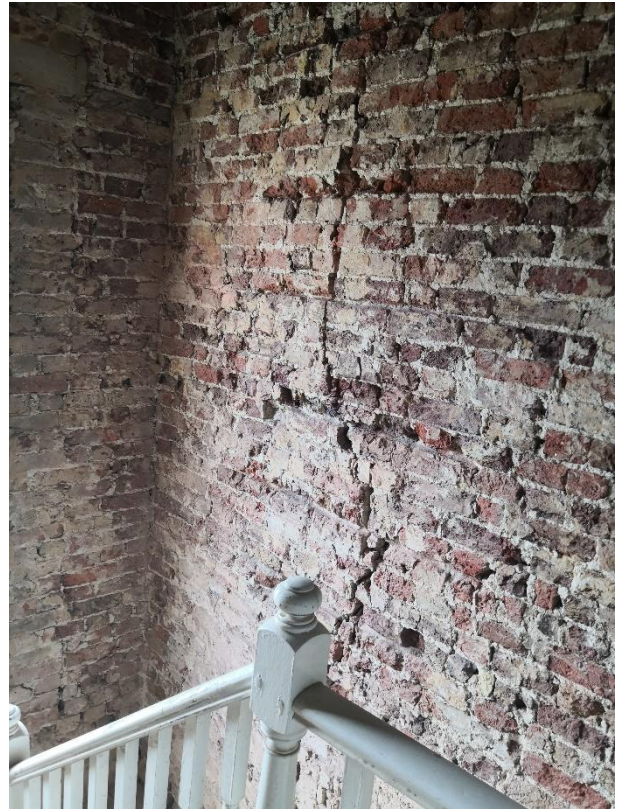
6.45 Area of masonry wall within the stair area that has deteriorated (right)

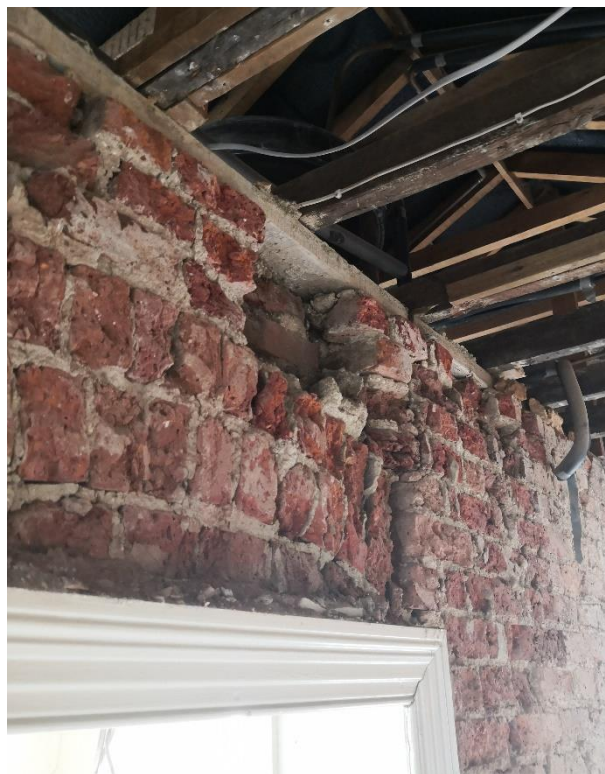
- 3.9.1 It was seen that areas of masonry walls have deteriorated (see photograph 6.46). Some areas of newer masonry were observed (see photographs 6.47 and 6.48).

6.46 Example of area of masonry wall on the first-floor landing that has deteriorated.

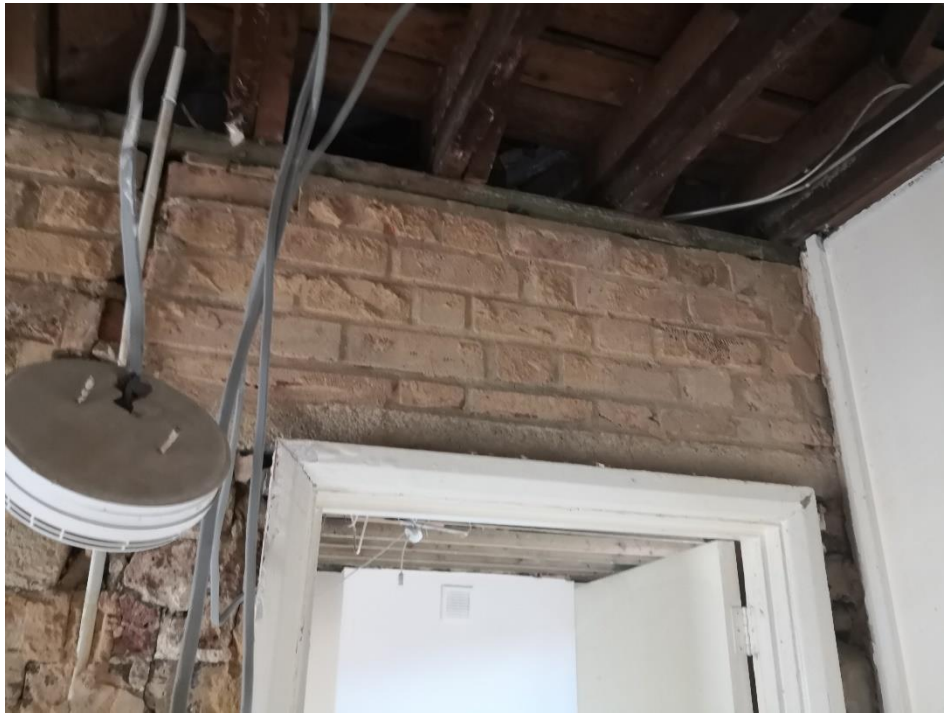
6.47 Area of newer masonry on the first-floor landing

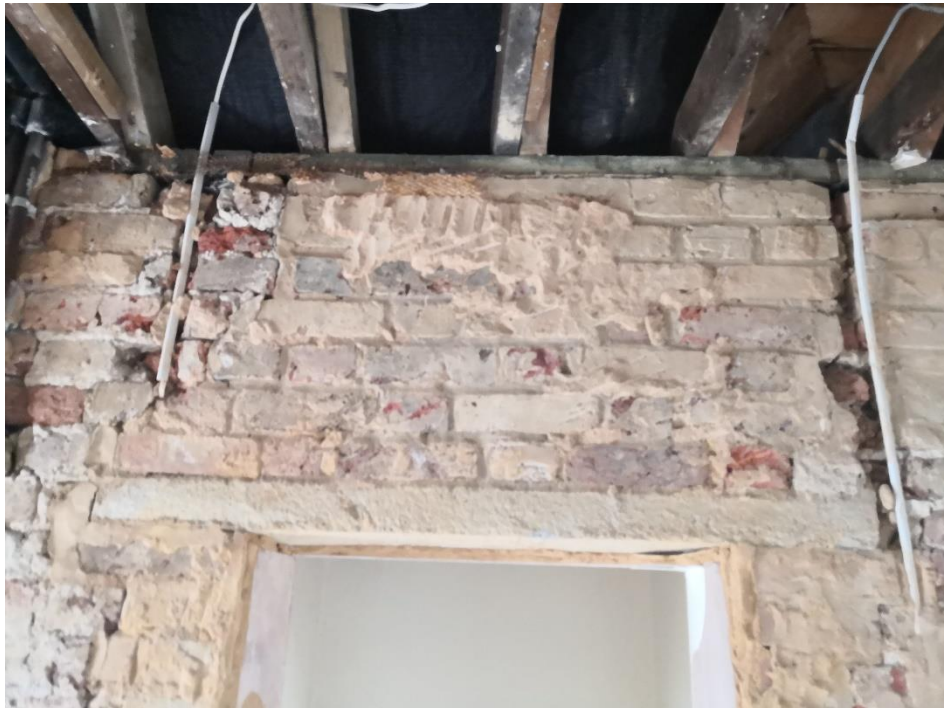
6.48 Another area of newer masonry on the first-floor landing

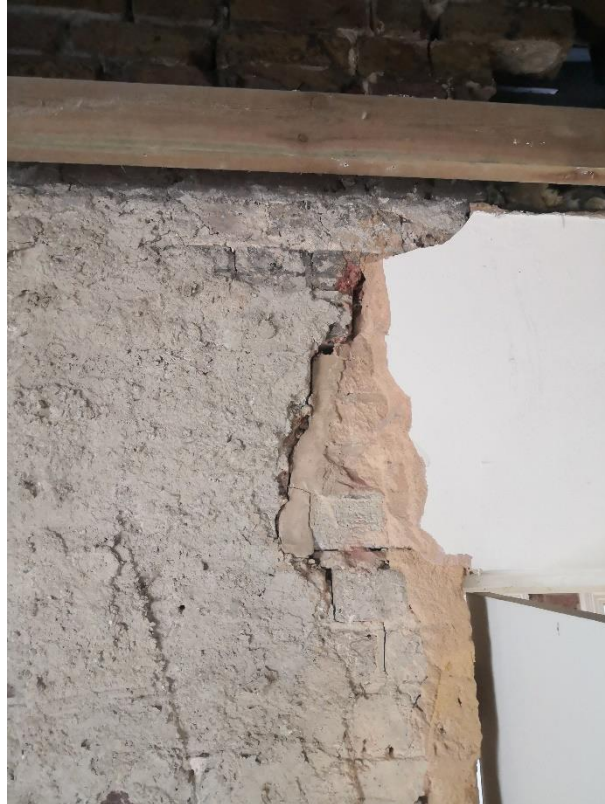
- 3.10.1 A 1-3mm wide crack was noted at the top left-hand corner of the door (see photograph 6.49).
- 3.10.2 Masonry units were noted to be missing from high level of an internal wall, within the roof void (see photograph 6.50).
- 3.10.3 A 10-15mm wide gap was observed in the corner between the front elevation and internal wall (see photograph 6.51).
- 3.10.4 A 1-2mm wide crack was seen in the corner between the party wall and internal wall (see photograph 6.52).
- 3.10.5 A 1-2mm wide crack was noted in the internal wall with the back right room (see photograph 6.53).

- 6.49 1-3mm wide crack in the first-floor front left-hand room at the top left-hand corner of the door

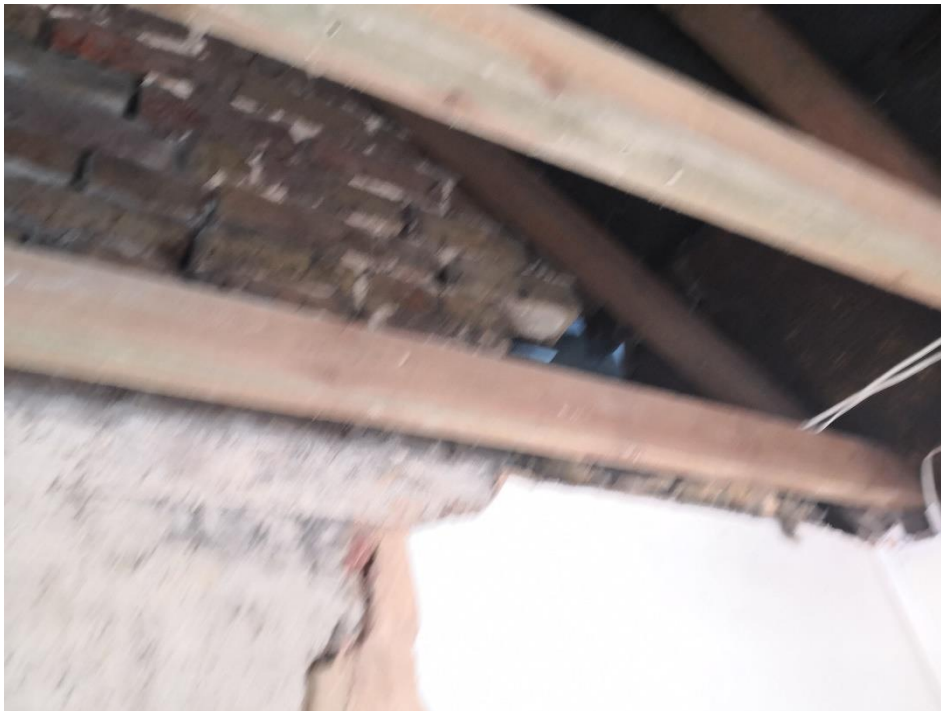
- 6.50 Missing masonry units in the first-floor front left-hand room at high level of internal wall within the roof void

- 5.6 We recommend that in the internal wall where it is apparent that significant portions of masonry units have been lost, remaining sections of masonry units are carefully cut out and removed and replaced to match existing.

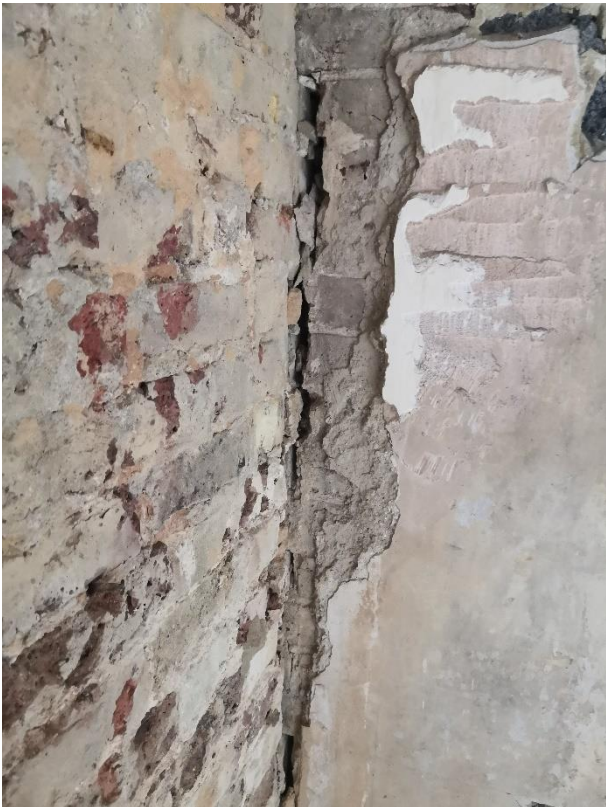
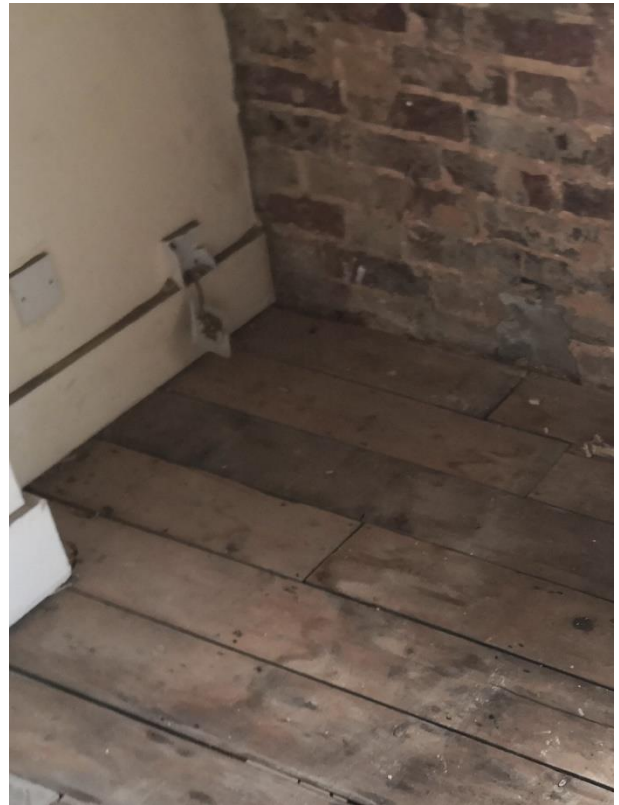
- 6.51 10-15mm wide gap in the first-floor front left-hand room in the corner between the front elevation and internal wall (left)
- 6.52 1-2mm wide crack in the first-floor front left-hand room in the corner between the party wall and internal wall (right)

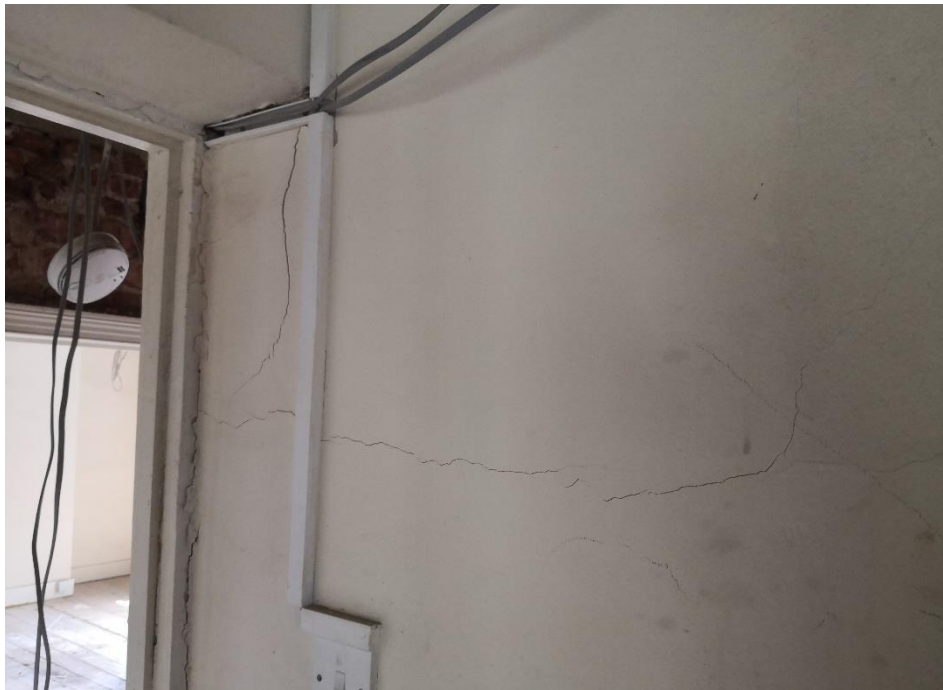
- 6.53 1-2mm wide crack in the first-floor front left-hand room in the internal wall with the back right room

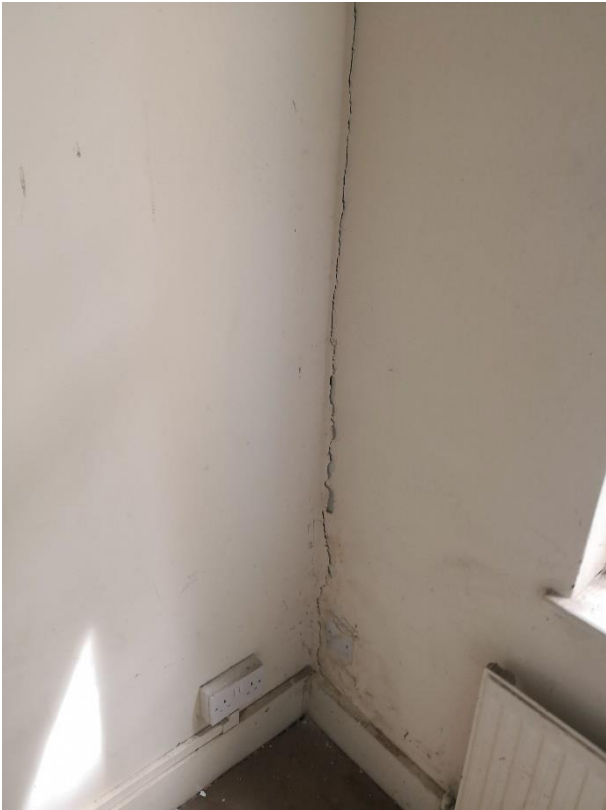
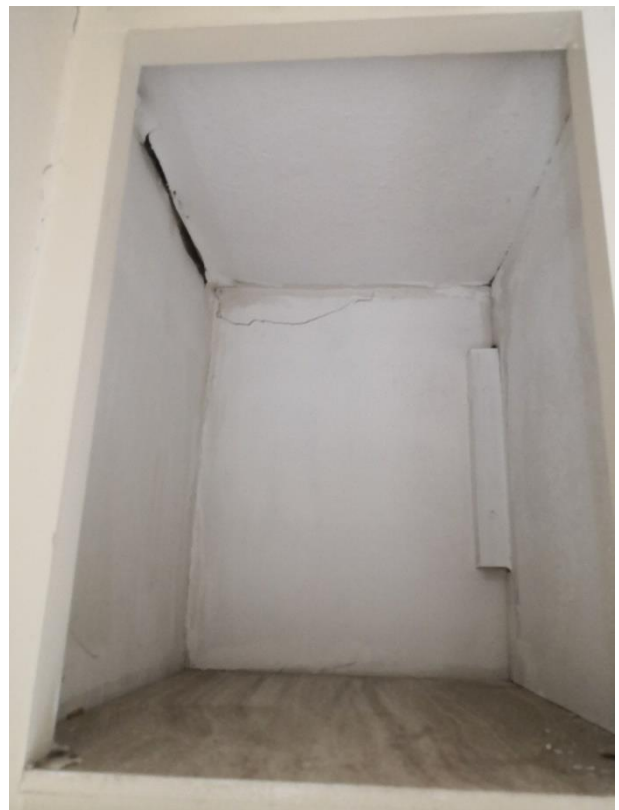
- 3.11.1 A 2-3mm wide crack was noted in the corner between the rear elevation and the internal wall (see photograph 6.54).
- 3.11.2 A 1-2mm wide crack was seen at high level of the party wall (see photograph 6.55).
- 3.11.3 A hairline crack was observed at the top right-hand corner of the door (see photograph 6.56).
- 3.11.4 A hairline crack was noted at the top right-hand corner of the window (see photograph 6.57).

- 6.54 2-3mm wide crack in the first floor back left-hand room in the corner between the rear elevation and the internal wall (left)
- 6.55 1-2mm wide crack in the first floor back left-hand room at high level of the party wall (right)

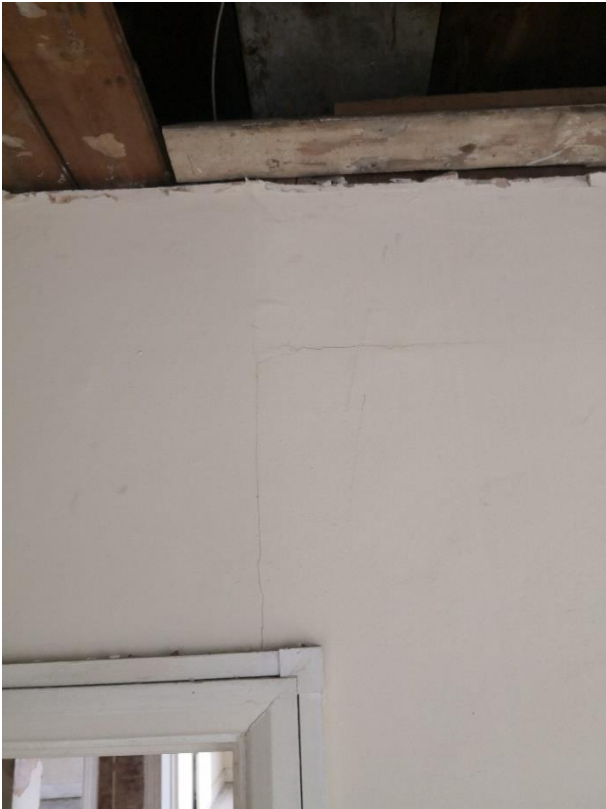
6.56 Hairline crack in the first floor back left-hand room at the top right-hand corner of the door (left)

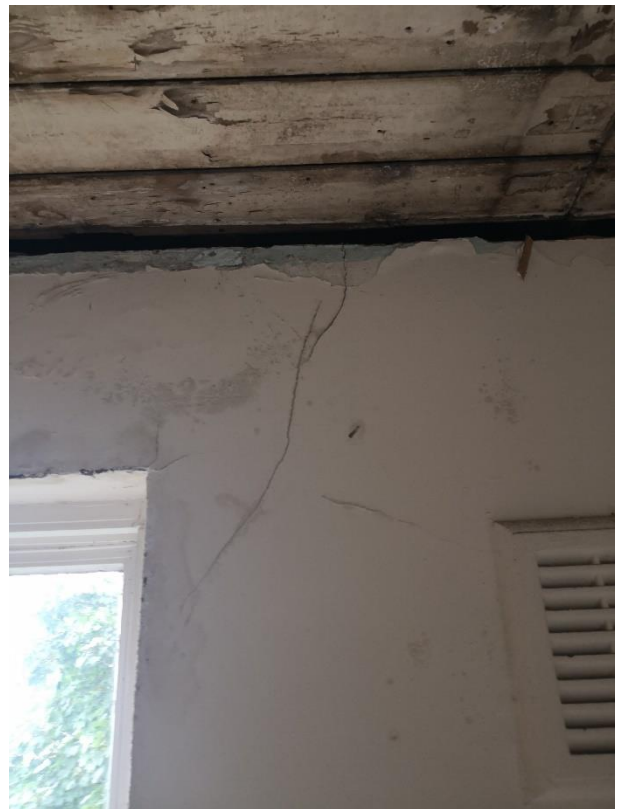
6.57 Hairline crack in the first floor back left-hand room at the top right-hand corner of the window (right)

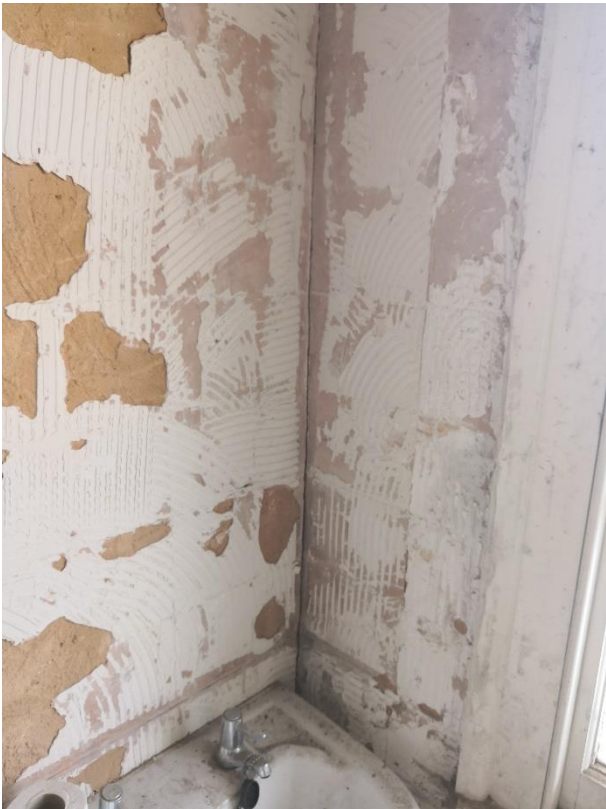
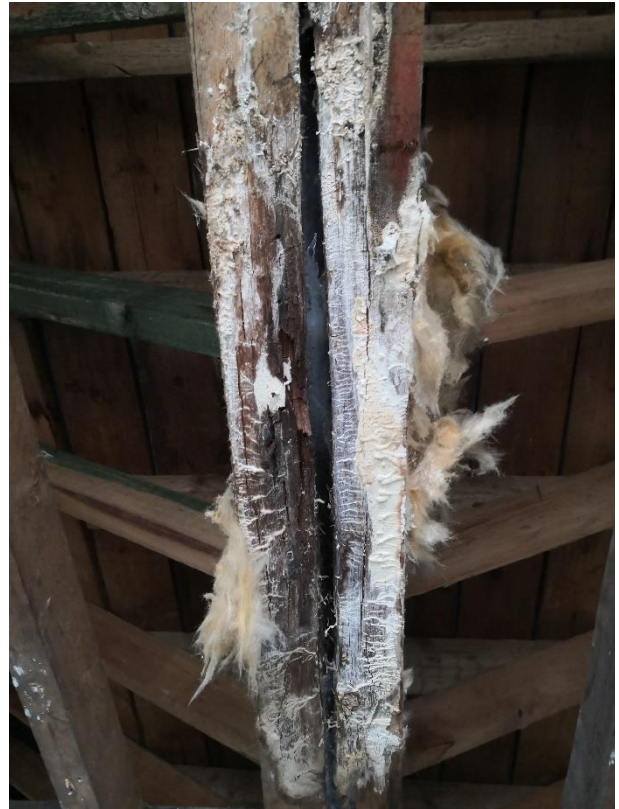
- 3.12.1 A 1-2mm wide crack was seen in the corner between the front elevation and the internal wall with the front right room (see photograph 6.58).

- 3.13.1 Evidence of significant water damage and what appeared to be fungal growth was noted on the double ceiling joist (see photograph 6.59).
- 3.13.2 1-2mm wide cracks were observed at the bottom right and left-hand corners of the window (see photographs 6.60 and 6.61).
- 3.13.3 Wallpaper at high level of the front elevation wall appeared to have been subject to moisture penetration (see photograph 6.62).

- 4.2 The double roof joist in the first-floor front right room appeared to have deteriorated further since July 2021. It does not appear to have dried out and is covered in what was thought to be fungal growth. It is therefore thought that water is still penetrating into the property.

- 6.58 1-2mm wide crack in the first-floor bathroom in the corner between the front elevation and internal wall with the front right room (left)
- 6.59 Evidence of significant water damage and fungal growth in the first-floor front right-hand room on the double ceiling joist (right)

- 5.4 We recommend that a timber preservation specialist is contracted to undertake an assessment of the rotten timber roof joist. The opportunity should be taken for an assessment of all timber that has been subject to long term moisture exposure. Any recommendations for making good of timber elements of the structure, whether this is treatment of timber or removal and replacement, should be undertaken.

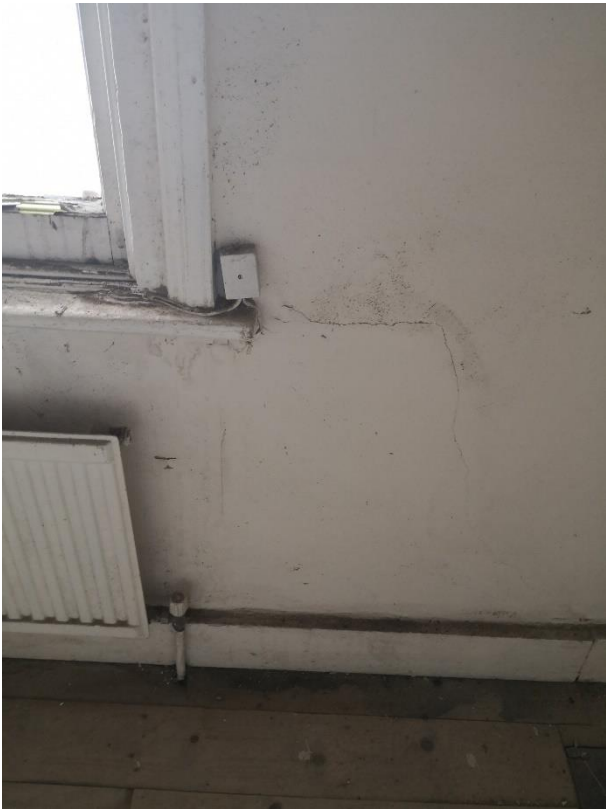
6.60 1-2mm wide crack in the first-floor front right-hand room at the bottom right-hand corner of the window (left)

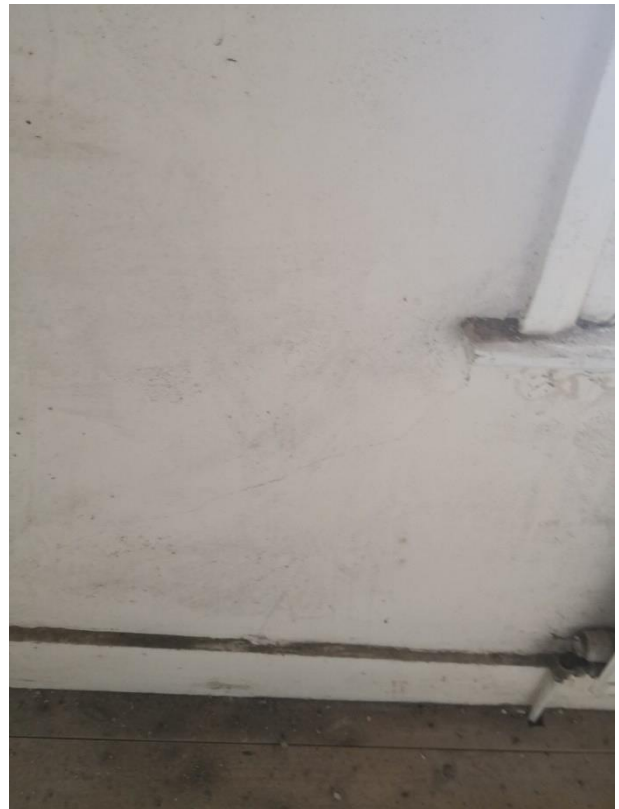
6.61 1-2mm wide crack in the first-floor front right-hand room at the bottom left-hand corner of the window (right)

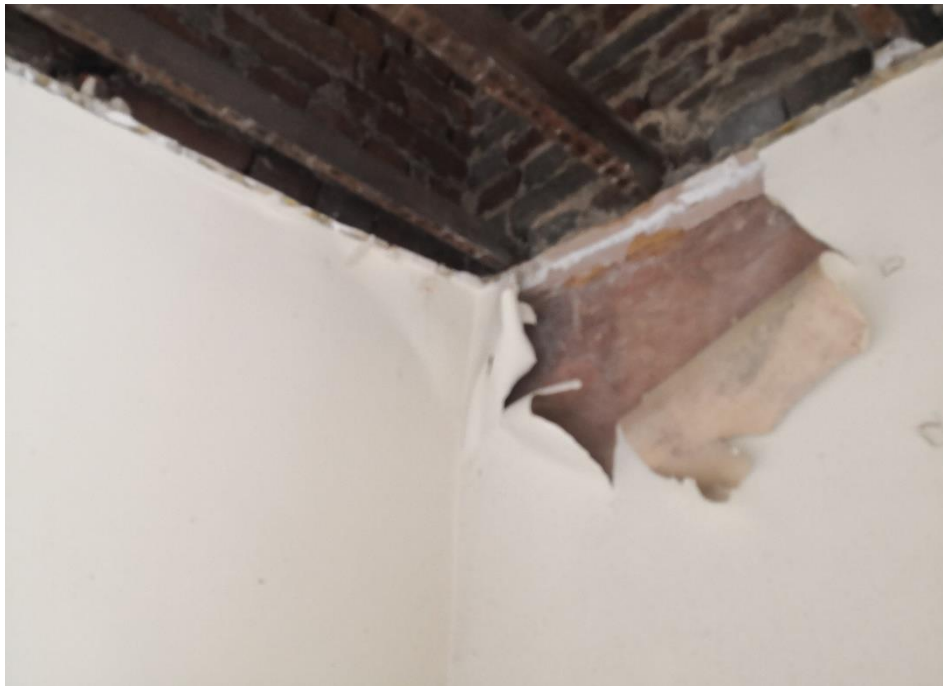
6.62 Evidence of water penetration on the wallpaper in the first-floor front right-hand room at high level of the front elevation wall

- 5.3 We recommend that as per recommendation 6.1 of SFSP's Second Final Report that a specialist roofer be instructed undertaken an inspection of the roof and make good any leaks or defects that are identified as per the roofers' recommendations.

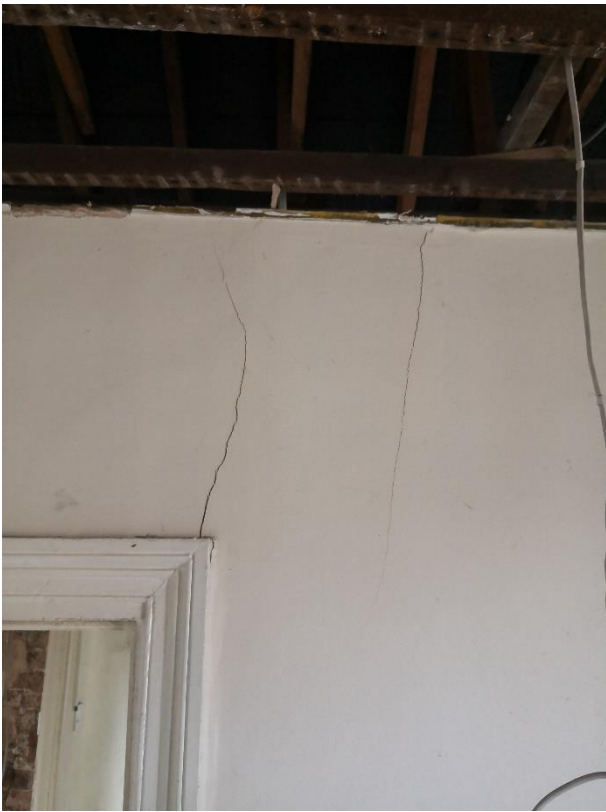
3.13.4 Two 1-2mm wide cracks were seen at the top right-hand corner of the door (see photograph 6.63).

6.63 Two 1-2mm wide cracks in the first-floor front right hand room at the top right-hand corner of the door (left)

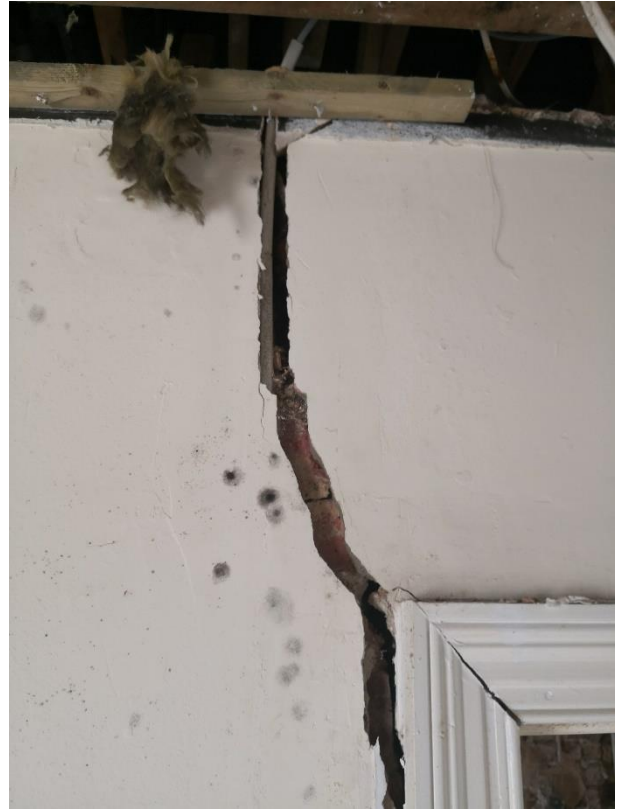
3.14.1 A 10-15mm wide crack was observed at the top left-hand corner of the door (see photograph 6.64).

6.64 10-15mm wide crack in the first-floor back right-hand room at the top left-hand corner of the door (right)

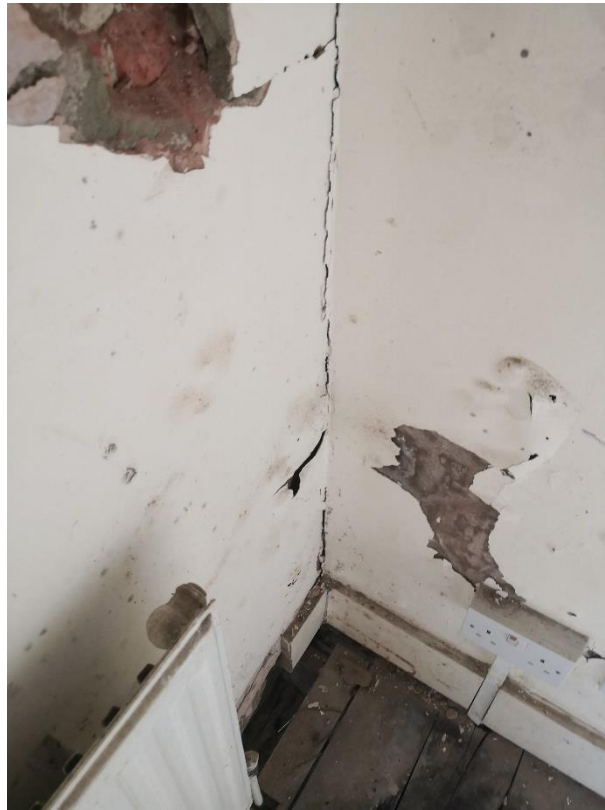
3.14.2 A 1-3mm wide crack was noted in the corner between the internal wall with the stairs and the rear elevation wall (see photograph 6.65).

6.65 1-3mm wide crack in the first floor back right-hand room in the corner between internal wall with the stairs and the rear elevation wall

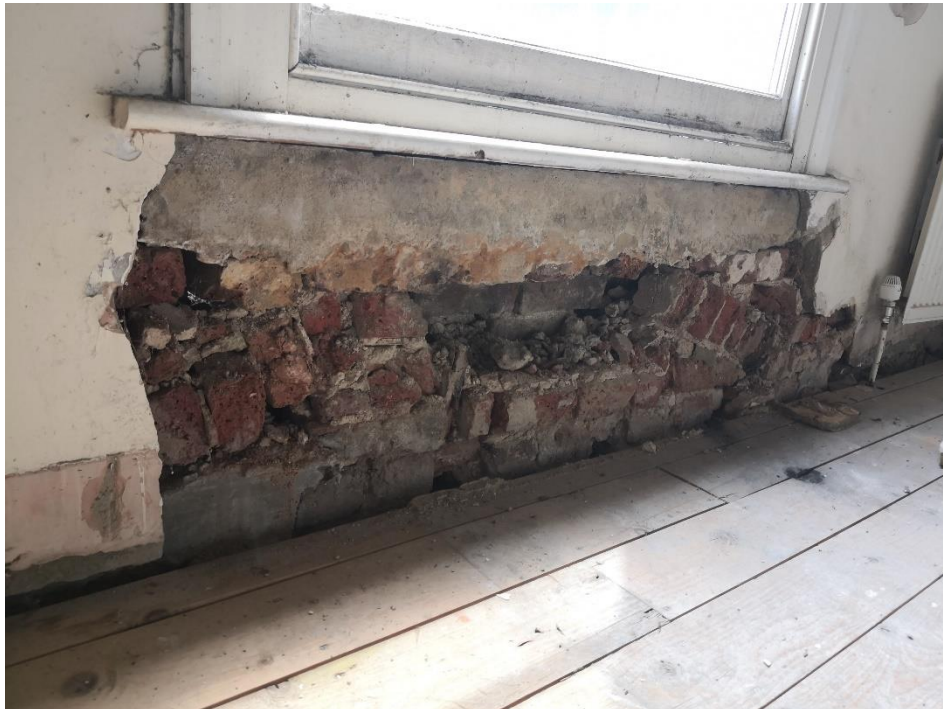
3.14.3 An area of deteriorated/missing masonry was seen below the window (see photograph 6.66).

6.66 Area of deteriorated/missing masonry in the first floor back right-hand room below the window

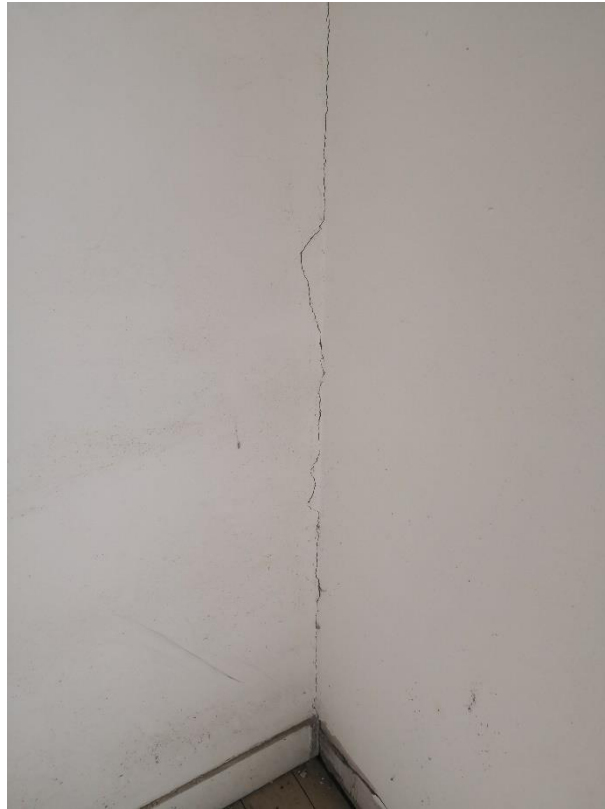
3.14.4 A 1-2mm wide crack was observed between the rear elevation and the party wall (see photograph 6.67).

6.67 1-2mm wide crack in the first floor back right-hand room between the rear elevation and the party wall

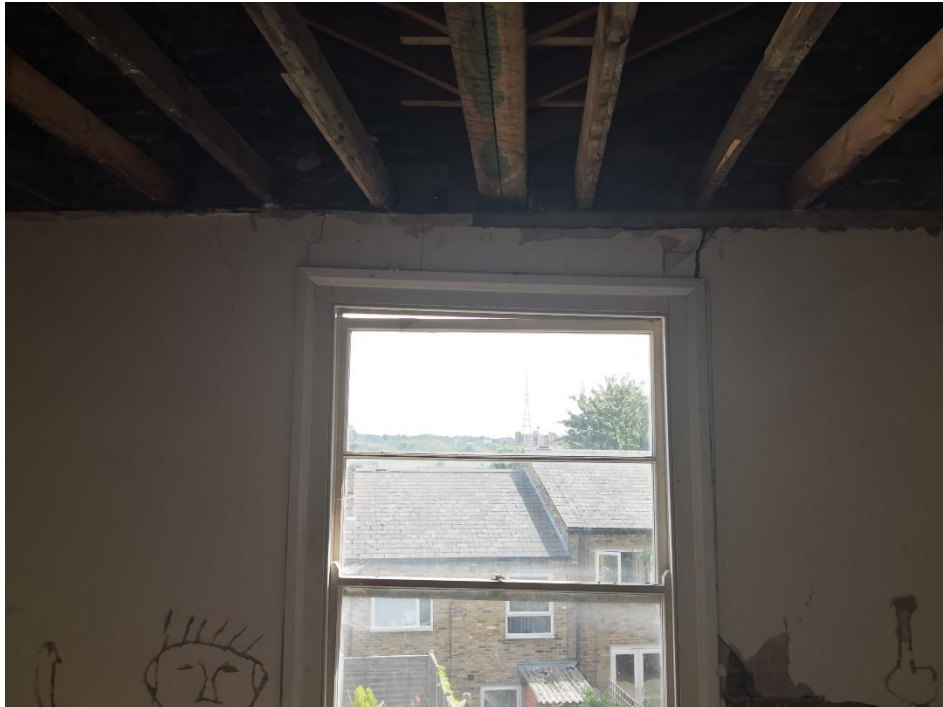
6.68 Window/window frame in the first floor back right-hand room that is distorted

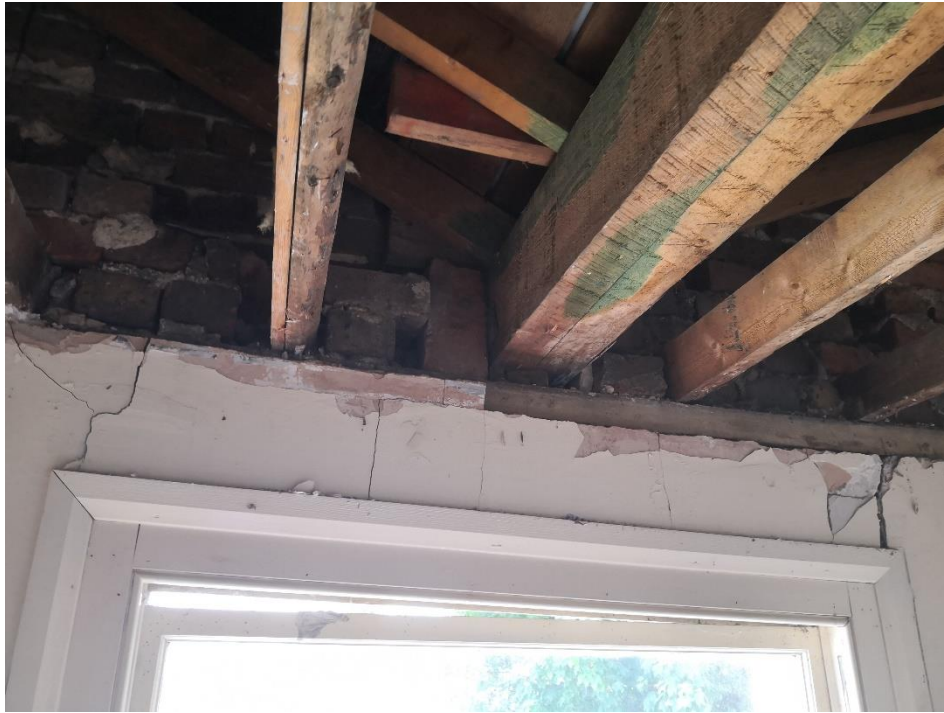
3.14.6 A 2-4mm wide crack was noted at the top left-hand corner of the window (see photograph 6.69).

3.14.7 A 4-10mm wide crack was seen at the top right-hand corner of the window (see photograph 6.69).

6.69 2-4mm wide crack in the first floor back right-hand room at the top left-hand corner of the window and 4-10mm wide crack at the top right-hand corner of the window

- 5.7.2 Bed joint reinforcement, such as Helifix Helibar, should be installed horizontally across the large cracks at the corners of the rear windows in accordance with manufacturer's

instructions and Helifix repair detail LR08, then the cracks be injected with Crackbond TE3 or similar, in accordance with the manufacturer's instructions.

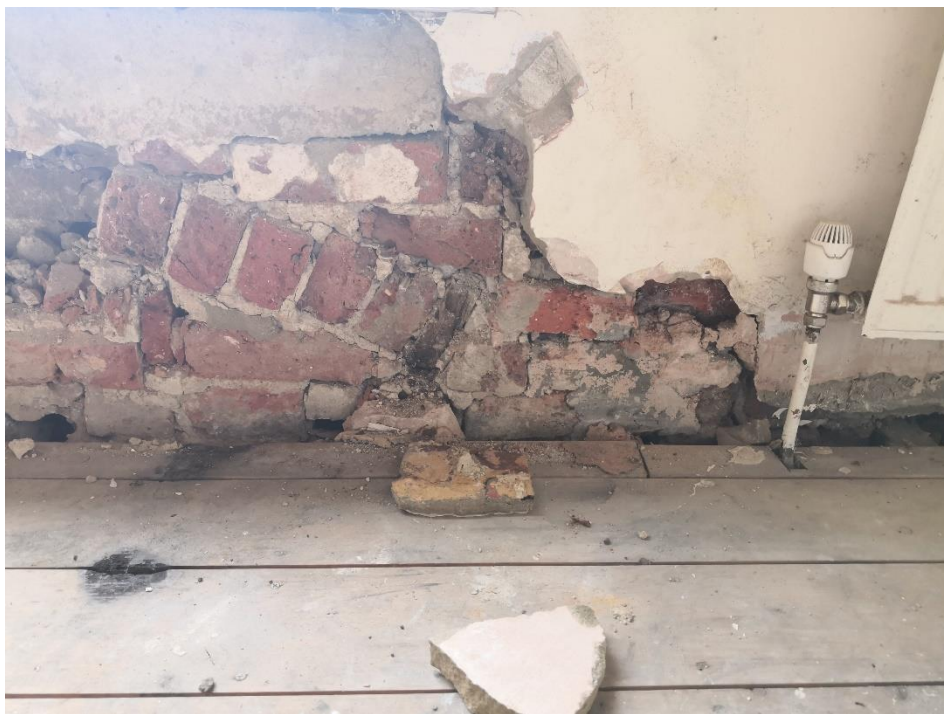
3.14.8 A 3-5mm wide crack was observed at the bottom right-hand corner of the window (see photograph 6.70).

6.70 3-5mm wide crack in the first floor back right-hand room at the bottom right-hand corner of the window

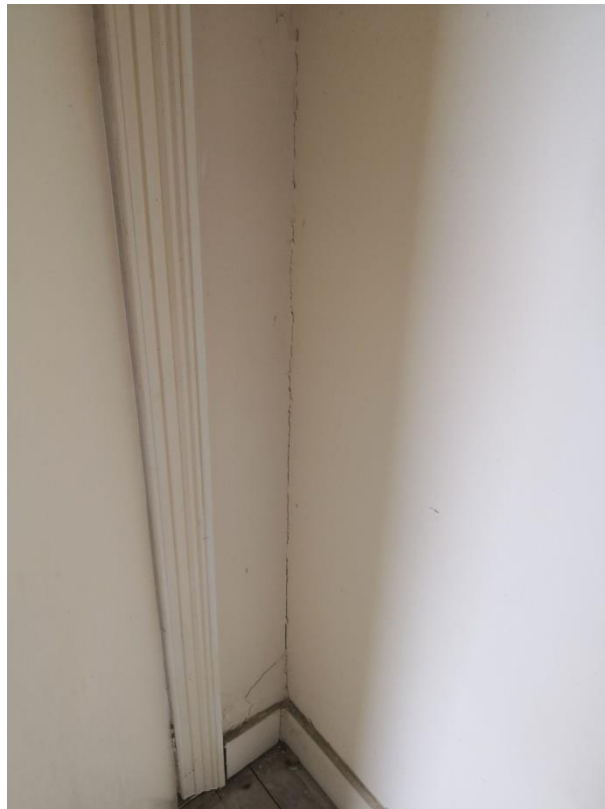
3.14.9 A 1-2mm wide crack was noted in the corner to the right of the door (see photograph 6.71).

- 6.71 1-2mm wide crack in the first floor back right-hand room in the corner to the right of the door

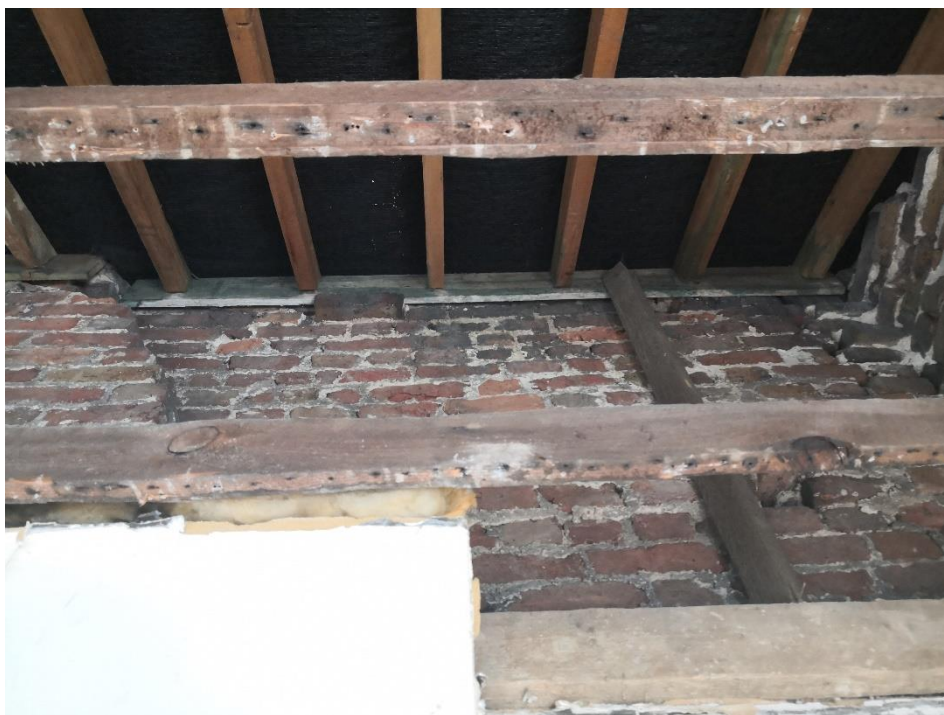
3.14.10 Vertical timber props were noted along the roof edge next to the party wall (see photograph 6.72).

- 6.72 Vertical timber prop in the first floor back right-hand room along the roof edge with the party wall
