## Operational Inspection

### Kildoran Road

Inspection Ref: 1564240

Inspected: 21 January 2022 at 10:09 Inspector: [REDACTED]

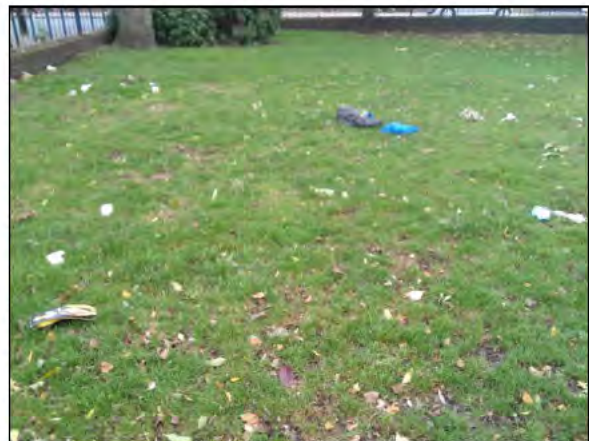
**Item:** Ancillary Items - Site General  
**Manufacturer:** Owner/Operator

**Risk Level:** 6 - Low Risk  
**Surface:** N/A

**Finding:** There is litter/debris in the area  
**Action:** Remove litter/debris from the area and maintain

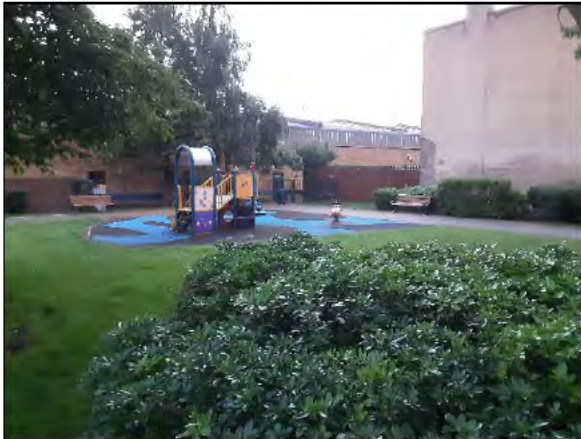
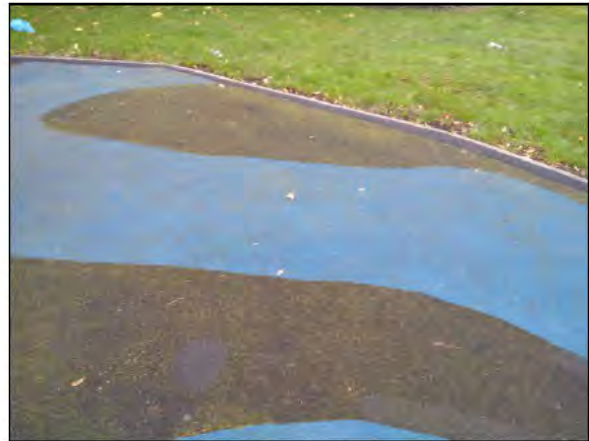
**Item:** Ancillary Items - Site General  
**Manufacturer:** Owner/Operator

**Risk Level:** 8 - Low Risk  
**Surface:** N/A

**Finding:** There is algae or moss growth on the surface resulting in slippery conditions  
**Action:** Clean and treat appropriately

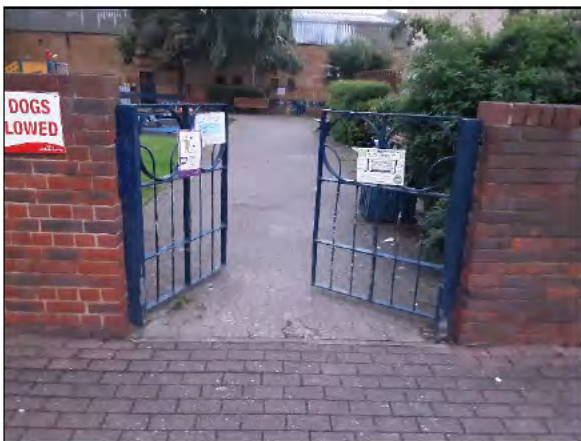
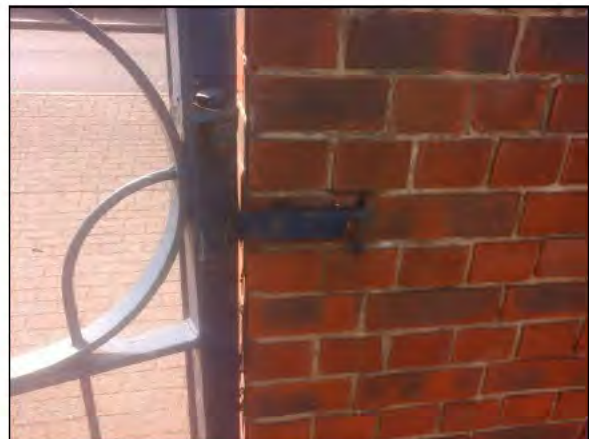
**Item:** Gates - Gate - Pedestrian  
**Manufacturer:** Unknown

**Risk Level:** 6 - Low Risk  
**Surface:** All Weather Surface

**Finding:** The gate is loose on its hinges  
**Action:** Investigate and take appropriate action to rectify

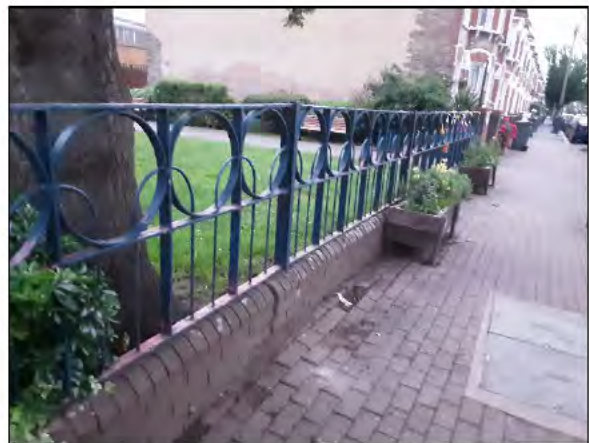
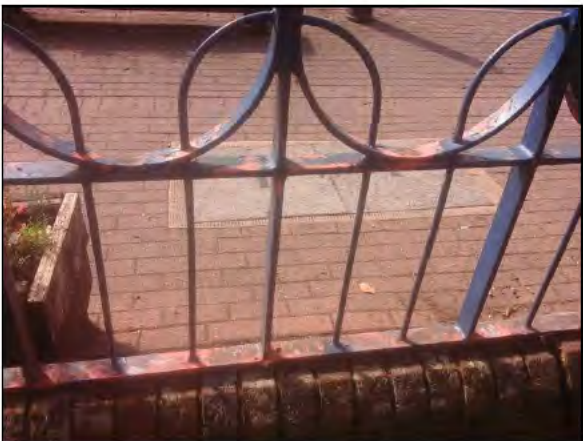
**Item:** Fences - Fencing - Flat Top  
**Manufacturer:** Unknown

**Risk Level:** 6 - Low Risk  
**Surface:** Brick Pavers

**Finding:** There is surface corrosion present on the item  
**Action:** Consider treating and repainting the item

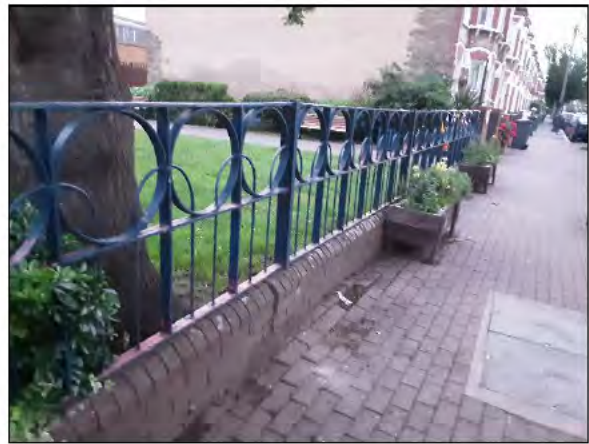
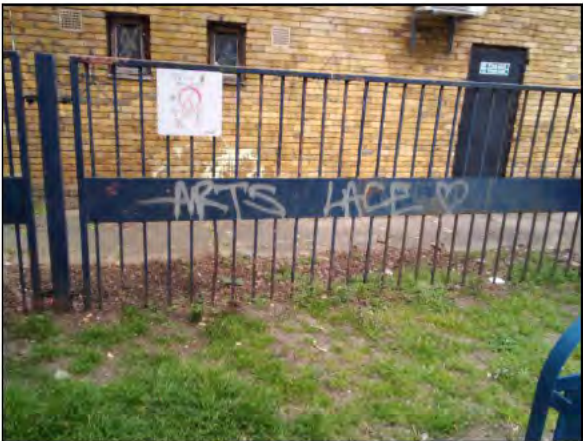
**Item:** Fences - Fencing - Flat Top  
**Manufacturer:** Unknown

**Risk Level:** 2 - Very Low Risk  
**Surface:** Brick Pavers

**Finding:** There is some graffiti present  
**Action:** Remove the graffiti

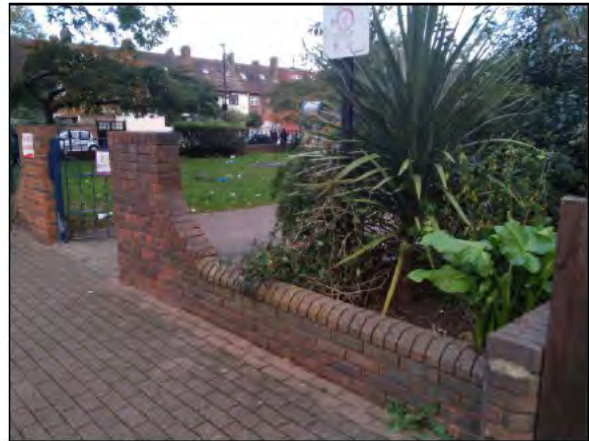
**Item:** Fences - Fencing - Flat Top  
**Manufacturer:** Unknown

**Risk Level:** 6 - Low Risk  
**Surface:** Brick Pavers

**Finding:** Section of railing is missing  
**Action:** Replace as required

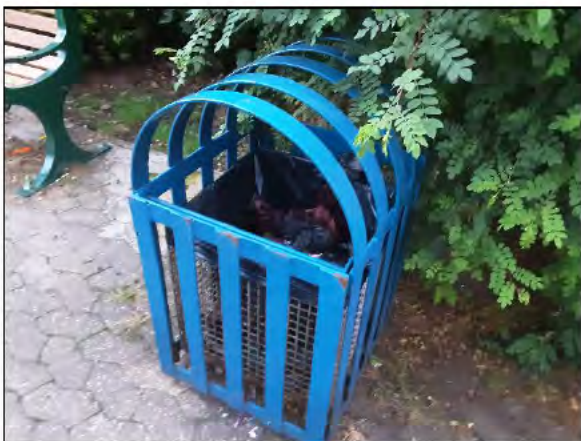
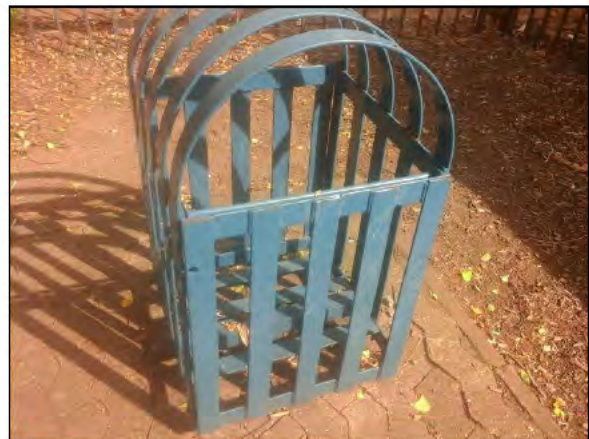
**Item:** Ancillary Items - Litter Bin  
**Manufacturer:** Unknown

**Risk Level:** 2 - Very Low Risk  
**Surface:** Brick Pavers

**Finding:** There is no liner present in the litterbin  
**Action:** Provide as required

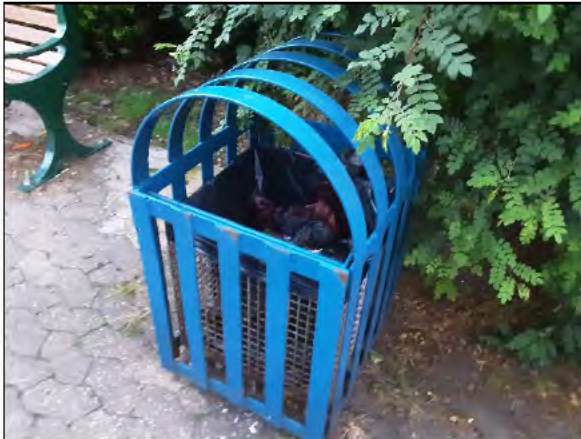
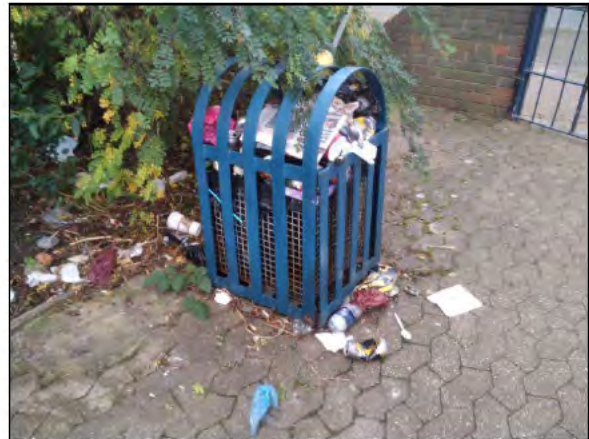
**Item:** Ancillary Items - Litter Bin  
**Manufacturer:** Unknown

**Risk Level:** 6 - Low Risk  
**Surface:** Brick Pavers

**Finding:** The litter bin is full  
**Action:** Empty and review the collection routine

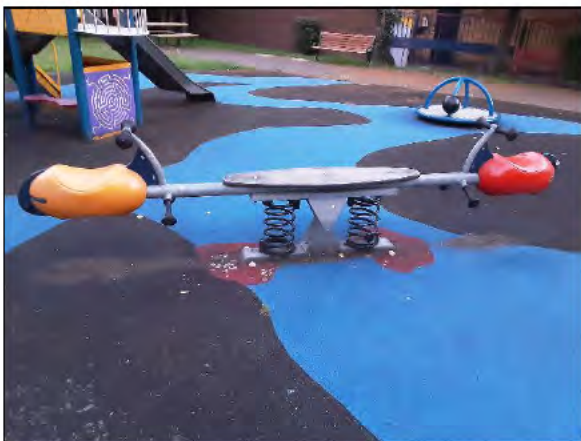
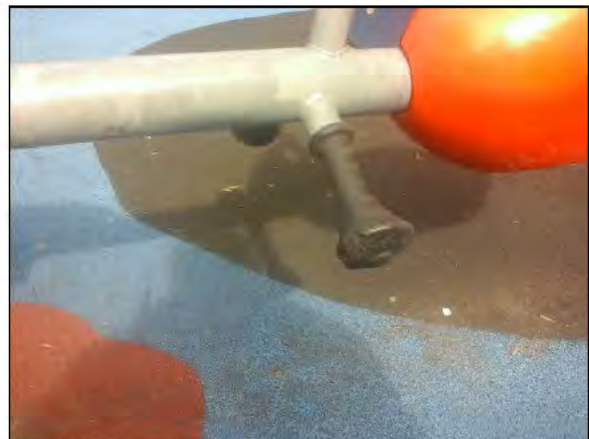
**Item:** Rocking Equipment - Spring See-Saw  
**Manufacturer:** Kompan Ltd

**Risk Level:** 5 - Very Low Risk  
**Surface:** Wet Pour

**Finding:** Hand/foot rests are wearing  
**Action:** Monitor for further wear

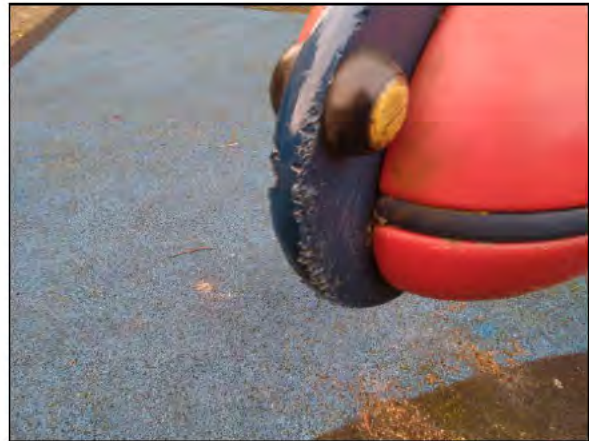
**Item:** Rocking Equipment - Spring See-Saw  
**Manufacturer:** Kompan Ltd

**Risk Level:** 6 - Low Risk  
**Surface:** Wet Pour

**Finding:** Evidence of vandalism, dog bites  
**Action:** Monitor for deterioration and consider replacing

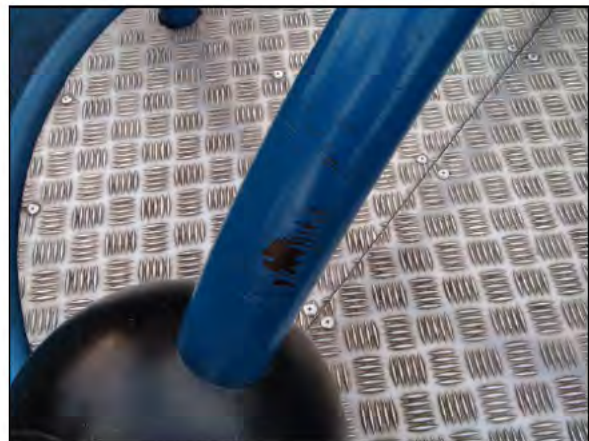
**Item:** Rotor Play - Roundabout  
**Manufacturer:** Berliner Seil Fabrik

**Risk Level:** 6 - Low Risk  
**Surface:** Wet Pour

**Finding:** There is surface corrosion present on the item  
**Action:** Consider treating and repainting the item

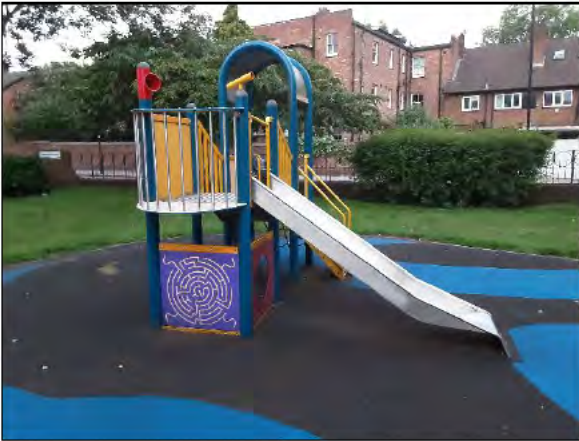
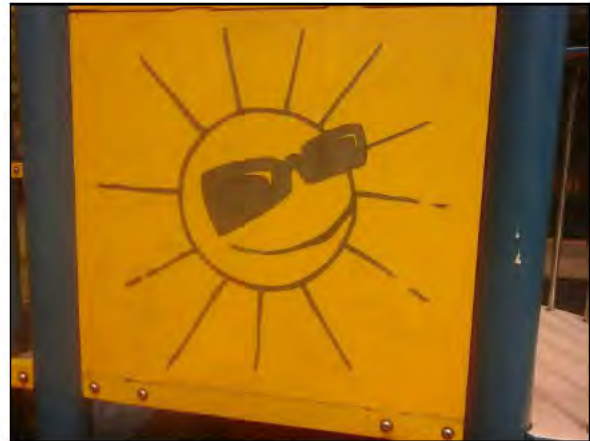
**Item:** Activity Equipment - Multi Play (Toddler)  
**Manufacturer:** Russell Leisure Ltd

**Risk Level:** 2 - Very Low Risk  
**Surface:** Wet Pour

**Finding:** There is some graffiti present  
**Action:** Remove the graffiti

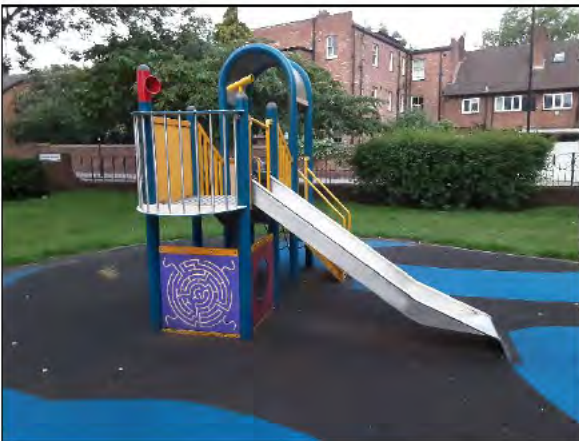
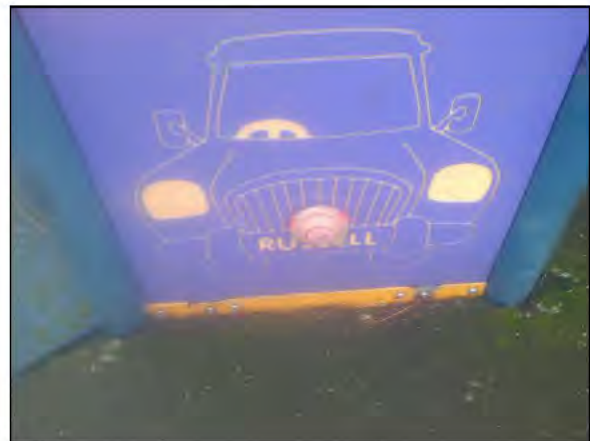
**Item:** Activity Equipment - Multi Play (Toddler)  
**Manufacturer:** Russell Leisure Ltd

**Risk Level:** 6 - Low Risk  
**Surface:** Wet Pour

**Finding:** Steering wheel is damaged  
**Action:** Replace

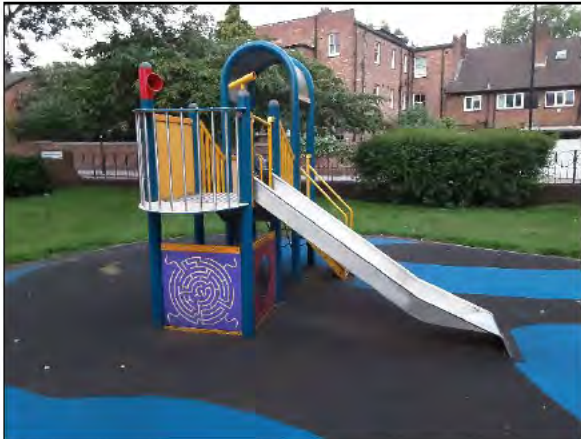
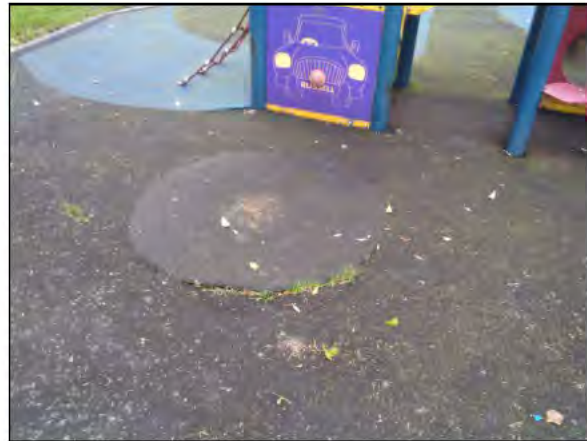
**Item:** Activity Equipment - Multi Play (Toddler)  
**Manufacturer:** Russell Leisure Ltd

**Risk Level:** 6 - Low Risk  
**Surface:** Wet Pour

**Finding:** There are gaps opening between the surfacing and the edging surround or between the joints in the surfacing  
**Action:** Monitor for any further deterioration and repair as required, 2 Lm

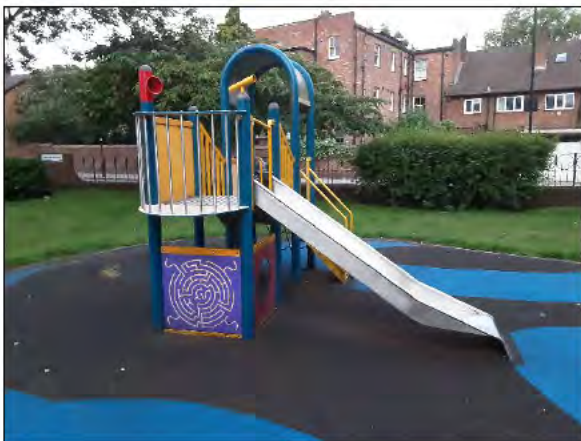
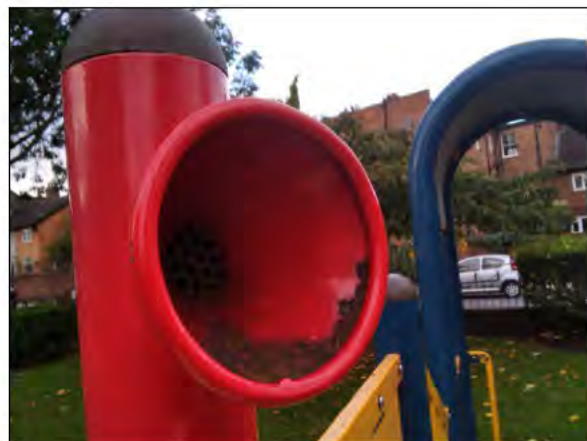
**Item:** Activity Equipment - Multi Play (Toddler)  
**Manufacturer:** Russell Leisure Ltd

**Risk Level:** 6 - Low Risk  
**Surface:** Wet Pour

**Finding:** The paintwork on this item has been damaged or worn exposing the metal underneath which is rusting  
**Action:** Treat any rusting components and repaint

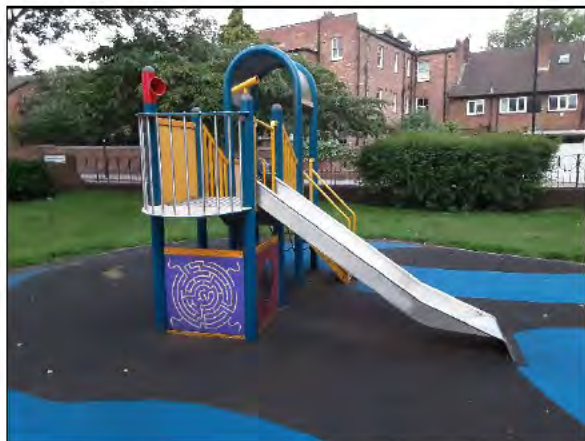
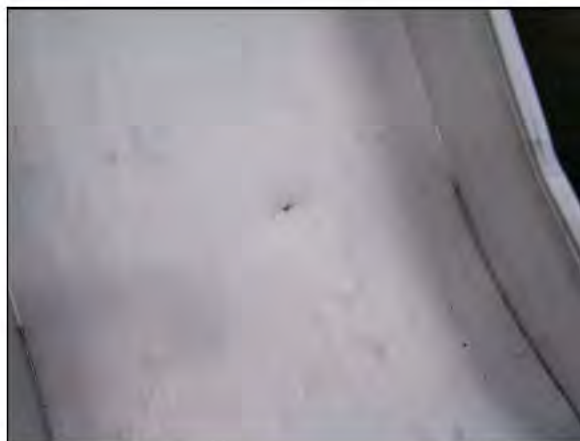
**Item:** Activity Equipment - Multi Play (Toddler)  
**Manufacturer:** Russell Leisure Ltd

**Risk Level:** 10 - Low Risk  
**Surface:** Wet Pour

**Finding:** There are a number of dents in the slide surface, sharp surface  
**Action:** Arrange to sand down any burrs on surface
