Operational Inspection

Kildoran Road

Inspection Ref: 1932010

Inspected: 30 January 2023 at 12:05 Inspector: [REDACTED]

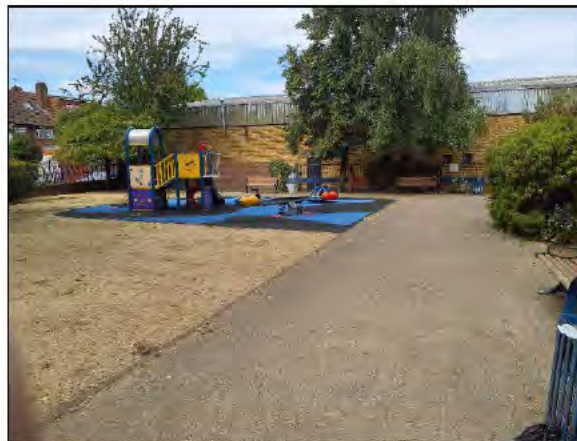
Item: Ancillary Items - Site General
Manufacturer: Owner/Operator
Comments

There are trip hazards at the edges of the surface
Reinstate surrounding surface levels to remove the trip points 20lm

There is algae or moss growth on the surface resulting in slippery conditions Clean and treat appropriately

Risk Assessment: 8 - Low Risk

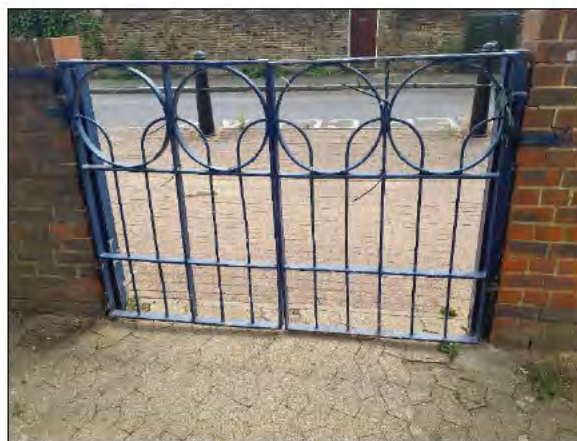
Item: Gates - Gate - Pedestrian
Manufacturer: Unknown
Comments

The gate is loose on its hinges Investigate and take appropriate action to rectify

Risk Assessment: 6 - Low Risk

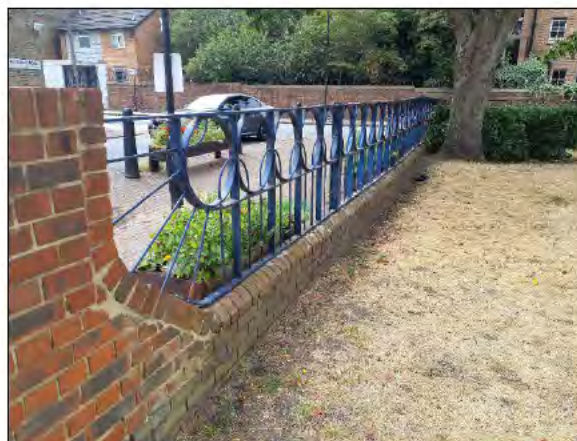
Item: Fences - Fencing - Flat Top
Manufacturer: Unknown
Comments

There is surface corrosion present on the item Consider treating and repainting the item

There is some graffiti present Remove the graffiti

Section of railing is missing Replace as required

Risk Assessment: 6 - Low Risk

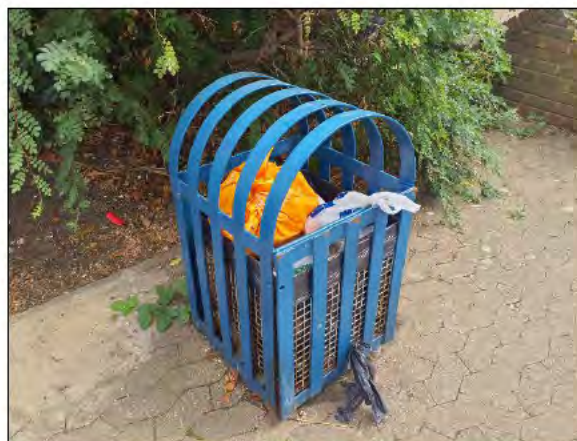
Item: Ancillary Items - Litter Bin
Manufacturer: Unknown
Comments

There is no liner present in the litterbin Provide as required

The litter bin is full Empty and review the collection routine

Risk Assessment: 6 - Low Risk

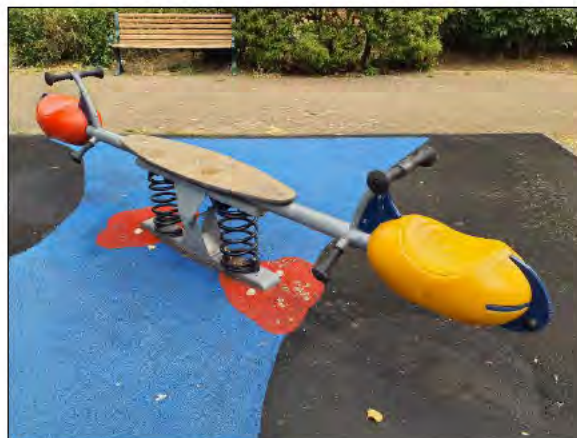
Item: Rocking Equipment - Spring See-Saw
Manufacturer: Kompan Ltd
Comments

Hand/foot rests are wearing Monitor for further wear

Evidence of vandalism, dog bites Monitor for deterioration and consider replacing

Risk Assessment: 6 - Low Risk

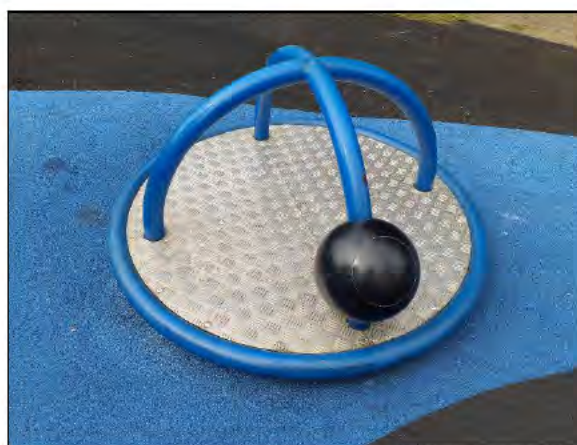
Item: Rotor Play - Roundabout
Manufacturer: Berliner Seil Fabrik
Comments

There is surface corrosion present on the item Consider treating and repainting the item

Risk Assessment: 6 - Low Risk

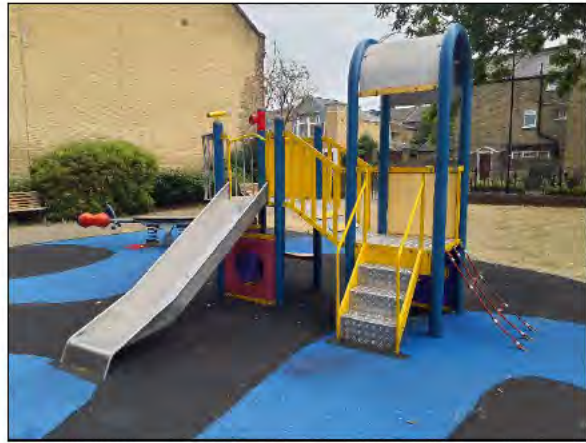
Item: Activity Equipment - Multi Play (Toddler)
Manufacturer: Russell Leisure Ltd
Comments

There is some graffiti present Remove the graffiti

Steering wheel is damaged Replace

There are gaps opening between the surfacing and the edging surround or between the joints in the surfacing
Monitor for any further deterioration and repair as required,
2 Lm

The paintwork on this item has been damaged or worn exposing the metal underneath which is rusting Treat any rusting components and repaint

There are a number of dents in the slide surface, sharp surface Arrange to sand down any burrs on surface

Risk Assessment: 10 - Low Risk

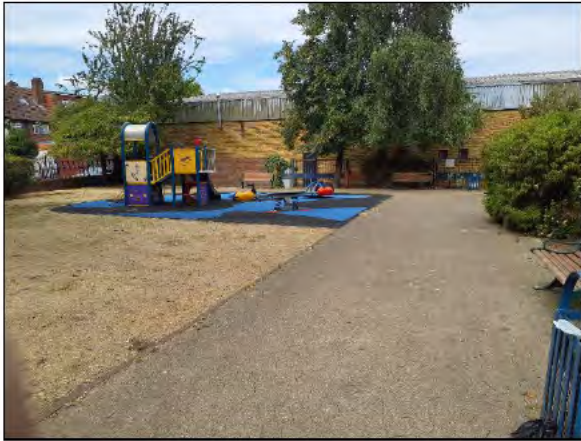
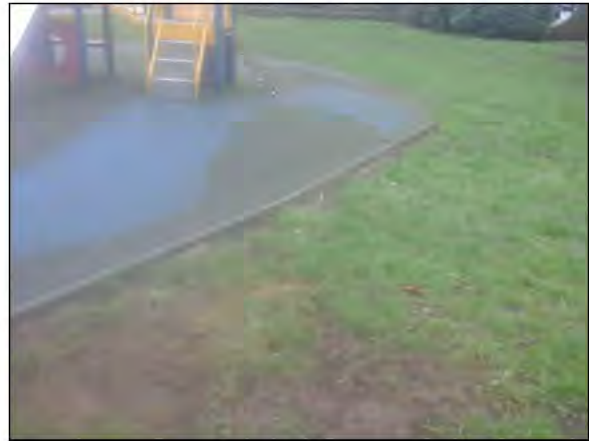
Item: Ancillary Items - Site General
Manufacturer: Owner/Operator

Risk Level: 8 - Low Risk
Surface: N/A

Finding: There are trip hazards at the edges of the surface
Action: Reinstate surrounding surface levels to remove the trip points 20lm

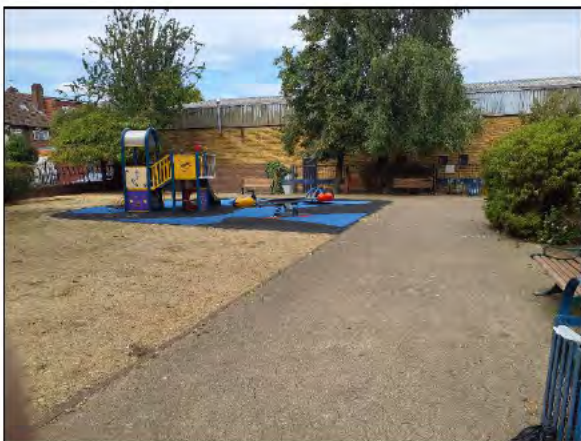
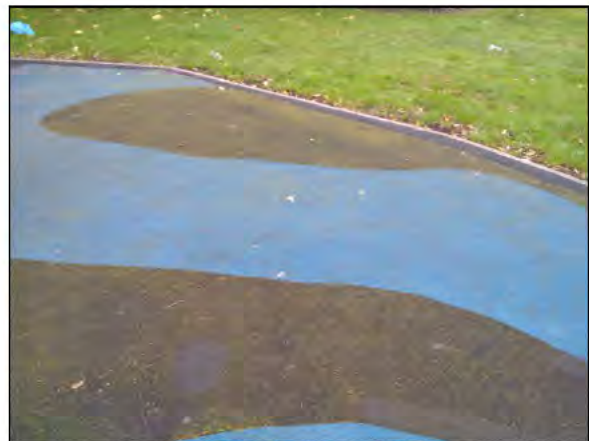
Item: Ancillary Items - Site General
Manufacturer: Owner/Operator

Risk Level: 8 - Low Risk
Surface: N/A

Finding: There is algae or moss growth on the surface resulting in slippery conditions
Action: Clean and treat appropriately

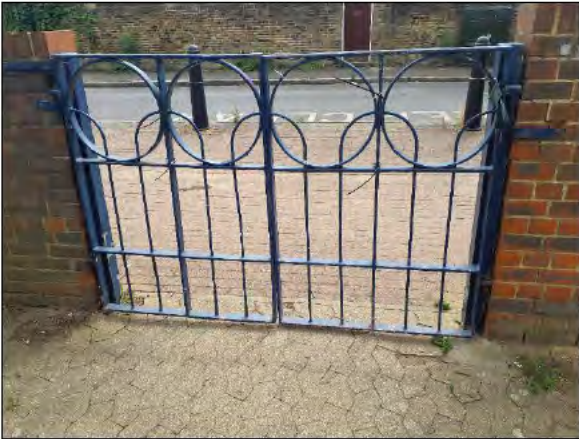
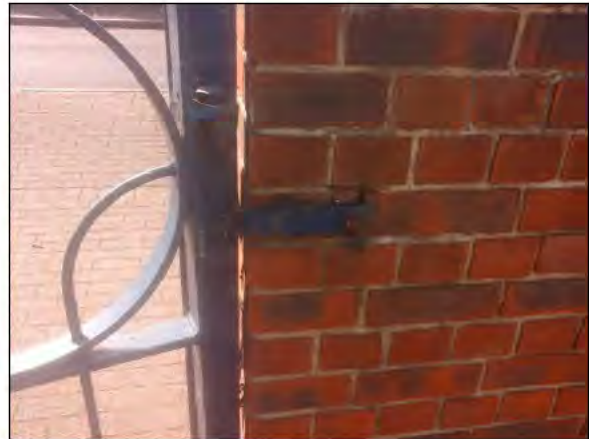
Item: Gates - Gate - Pedestrian
Manufacturer: Unknown

Risk Level: 6 - Low Risk
Surface: All Weather Surface

Finding: The gate is loose on its hinges
Action: Investigate and take appropriate action to rectify

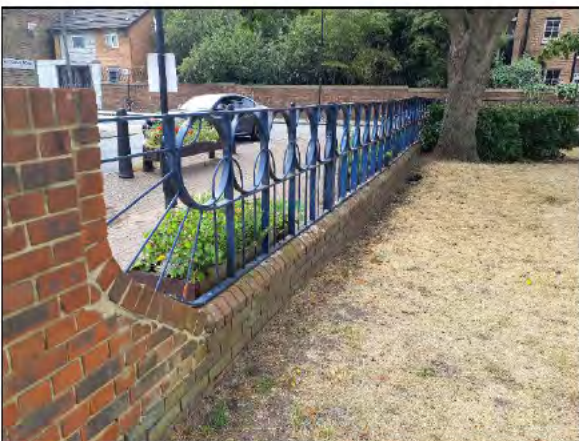
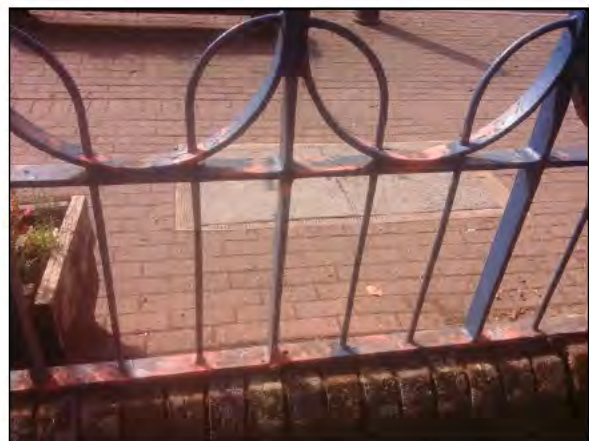
Item: Fences - Fencing - Flat Top
Manufacturer: Unknown

Risk Level: 6 - Low Risk
Surface: Brick Pavers

Finding: There is surface corrosion present on the item
Action: Consider treating and repainting the item

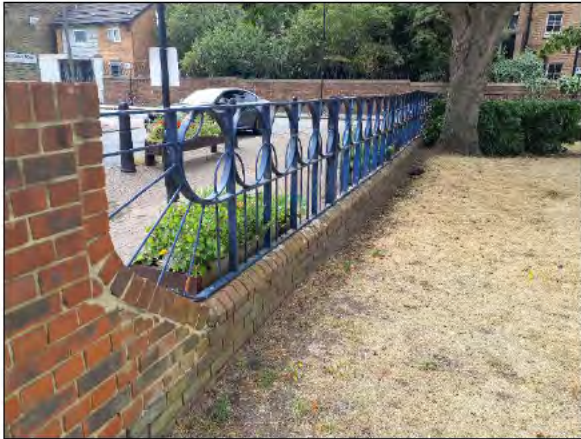
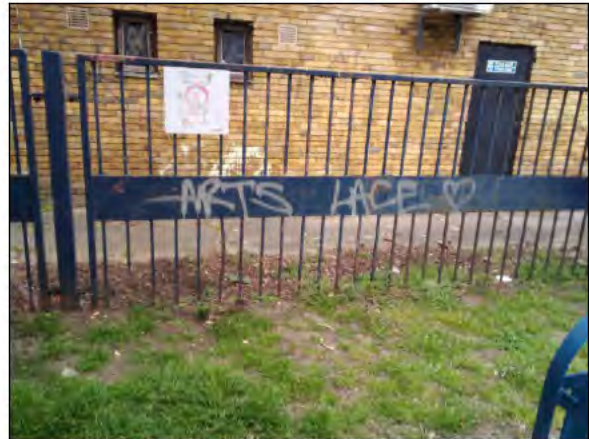
Item: Fences - Fencing - Flat Top
Manufacturer: Unknown

Risk Level: 2 - Very Low Risk
Surface: Brick Pavers

Finding: There is some graffiti present
Action: Remove the graffiti

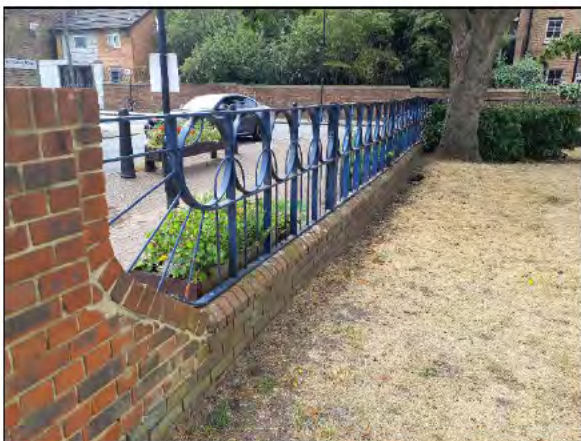
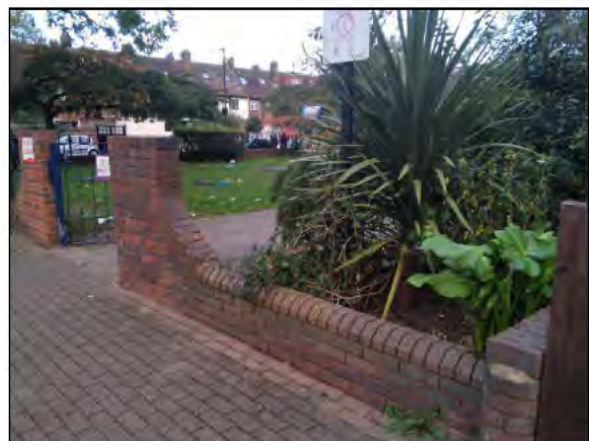
Item: Fences - Fencing - Flat Top
Manufacturer: Unknown

Risk Level: 6 - Low Risk
Surface: Brick Pavers

Finding: Section of railing is missing
Action: Replace as required

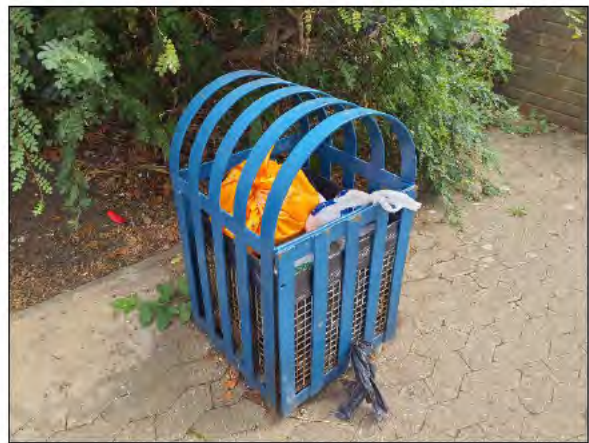
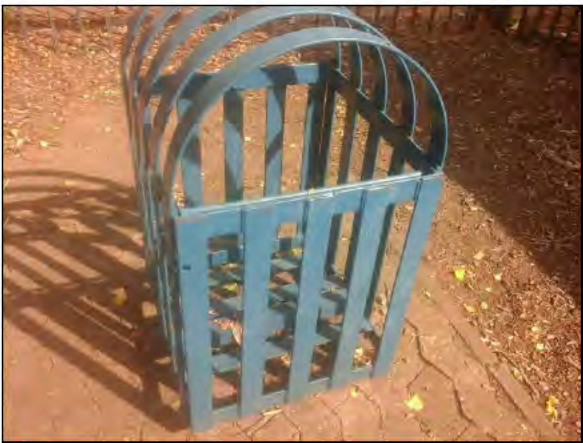
Item:	Ancillary Items - Litter Bin	Risk Level:	2 - Very Low Risk
Manufacturer:	Unknown	Surface:	Brick Pavers

Finding: There is no liner present in the litterbin
Action: Provide as required

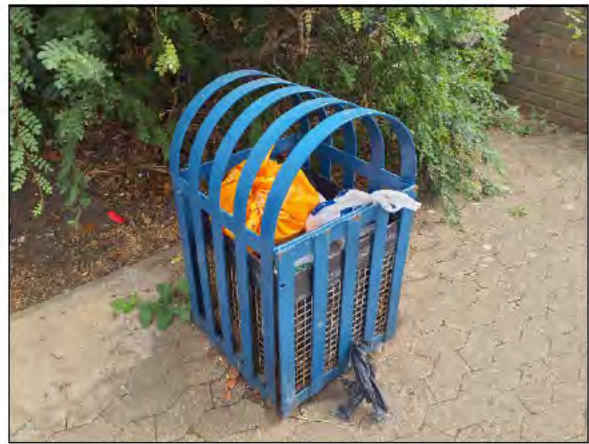
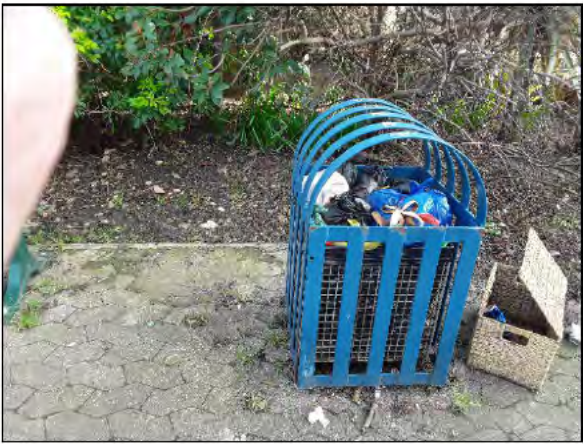
Item:	Ancillary Items - Litter Bin	Risk Level:	6 - Low Risk
Manufacturer:	Unknown	Surface:	Brick Pavers

Finding: The litter bin is full
Action: Empty and review the collection routine

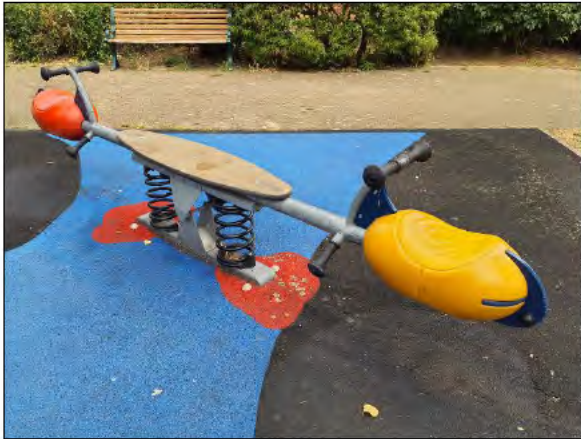
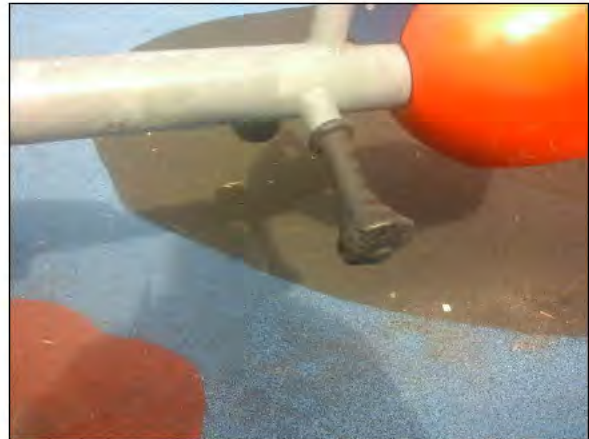
Item: Rocking Equipment - Spring See-Saw
Manufacturer: Kompan Ltd

Risk Level: 5 - Very Low Risk
Surface: Wet Pour

Finding: Hand/foot rests are wearing
Action: Monitor for further wear

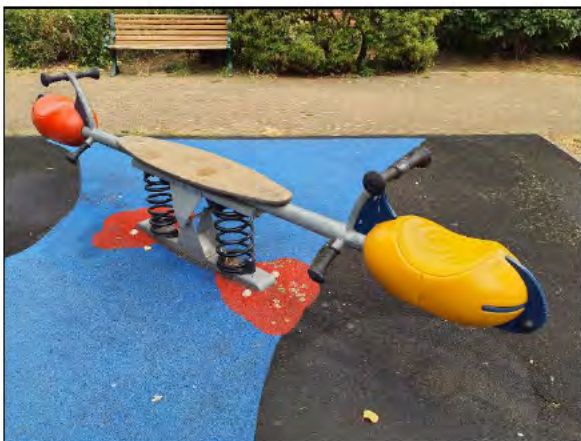
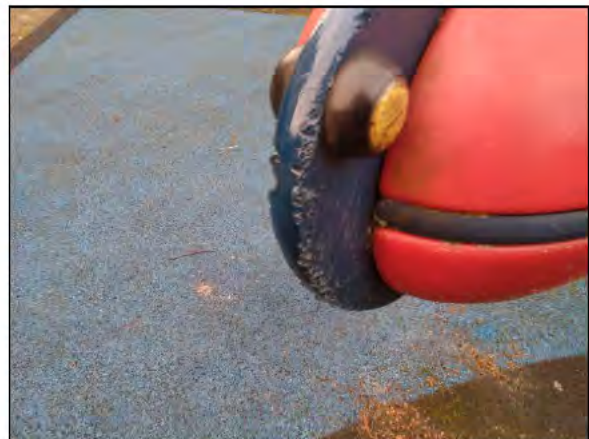
Item: Rocking Equipment - Spring See-Saw
Manufacturer: Kompan Ltd

Risk Level: 6 - Low Risk
Surface: Wet Pour

Finding: Evidence of vandalism, dog bites
Action: Monitor for deterioration and consider replacing

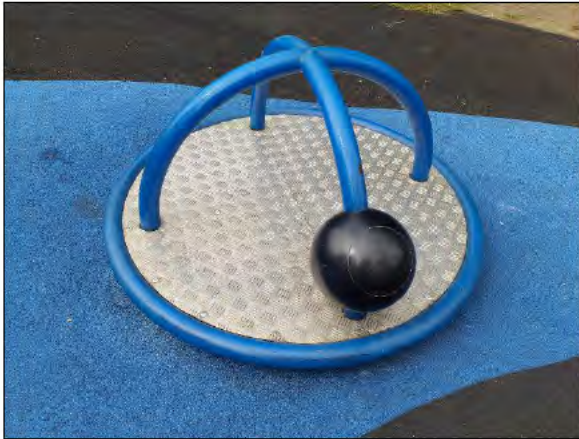
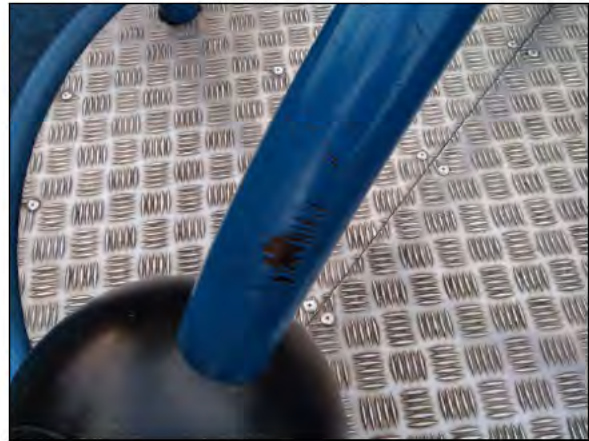
Item: Rotor Play - Roundabout
Manufacturer: Berliner Seil Fabrik

Risk Level: 6 - Low Risk
Surface: Wet Pour

Finding: There is surface corrosion present on the item
Action: Consider treating and repainting the item

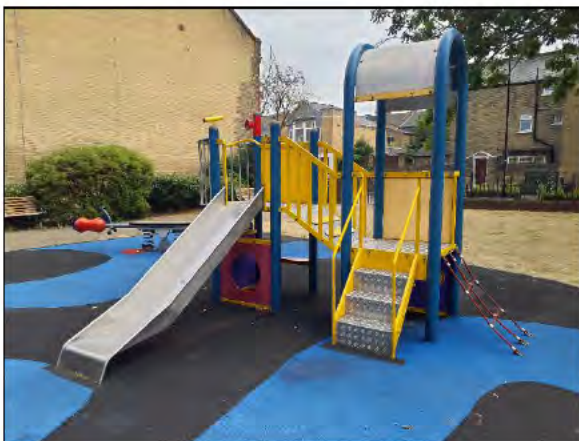
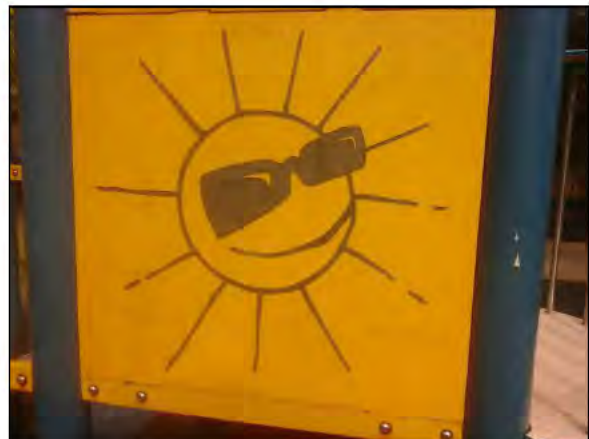
Item: Activity Equipment - Multi Play (Toddler)
Manufacturer: Russell Leisure Ltd

Risk Level: 2 - Very Low Risk
Surface: Wet Pour

Finding: There is some graffiti present
Action: Remove the graffiti

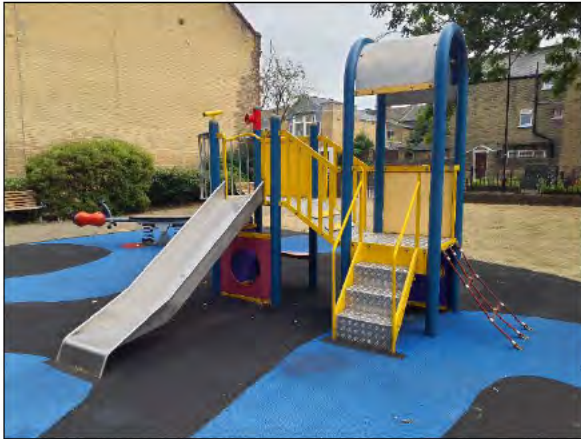
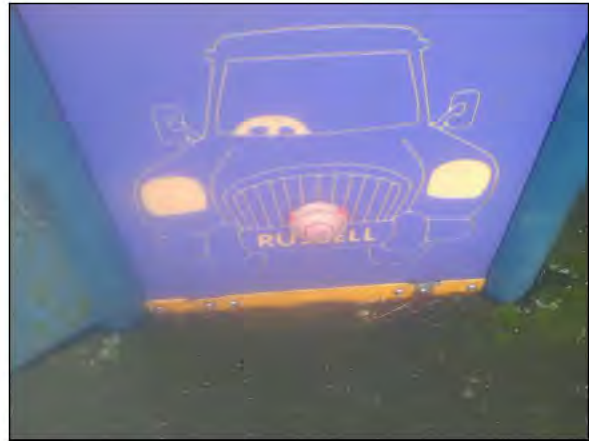
Item: Activity Equipment - Multi Play (Toddler)
Manufacturer: Russell Leisure Ltd

Risk Level: 6 - Low Risk
Surface: Wet Pour

Finding: Steering wheel is damaged
Action: Replace

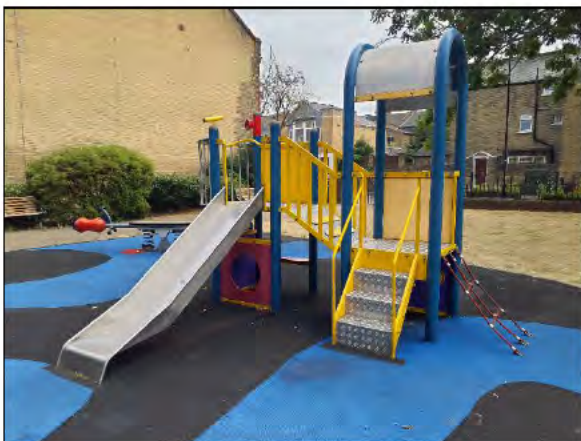
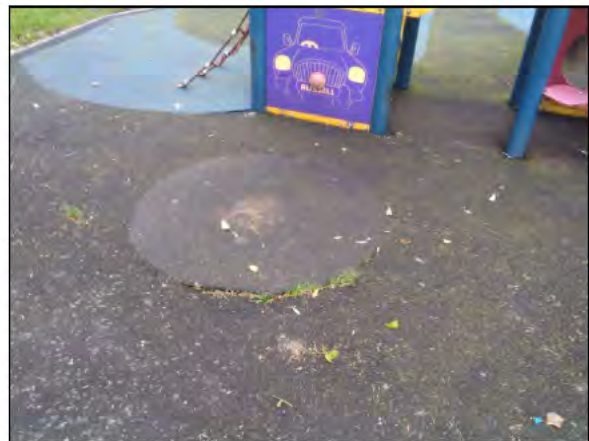
Item: Activity Equipment - Multi Play (Toddler)
Manufacturer: Russell Leisure Ltd

Risk Level: 6 - Low Risk
Surface: Wet Pour

Finding: There are gaps opening between the surfacing and the edging surround or between the joints in the surfacing
Action: Monitor for any further deterioration and repair as required, 2 Lm

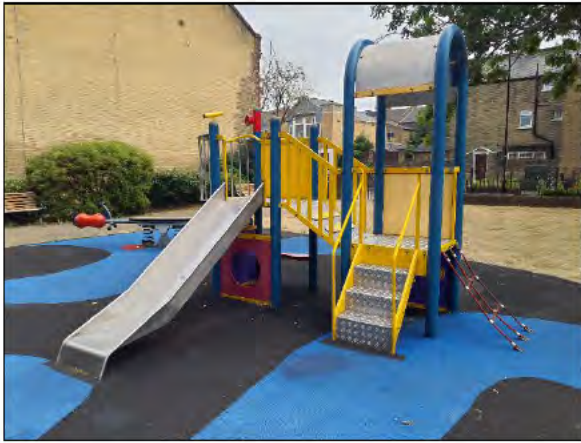
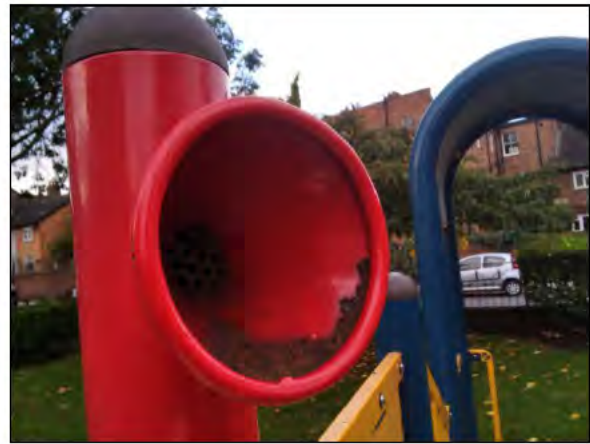
Item:	Activity Equipment - Multi Play (Toddler)	Risk Level:	6 - Low Risk
Manufacturer:	Russell Leisure Ltd	Surface:	Wet Pour

The paintwork on this item has been damaged or worn exposing the metal underneath which is rusting

Treat any rusting components and repaint

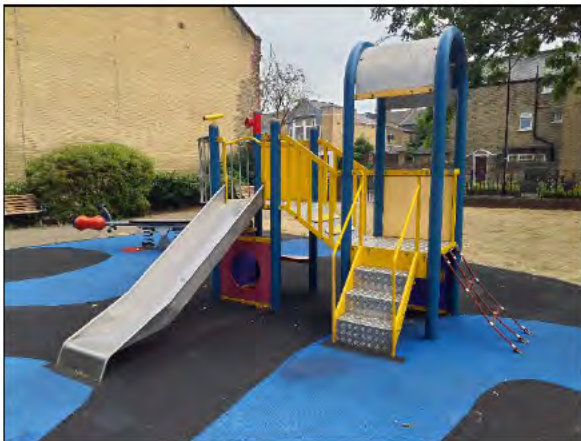
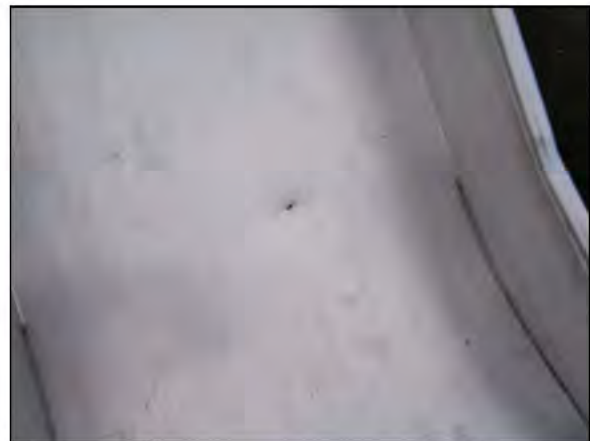
Activity Equipment - Multi Play (Toddler)

10 - Low Risk

There are a number of dents in the slide surface, sharp surface

Arrange to sand down any burrs on surface
