Annual Inspection  
Kildoran Road

Inspection Ref: 1406328

Site Ref: 63714

Inspected: 01 July 2021 at 04:36 Inspector: [REDACTED]

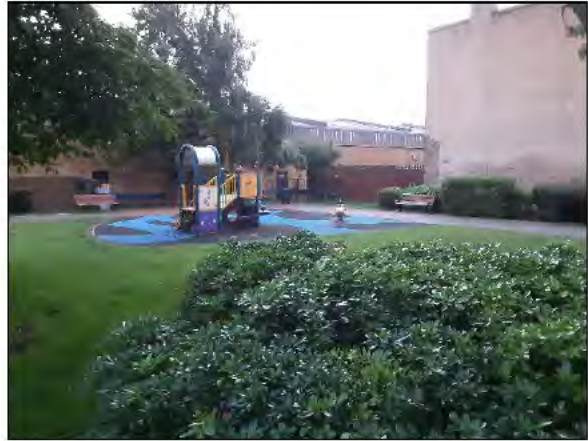
**Item:** Ancillary Items - Site General  
**Manufacturer:** Owner/Operator  
**Comments**

The site is accessible to the public during the COVID 19 pandemic. The government have released guidelines for safely re-opening these types of facilities which is available on the government website. Ensure there is an appropriate risk assessment in place and review regularly

Outdated Covid19 information signage is posted on the gate Remove the signage

There is weed / vegetation growth on, between, or around the edges of the paved surfacing Remove weed / vegetation growth

There is algae or moss growth on the safety surface resulting in slippery conditions Clean and treat appropriately

**Risk Assessment:** 8 - Low Risk

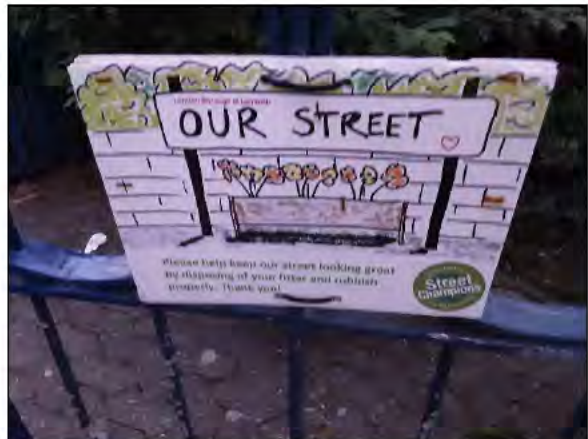
**Item:** Ancillary Items - Sign  
**Manufacturer:** Not Applicable  
**Comments**

It is recommended that signage, with information including the site address, contact information for maintenance issues and emergency contact details are provided for the facility Provide in accordance with the recommendations

**Risk Assessment:** 5 - Very Low Risk

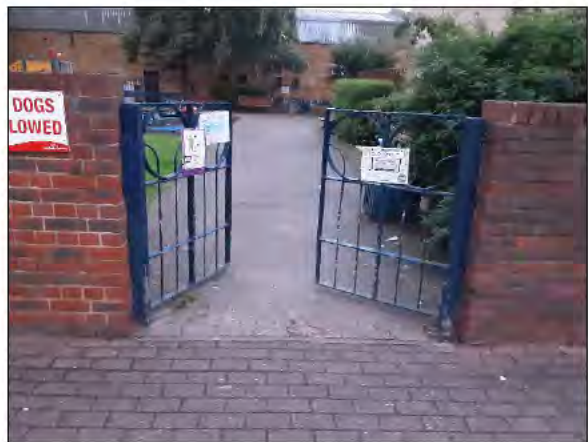
**Item:** Gates - Gate - Pedestrian  
**Manufacturer:** Unknown  
**Comments**

There are openings that are less than 12mm that could trap or crush fingers Where possible a 12mm gap should be maintained on both sides or between the gate leafs

The gate has no drop bolt sleeves and/or drop bolts fitted Provide drop bolt sleeves and/or drop bolts

There is no padlock on the maintenance gate Provide a padlock to secure the gate

**Risk Assessment:** 8 - Low Risk

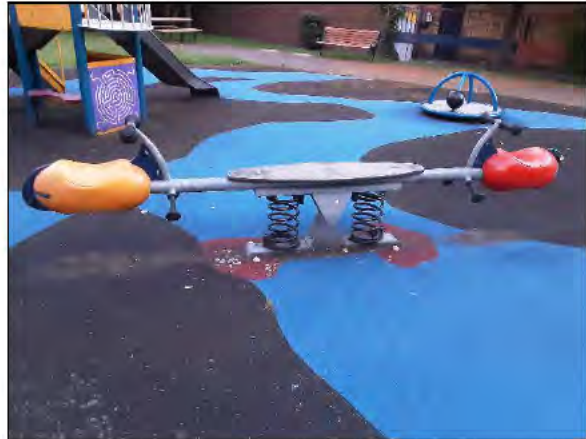
**Item:** Rocking Equipment - Spring See-Saw  
**Manufacturer:** Kompan Ltd  
**Comments**

There is some minor wear damage to the surface Monitor for any further deterioration and repair as required

There is minor damage to the handgrips/footrests Monitor and replace if required

There is minor vandalism damage to the body Remove the sharp protrusions

**Risk Assessment:** 6 - Low Risk

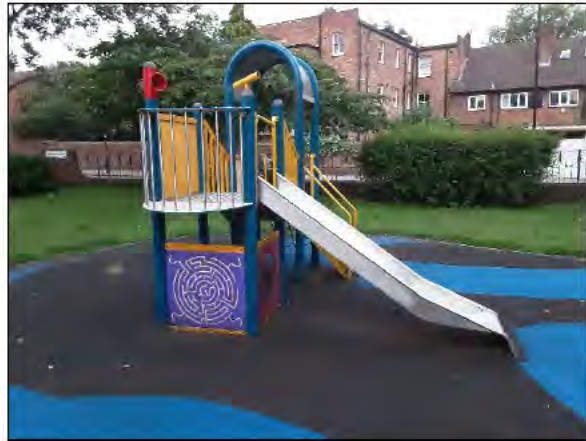
**Item:** Activity Equipment - Multi Play (Toddler)  
**Manufacturer:** Russell Leisure Ltd  
**Comments**

The equipment item does not comply with the requirements of the current applicable standard.

There are a number of dents in the slide surface Monitor for any further deterioration and repair as required

The design of the barriers encourages standing or sitting and fails the requirements of BS EN 1176 Monitor - No remedial work recommended

There is/are finger entrapment/s in the structure and the item fails to meet the requirements of BS EN 1176 Part 1 4.2.7.6 Entrapment of fingers Monitor - No remedial work recommended

There is weed / vegetation growth on, between, or around the edges of the surfacing Remove weed / vegetation growth

There is some graffiti present Remove the graffiti

The item has damaged/missing component(s) Consider replacing damaged/missing components

There is damage to the surface Repair the damaged areas of surfacing

The bushes are worn or missing Replace worn or missing bushes

The paintwork on this item has been damaged or worn exposing the metal underneath which is rusting Treat any rusting components and repaint

There is algae or moss on the surface of the equipment Clean and treat appropriately

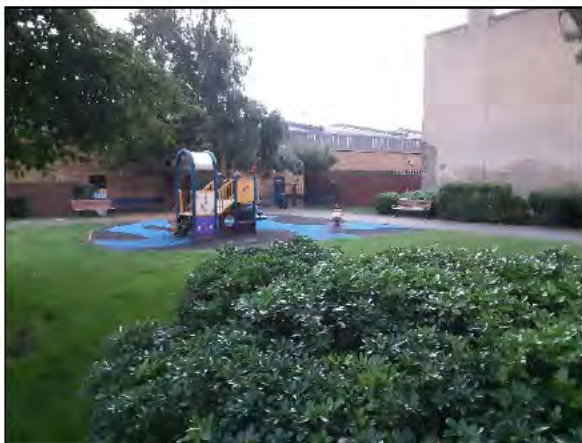
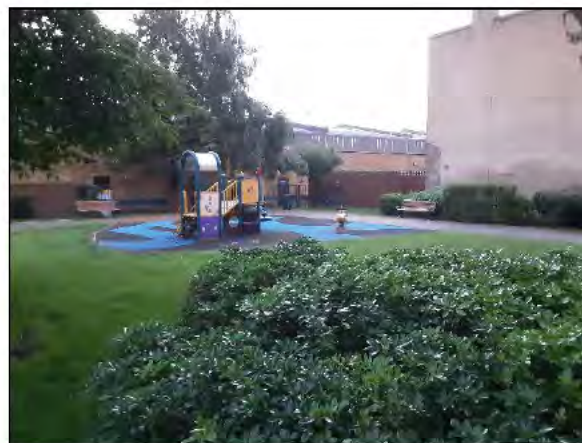
<b>Item:</b>	Ancillary Items - Site General	<b>Risk Level:</b>	0 - Risk Assessment not Undertaken
<b>Manufacturer:</b>	Owner/Operator	<b>Surface:</b>	N/A

<b>Finding:</b>	The site is accessible to the public during the COVID 19 pandemic. The government have released guidelines for safely re-opening these types of facilities which is available on the government website.
<b>Action:</b>	Ensure there is an appropriate risk assessment in place and review regularly

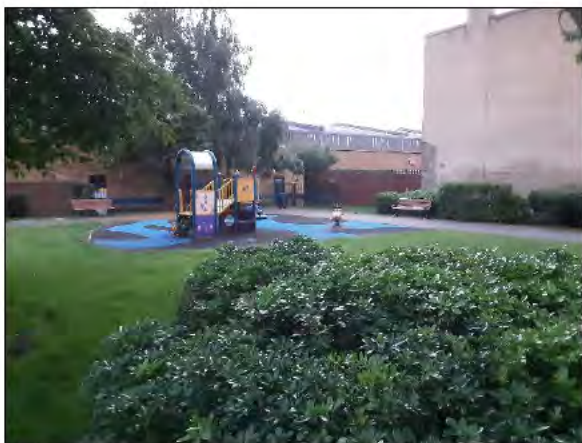
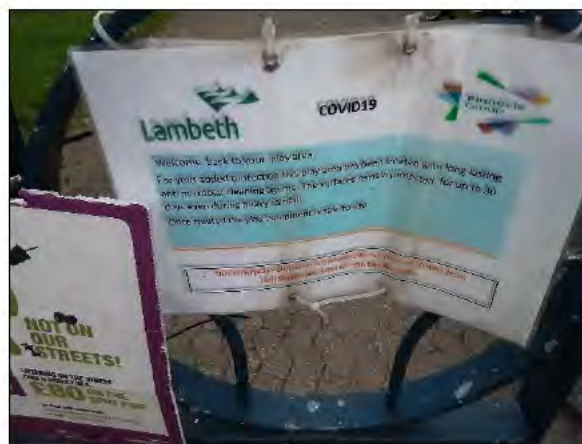
<b>Item:</b>	Ancillary Items - Site General	<b>Risk Level:</b>	4 - Very Low Risk
<b>Manufacturer:</b>	Owner/Operator	<b>Surface:</b>	N/A

<b>Finding:</b>	Outdated Covid19 information signage is posted on the gate
<b>Action:</b>	Remove the signage

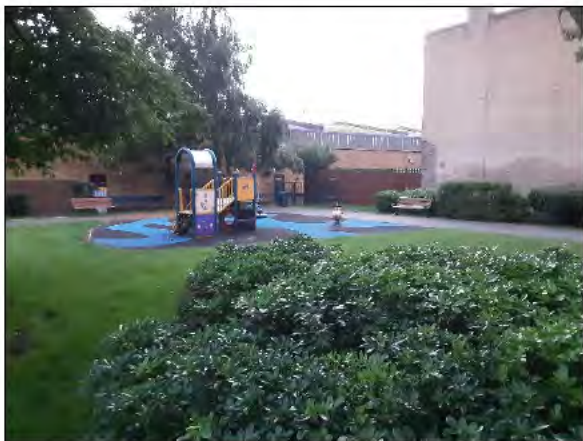
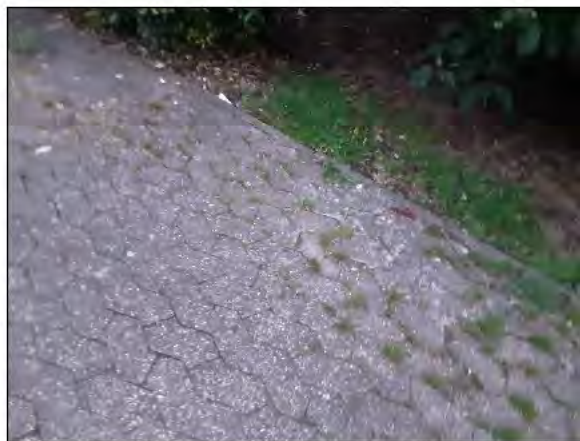
**Item:** Ancillary Items - Site General  
**Manufacturer:** Owner/Operator

**Finding:** There is weed / vegetation growth on, between, or around the edges of the paved surfacing  
**Action:** Remove weed / vegetation growth

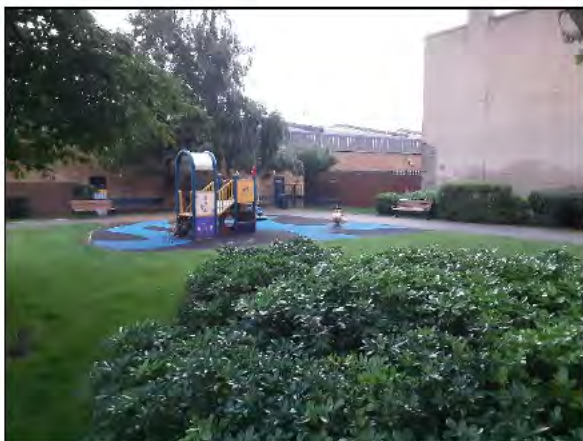
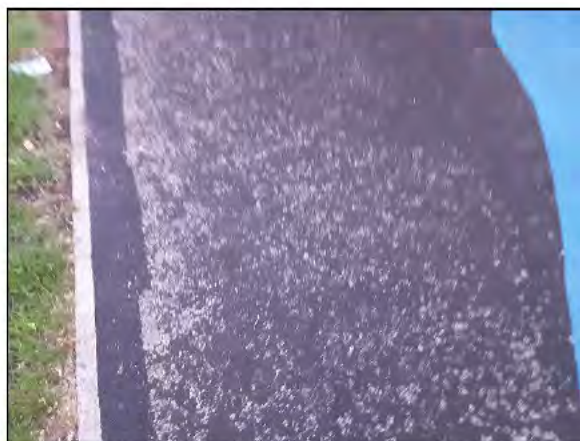
**Item:** Ancillary Items - Site General  
**Manufacturer:** Owner/Operator

**Finding:** There is algae or moss growth on the safety surface resulting in slippery conditions  
**Action:** Clean and treat appropriately

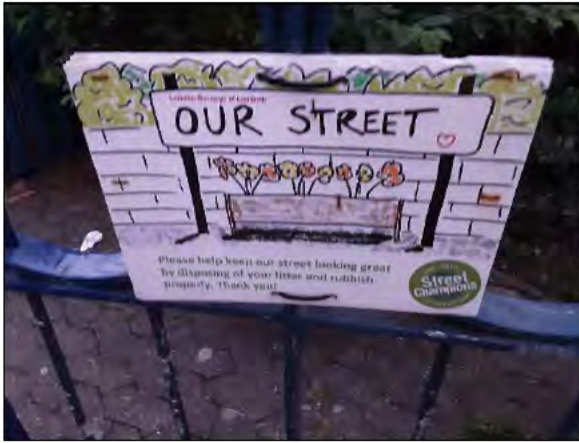
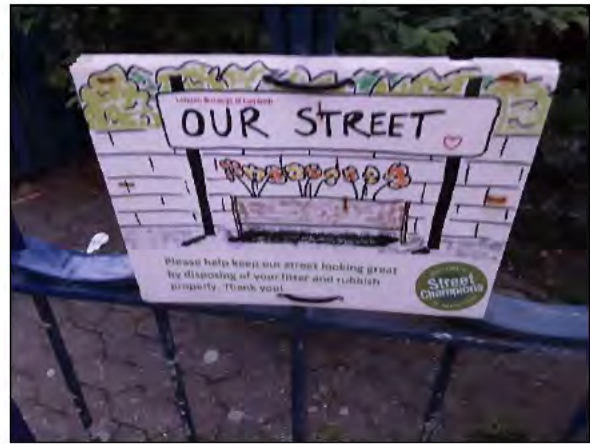
<b>Item:</b>	Ancillary Items - Sign	<b>Risk Level:</b>	5 - Very Low Risk
<b>Manufacturer:</b>	Not Applicable	<b>Surface:</b>	N/A

It is recommended that signage, with information including the site address, contact information for maintenance issues and emergency contact details are provided for the facility

Provide in accordance with the recommendations

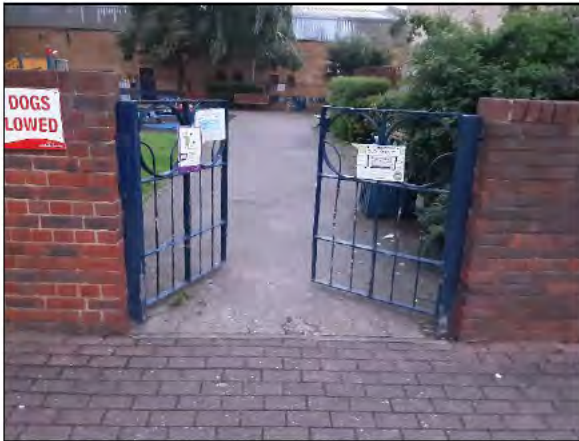
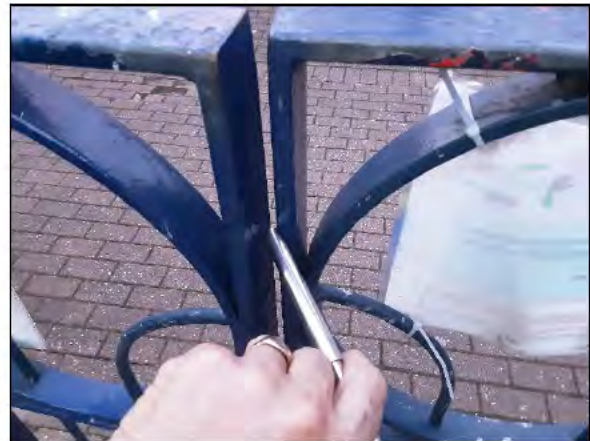
**Item:** Gates - Gate - Pedestrian  
**Manufacturer:** Unknown

There are openings that are less than 12mm that could trap or crush fingers

Where possible a 12mm gap should be maintained on both sides or between the gate leaves

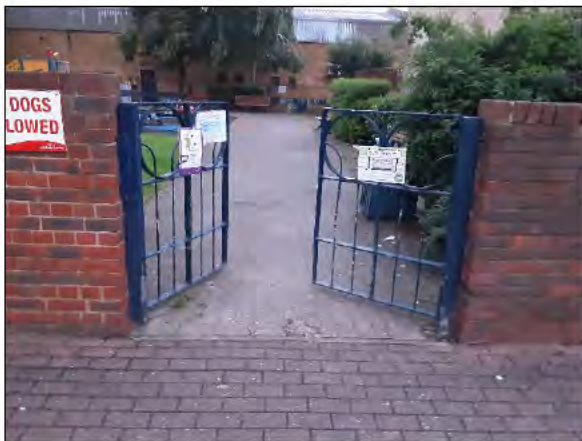
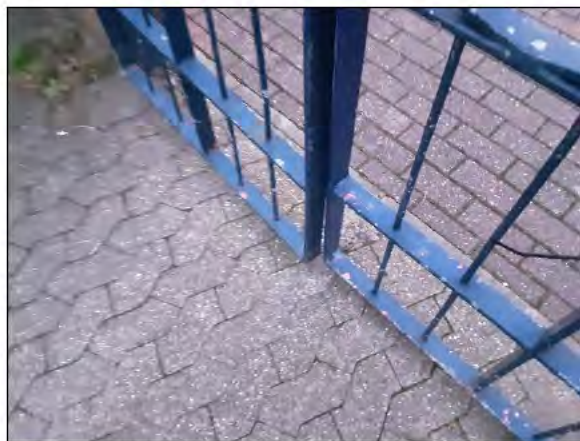
**Item:** Gates - Gate - Pedestrian  
**Manufacturer:** Unknown

**Finding:** The gate has no drop bolt sleeves and/or drop bolts fitted  
**Action:** Provide drop bolt sleeves and/or drop bolts

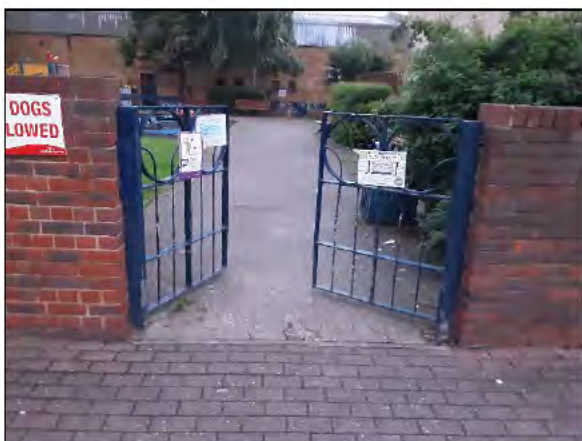
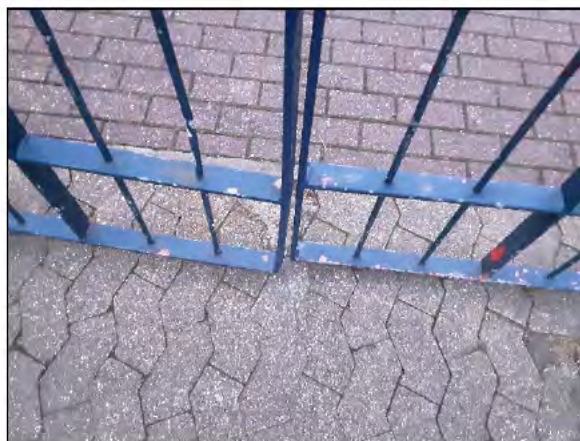
**Item:** Gates - Gate - Pedestrian  
**Manufacturer:** Unknown

**Finding:** There is no padlock on the maintenance gate  
**Action:** Provide a padlock to secure the gate

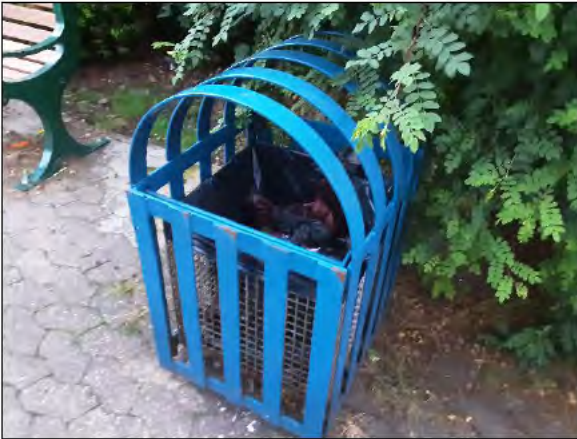
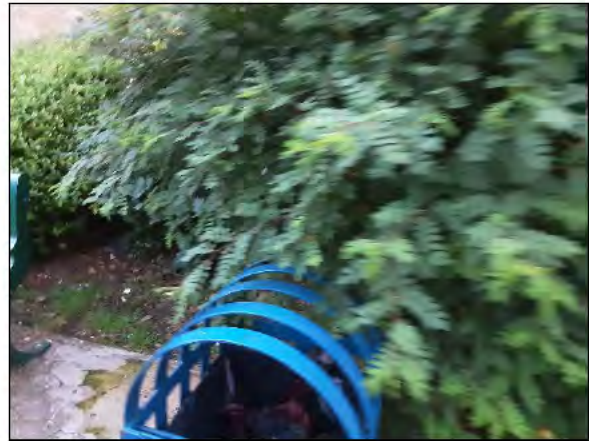
**Item:** Ancillary Items - Litter Bin  
**Manufacturer:** Unknown

**Finding:** The adjacent foliage is overhanging the bin  
**Action:** Cut back and maintain

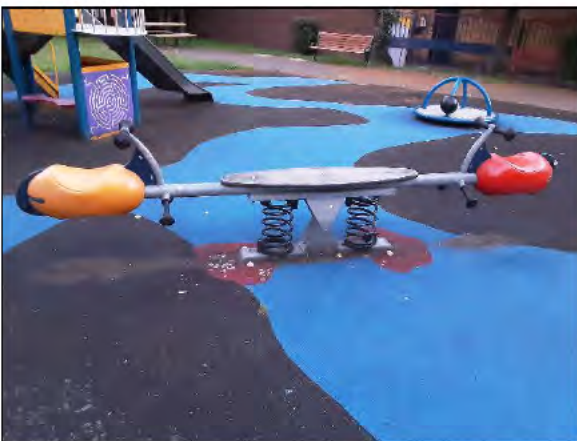
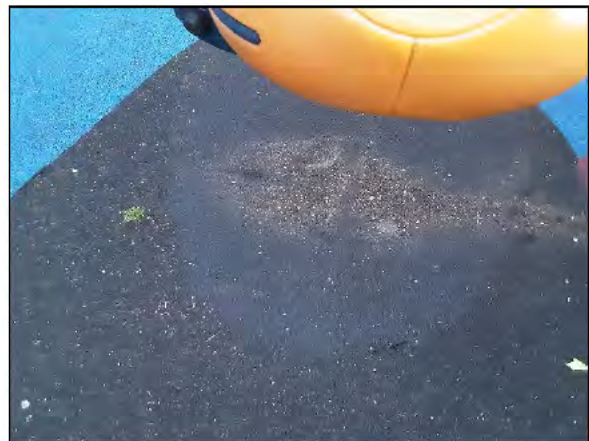
**Item:** Rocking Equipment - Spring See-Saw  
**Manufacturer:** Kompan Ltd

**Finding:** There is some minor wear damage to the surface  
**Action:** Monitor for any further deterioration and repair as required

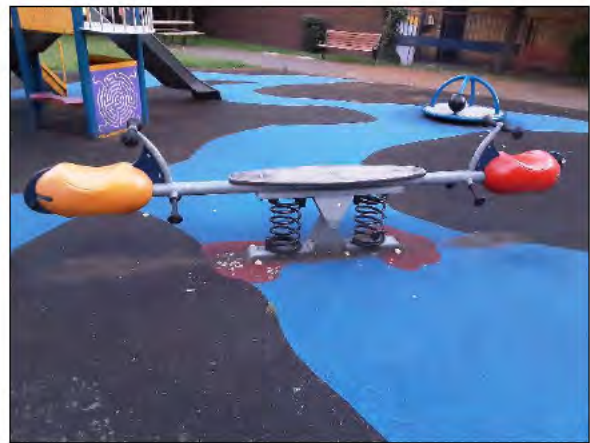
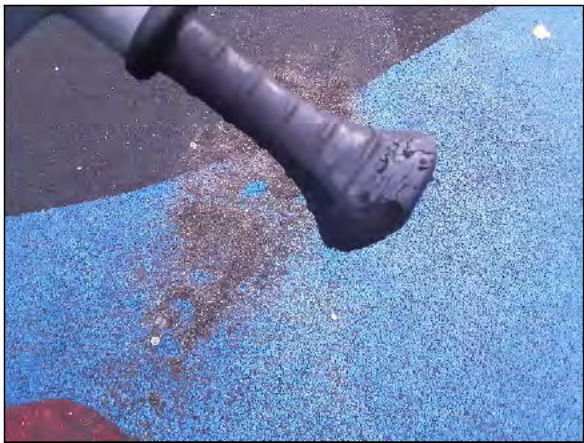
Item:	Rocking Equipment - Spring See-Saw	Risk Level:	6 - Low Risk
Manufacturer:	Kompan Ltd	Surface:	Wet Pour

**Finding:** There is minor damage to the handgrips/footrests  
**Action:** Monitor and replace if required

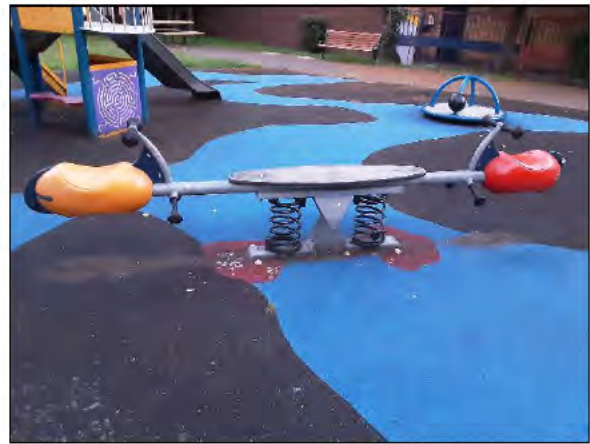
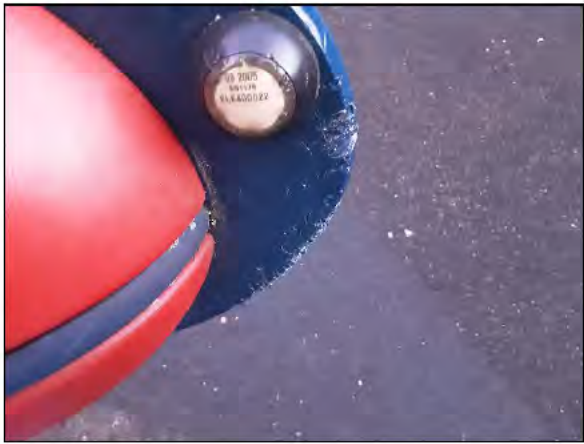
Item:	Rocking Equipment - Spring See-Saw	Risk Level:	6 - Low Risk
Manufacturer:	Kompan Ltd	Surface:	Wet Pour

**Finding:** There is minor vandalism damage to the body  
**Action:** Remove the sharp protrusions

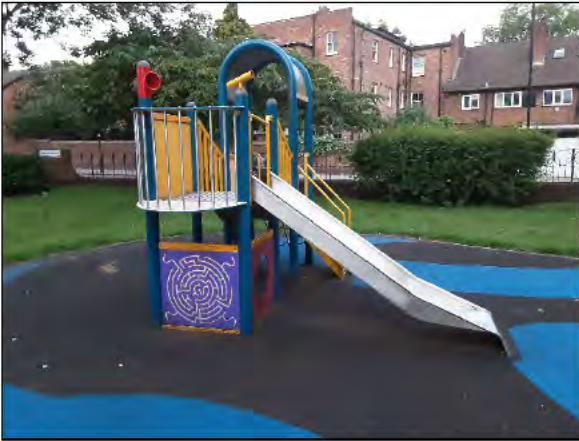
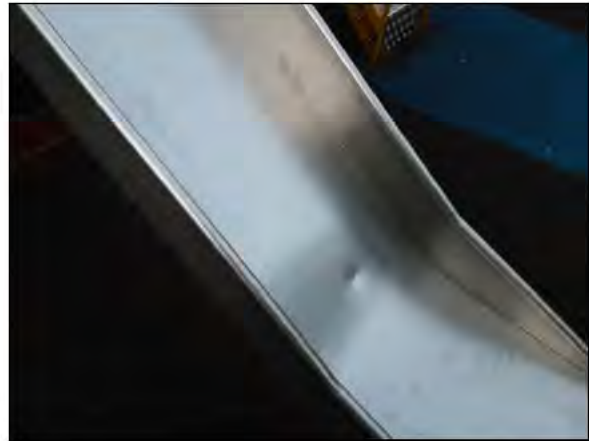
**Item:** Activity Equipment - Multi Play (Toddler)  
**Manufacturer:** Russell Leisure Ltd

**Finding:** There are a number of dents in the slide surface  
**Action:** Monitor for any further deterioration and repair as required

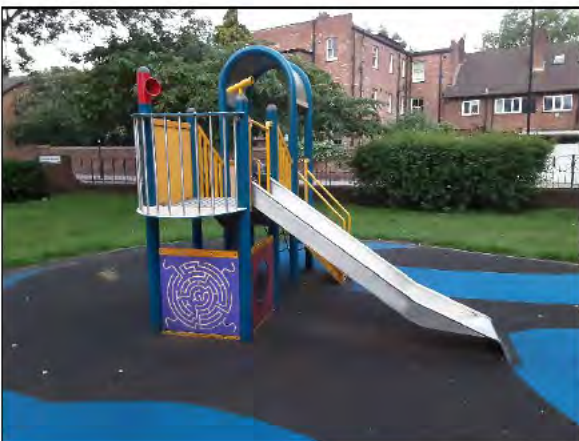
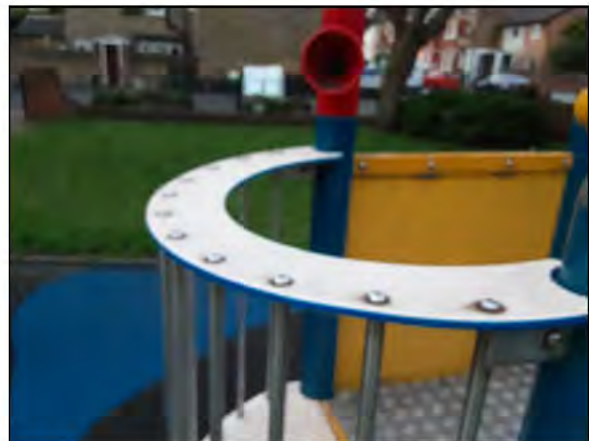
**Item:** Activity Equipment - Multi Play (Toddler)  
**Manufacturer:** Russell Leisure Ltd

**Finding:** The design of the barriers encourages standing or sitting and fails the requirements of BS EN 1176  
**Action:** Monitor - No remedial work recommended

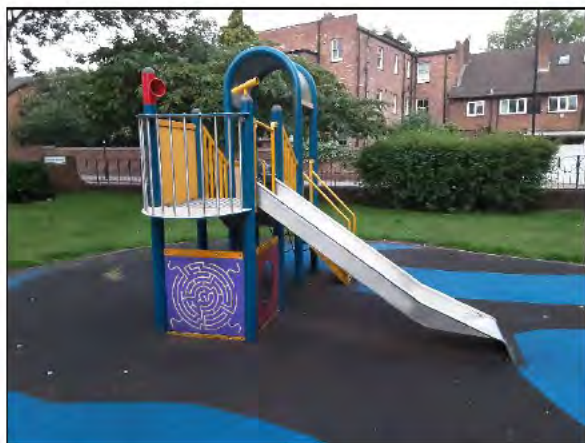
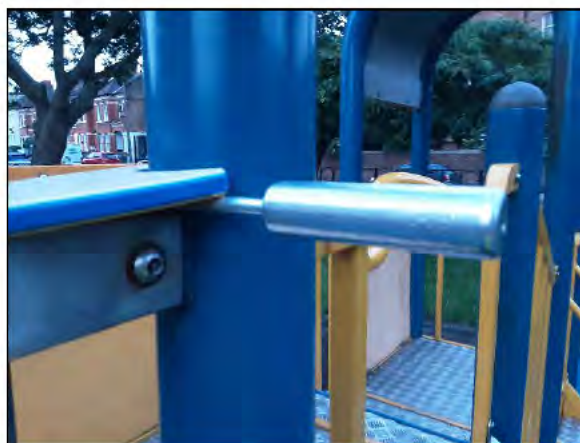
<b>Item:</b>	Activity Equipment - Multi Play (Toddler)	<b>Risk Level:</b>	5 - Very Low Risk
<b>Manufacturer:</b>	Russell Leisure Ltd	<b>Surface:</b>	Wet Pour

There is/are finger entrapment/s in the structure and the item fails to meet the requirements of BS EN 1176 Part 1 4.2.7.6 Entrapment of fingers

Monitor - No remedial work recommended

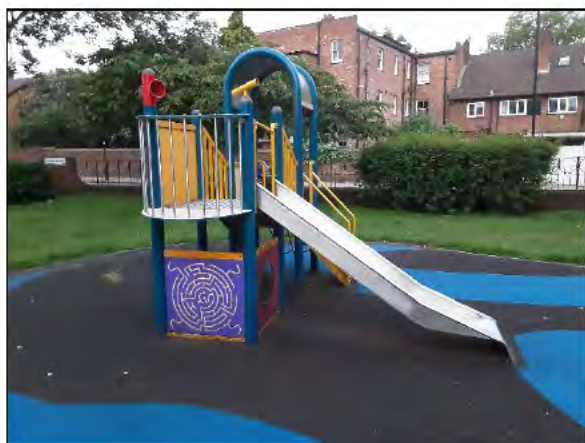
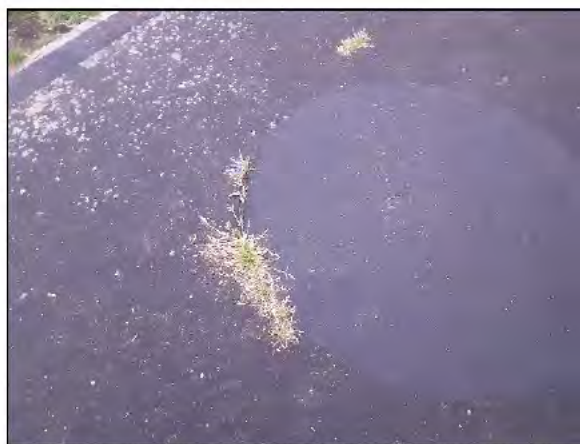
Activity Equipment - Multi Play (Toddler)

There is weed / vegetation growth on, between, or around the edges of the surfacing

Remove weed / vegetation growth

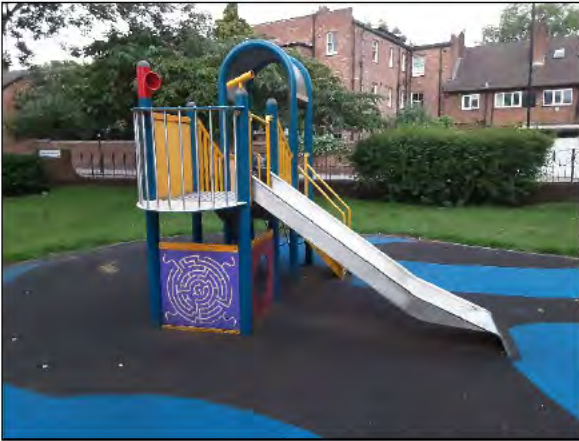
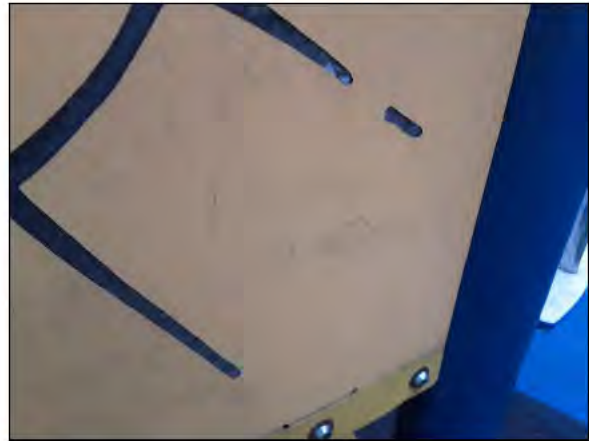
**Item:** Activity Equipment - Multi Play (Toddler)  
**Manufacturer:** Russell Leisure Ltd

**Finding:** There is some graffiti present  
**Action:** Remove the graffiti

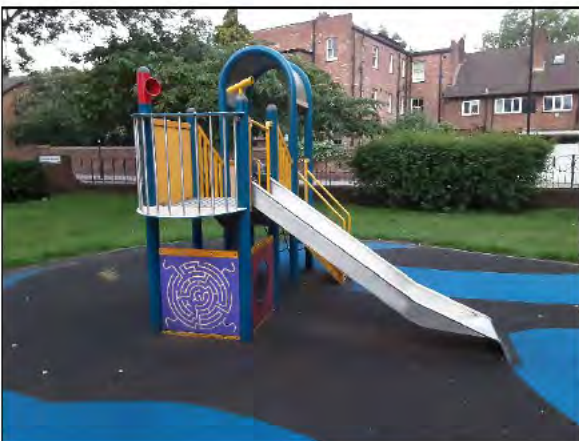
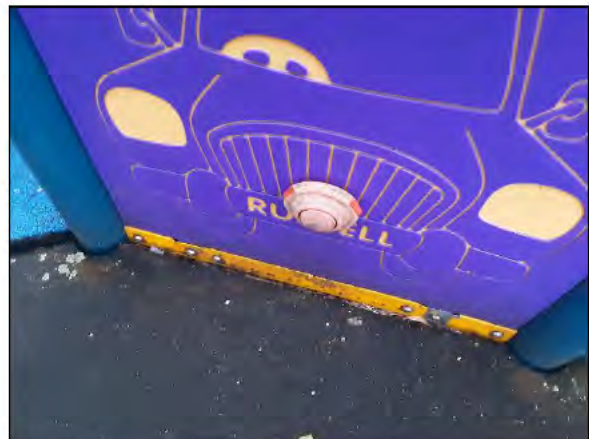
**Item:** Activity Equipment - Multi Play (Toddler)  
**Manufacturer:** Russell Leisure Ltd

**Finding:** The item has damaged/missing component(s)  
**Action:** Consider replacing damaged/missing components

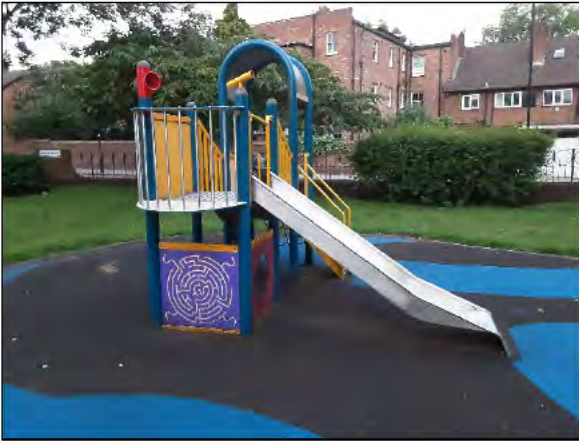
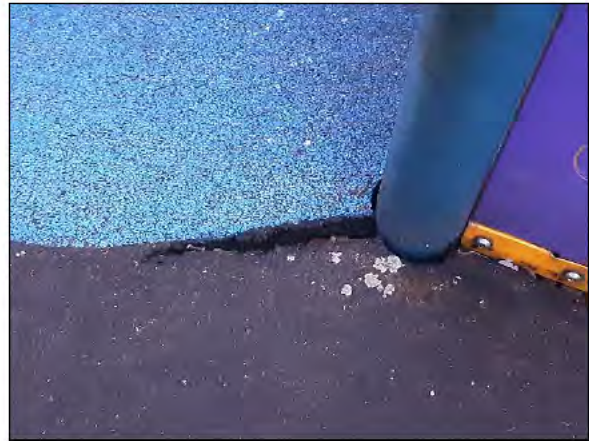
**Item:** Activity Equipment - Multi Play (Toddler)  
**Manufacturer:** Russell Leisure Ltd

**Finding:** There is damage to the surface  
**Action:** Repair the damaged areas of surfacing

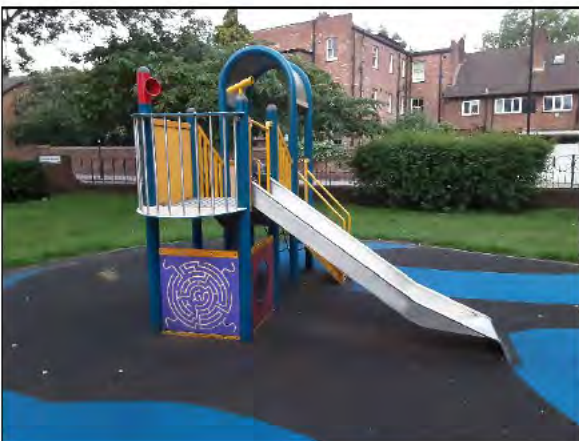
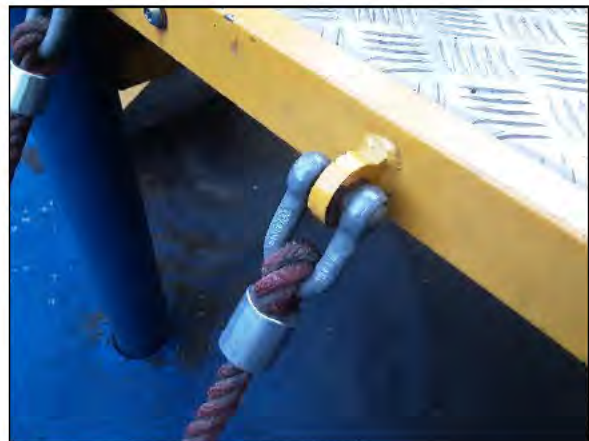
**Item:** Activity Equipment - Multi Play (Toddler)  
**Manufacturer:** Russell Leisure Ltd

**Finding:** The bushes are worn or missing  
**Action:** Replace worn or missing bushes

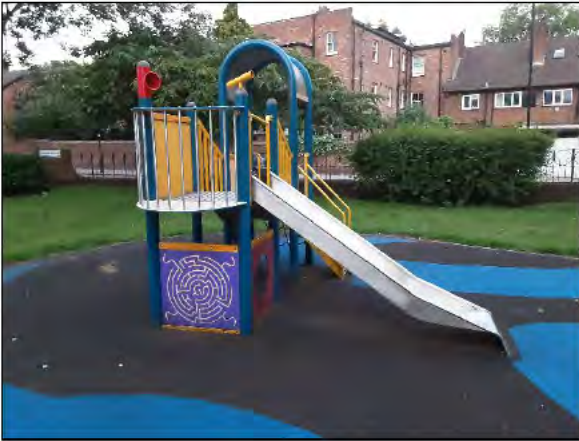
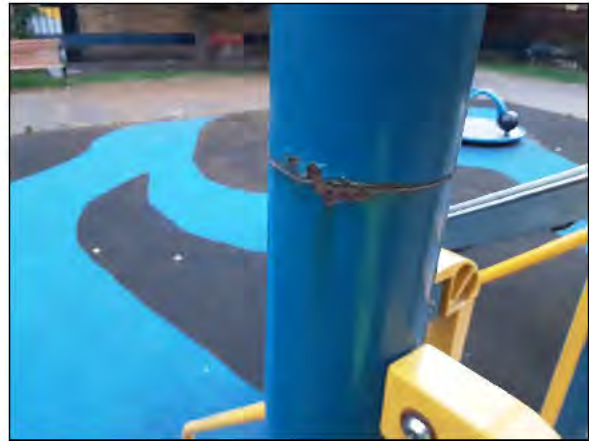
**Item:** Activity Equipment - Multi Play (Toddler)  
**Manufacturer:** Russell Leisure Ltd

**Finding:** The paintwork on this item has been damaged or worn exposing the metal underneath which is rusting  
**Action:** Treat any rusting components and repaint

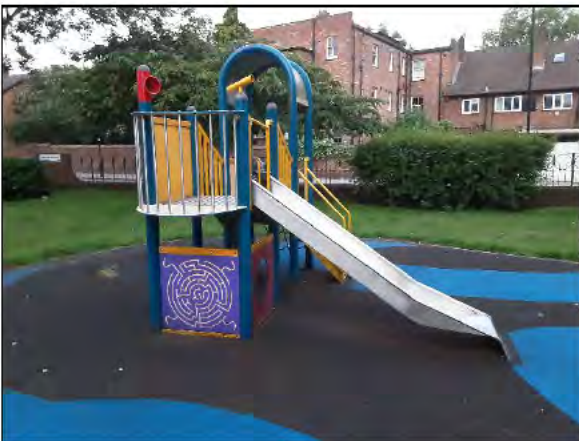
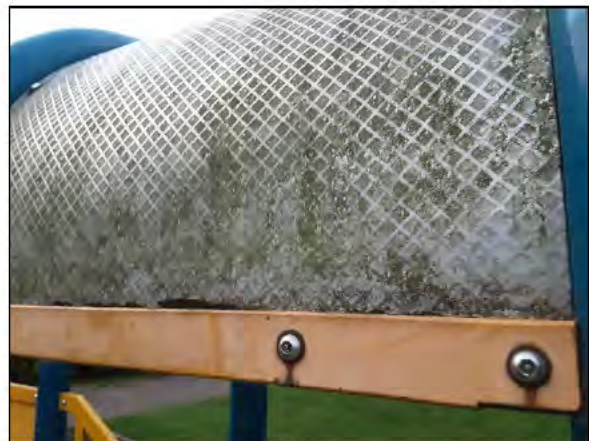
**Item:** Activity Equipment - Multi Play (Toddler)  
**Manufacturer:** Russell Leisure Ltd

**Finding:** There is algae or moss on the surface of the equipment  
**Action:** Clean and treat appropriately
