Operational Inspection

Kildoran Road

Inspection Ref: 2057706

Inspected: 02 May 2023 at 12:20 Inspector: [REDACTED]

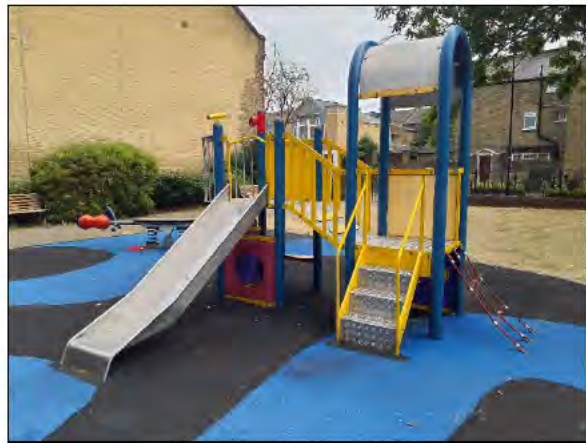
Item: Activity Equipment - Multi Play (Toddler)
Manufacturer: Russell Leisure Ltd
Comments

There is some graffiti present Remove the graffiti

Steering wheel is damaged Replace

There are gaps opening between the surfacing and the edging surround or between the joints in the surfacing Monitor for any further deterioration and repair as required, 2 Lm

The paintwork on this item has been damaged or worn exposing the metal underneath which is rusting Treat any rusting components and repaint

There are a number of dents in the slide surface, sharp surface Arrange to sand down any burrs on surface

Risk Assessment: 10 - Low Risk

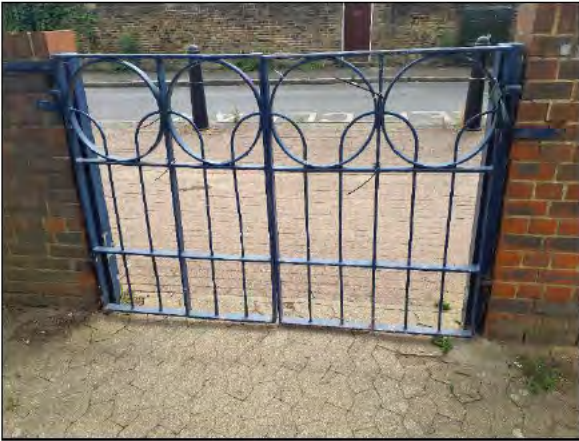
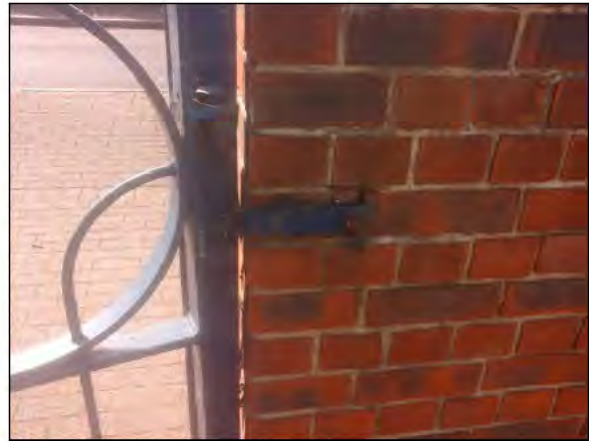
Item: Gates - Gate - Pedestrian
Manufacturer: Unknown

Risk Level: 6 - Low Risk
Surface: All Weather Surface

Finding: The gate is loose on its hinges
Action: Investigate and take appropriate action to rectify

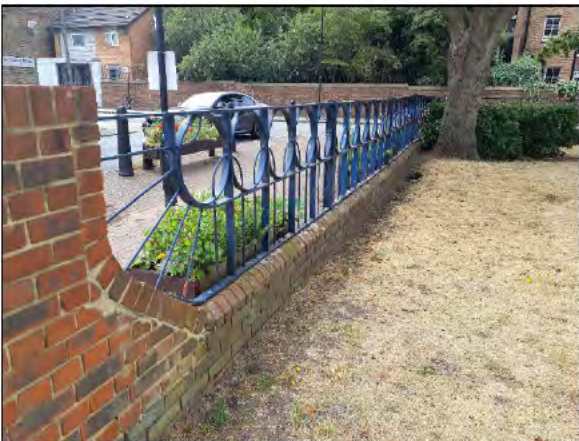
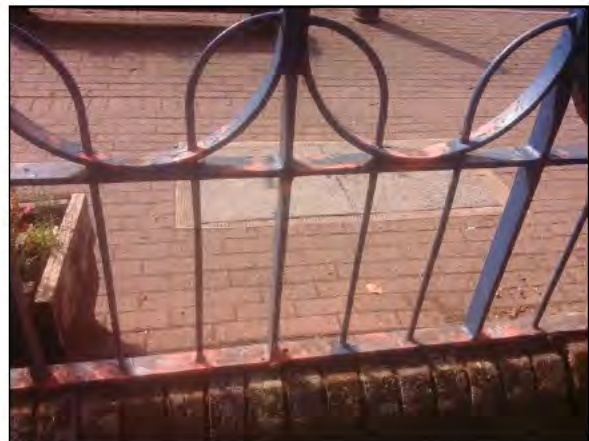
Item: Fences - Fencing - Flat Top
Manufacturer: Unknown

Risk Level: 6 - Low Risk
Surface: Brick Pavers

Finding: There is surface corrosion present on the item
Action: Consider treating and repainting the item

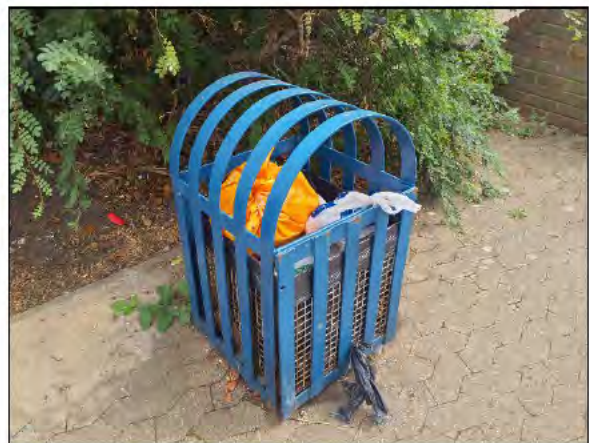
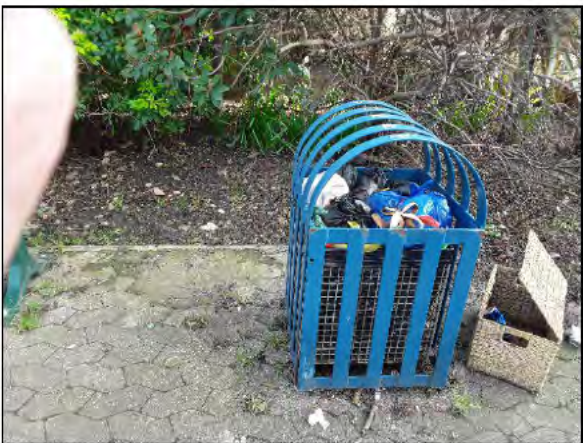
Item:	Ancillary Items - Litter Bin	Risk Level:	6 - Low Risk
Manufacturer:	Unknown	Surface:	Brick Pavers

Finding: The litter bin is full
Action: Empty and review the collection routine

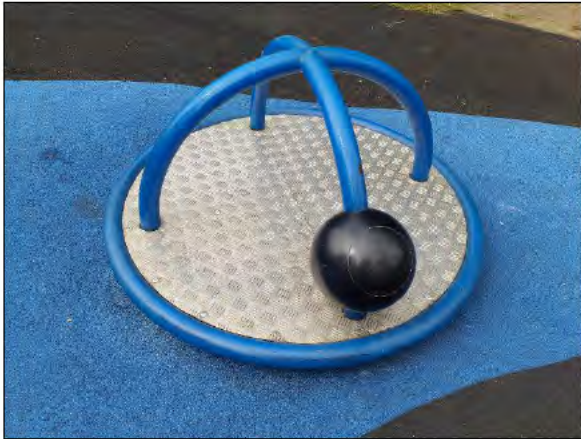
Item: Rotor Play - Roundabout
Manufacturer: Berliner Seil Fabrik

Risk Level: 6 - Low Risk
Surface: Wet Pour

Finding: There is surface corrosion present on the item
Action: Consider treating and repainting the item

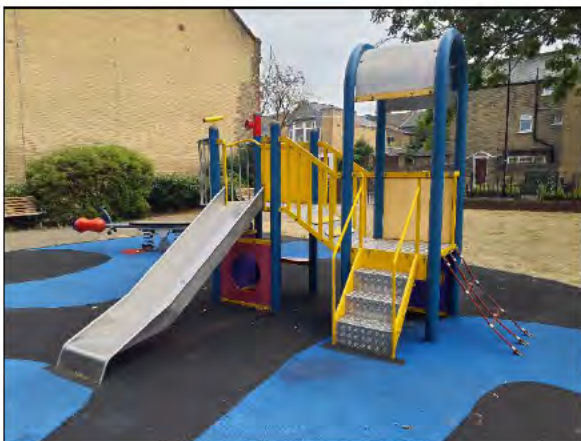
Item: Activity Equipment - Multi Play (Toddler)
Manufacturer: Russell Leisure Ltd

Risk Level: 2 - Very Low Risk
Surface: Wet Pour

Finding: There is some graffiti present
Action: Remove the graffiti
