## Operational Inspection

### Kildoran Road

Inspection Ref: 1498660

Inspected: 28 October 2021 at 09:01 Inspector: [REDACTED]

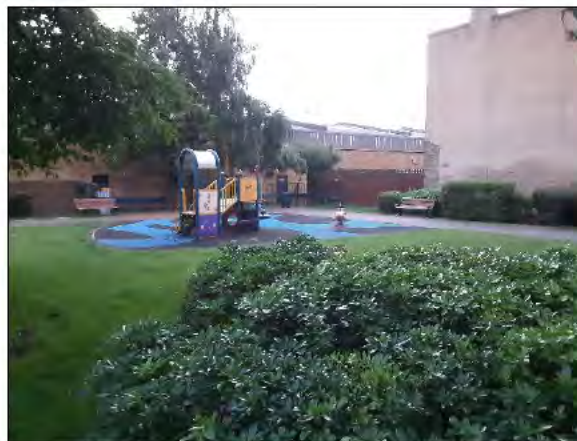
**Item:** Ancillary Items - Site General  
**Manufacturer:** Owner/Operator  
**Comments**

There are trip hazards at the edges of the surface  
Reinstate surrounding surface levels to remove the trip points 20lm

There is litter/debris in the area Remove litter/debris from the area and maintain

There is algae or moss growth on the surface resulting in slippery conditions Clean and treat appropriately

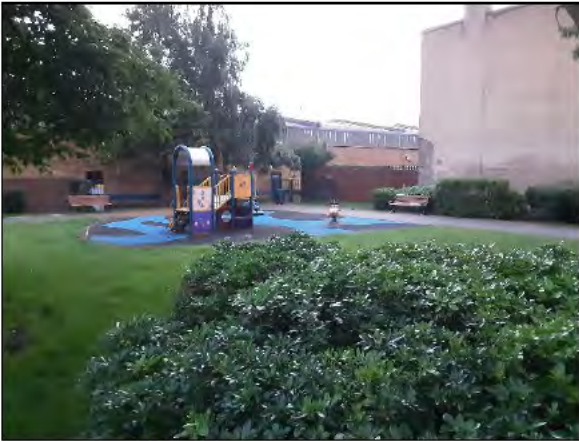
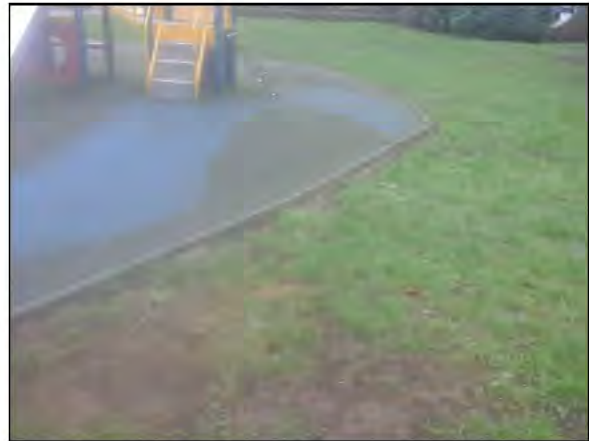
**Item:** Ancillary Items - Site General  
**Manufacturer:** Owner/Operator

**Finding:** There are trip hazards at the edges of the surface  
**Action:** Reinstate surrounding surface levels to remove the trip points 20lm

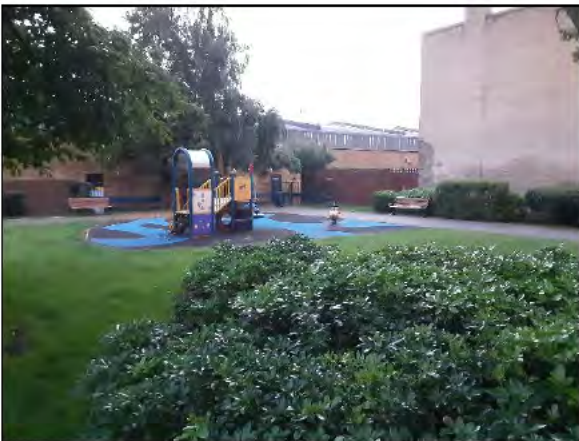
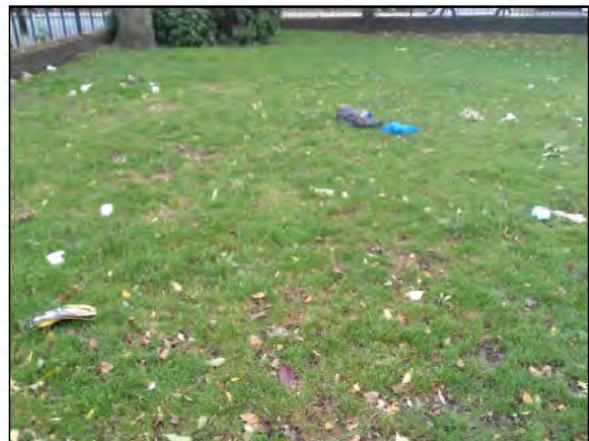
**Item:** Ancillary Items - Site General  
**Manufacturer:** Owner/Operator

**Finding:** There is litter/debris in the area  
**Action:** Remove litter/debris from the area and maintain

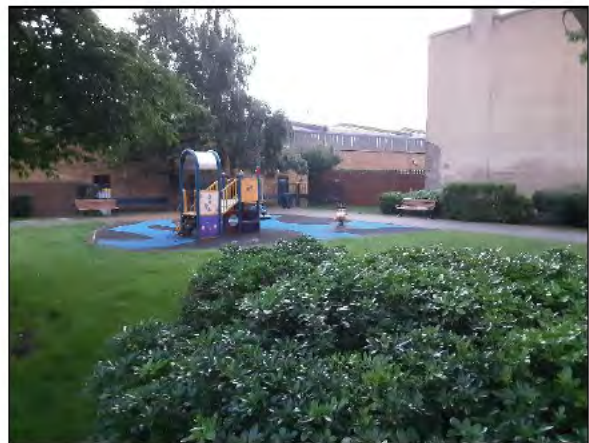
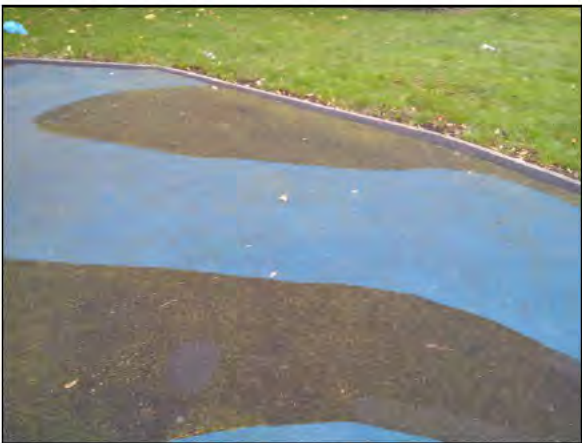
<b>Item:</b>	Ancillary Items - Site General	<b>Risk Level:</b>	8 - Low Risk
<b>Manufacturer:</b>	Owner/Operator	<b>Surface:</b>	N/A

**Finding:** There is algae or moss growth on the surface resulting in slippery conditions

**Action:** Clean and treat appropriately

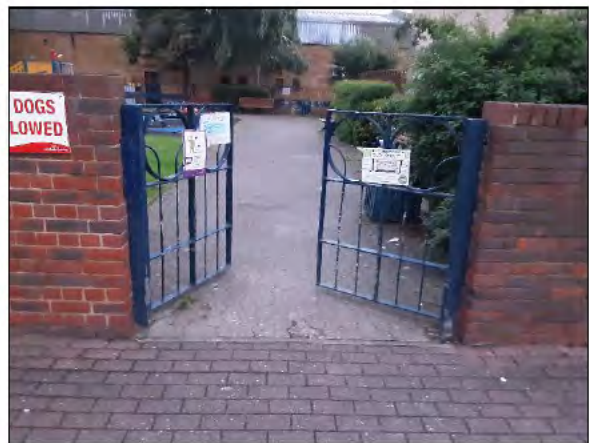
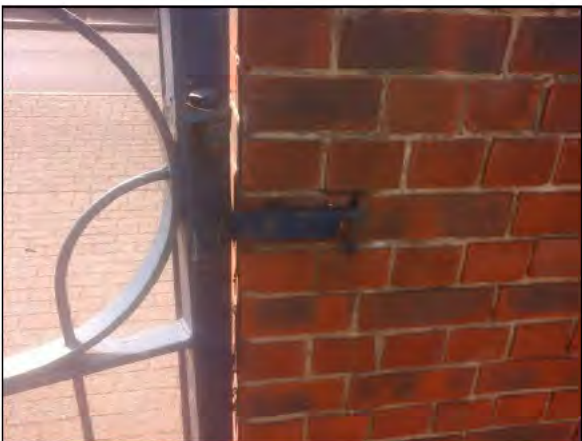
<b>Item:</b>	Gates - Gate - Pedestrian	<b>Risk Level:</b>	6 - Low Risk
<b>Manufacturer:</b>	Unknown	<b>Surface:</b>	All Weather Surface

**Finding:** The gate is loose on its hinges

**Action:** Investigate and take appropriate action to rectify

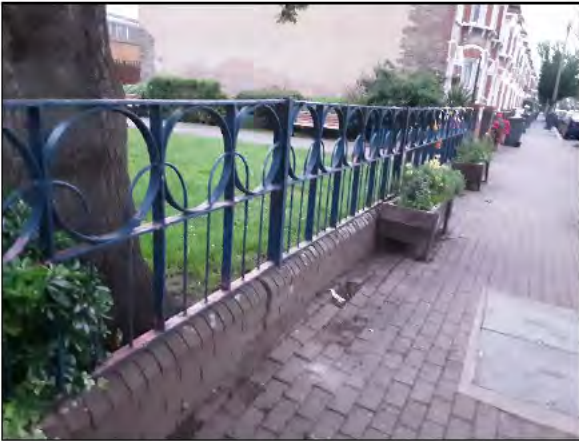
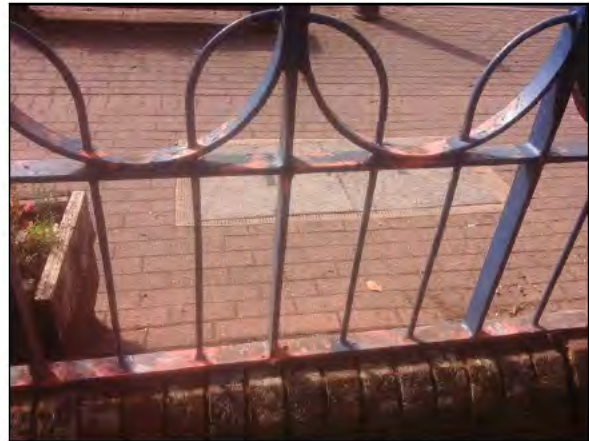
**Item:** Fences - Fencing - Flat Top  
**Manufacturer:** Unknown

**Finding:** There is surface corrosion present on the item  
**Action:** Consider treating and repainting the item

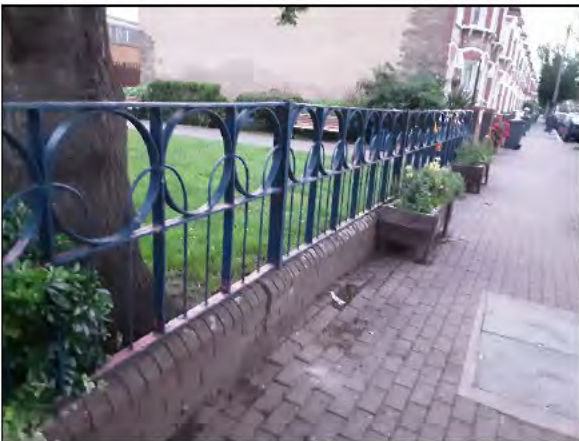
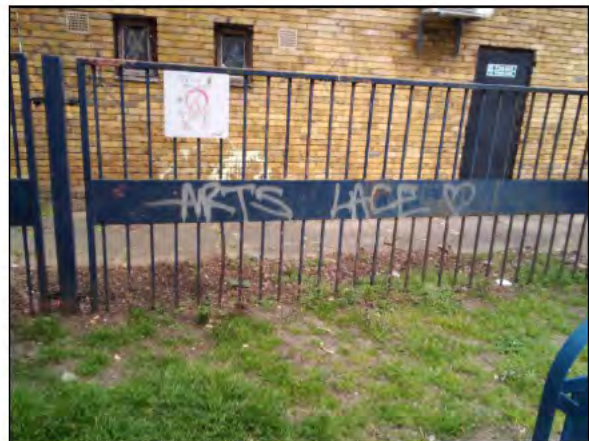
**Item:** Fences - Fencing - Flat Top  
**Manufacturer:** Unknown

**Finding:** There is some graffiti present  
**Action:** Remove the graffiti

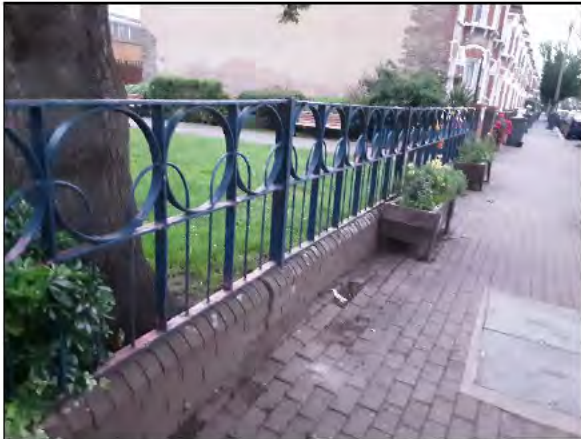
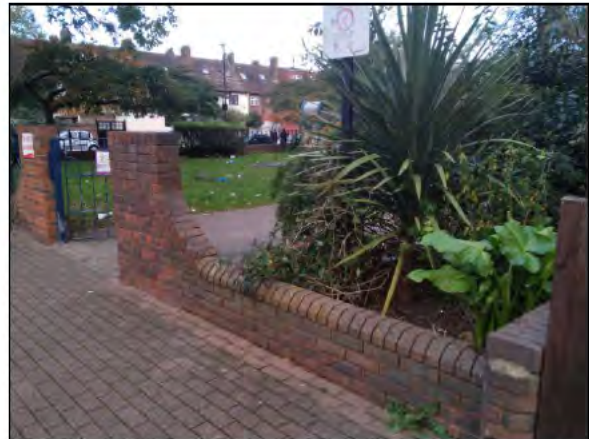
**Item:** Fences - Fencing - Flat Top  
**Manufacturer:** Unknown

**Finding:** Section of railing is missing  
**Action:** Replace as required

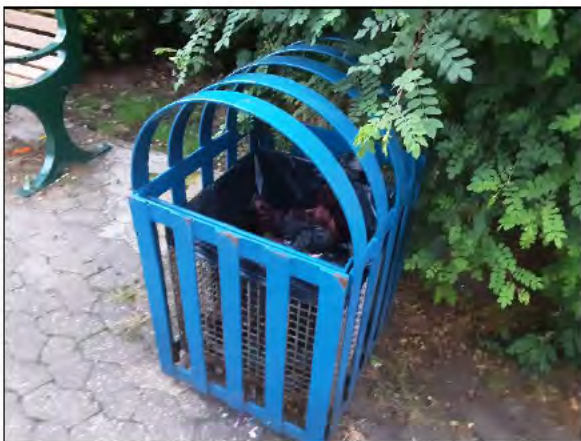
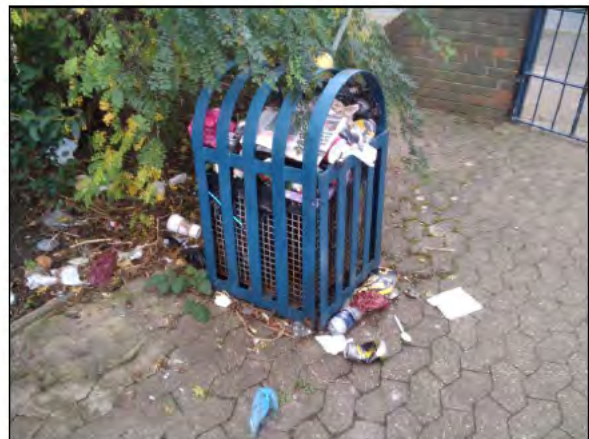
**Item:** Ancillary Items - Litter Bin  
**Manufacturer:** Unknown

**Finding:** The litter bin is full  
**Action:** Empty and review the collection routine

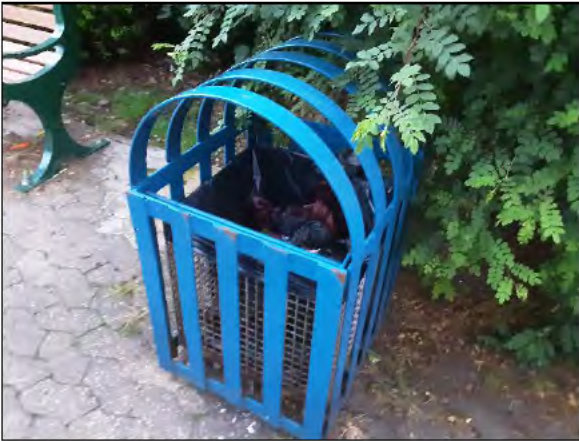
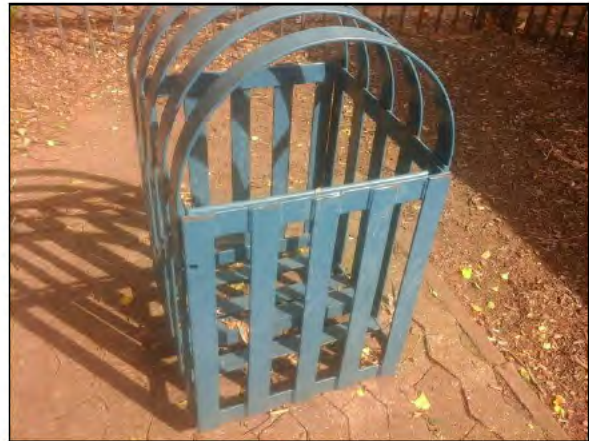
**Item:** Ancillary Items - Litter Bin  
**Manufacturer:** Unknown

**Finding:** There is no liner present in the litterbin  
**Action:** Provide as required

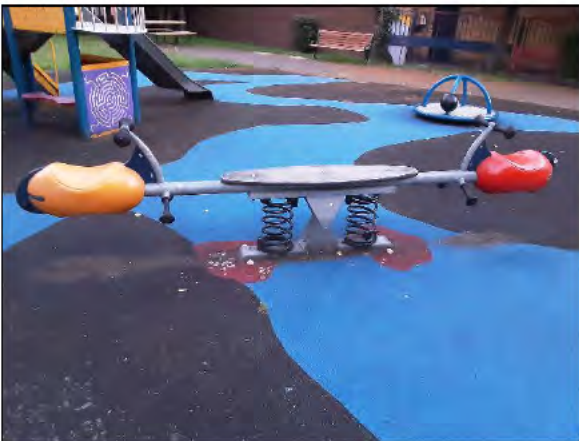
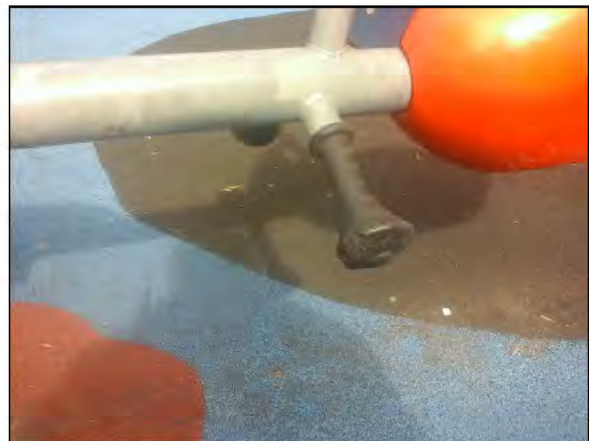
**Item:** Rocking Equipment - Spring See-Saw  
**Manufacturer:** Kompan Ltd

**Finding:** Hand/foot rests are wearing  
**Action:** Monitor for further wear

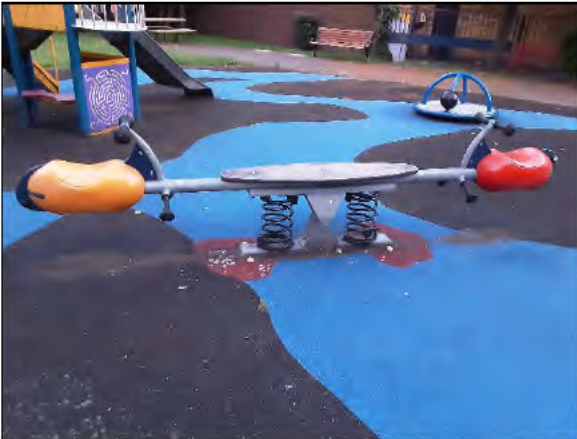
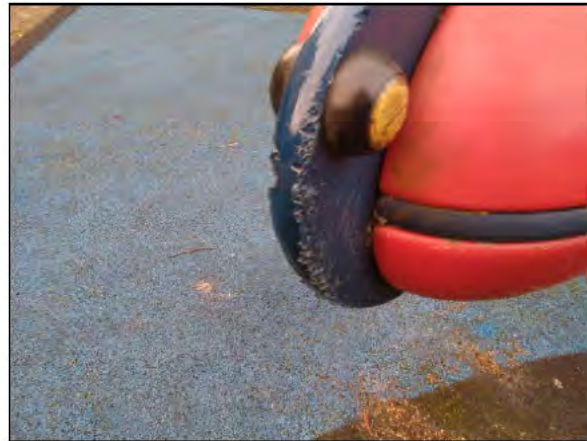
**Item:** Rocking Equipment - Spring See-Saw  
**Manufacturer:** Kompan Ltd

**Finding:** Evidence of vandalism, dog bites  
**Action:** Monitor for deterioration and consider replacing

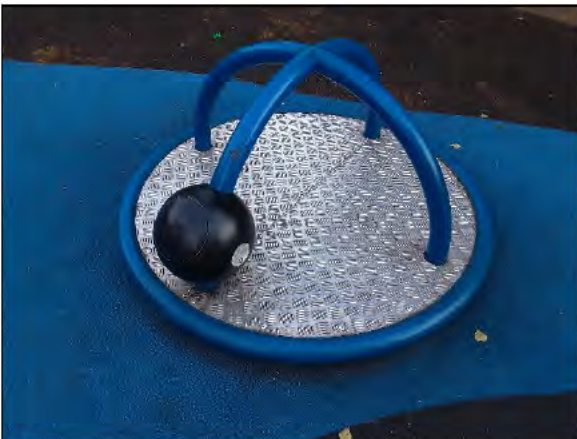
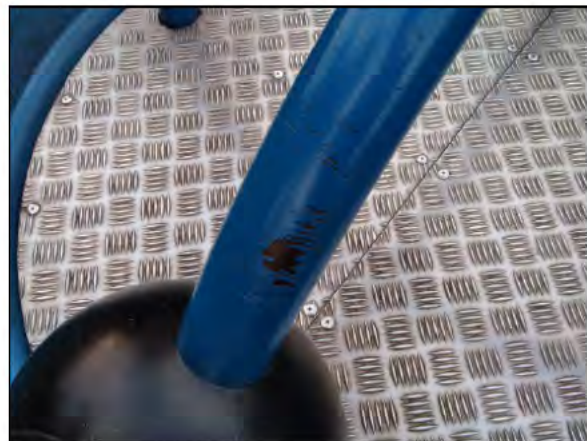
**Item:** Rotor Play - Roundabout  
**Manufacturer:** Berliner Seil Fabrik

**Finding:** There is surface corrosion present on the item  
**Action:** Consider treating and repainting the item

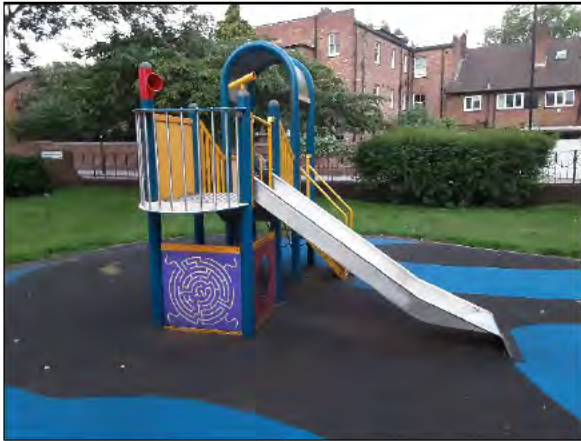
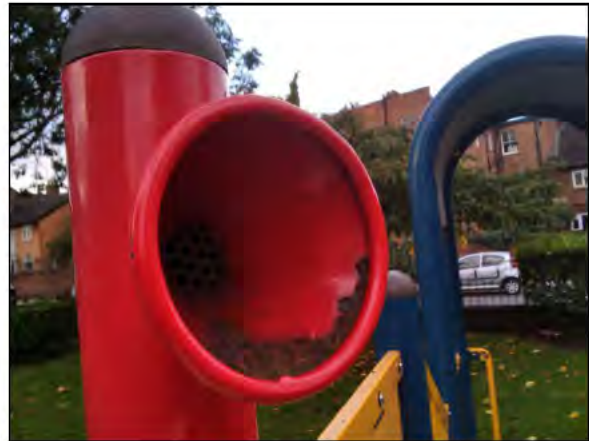
**Item:** Activity Equipment - Multi Play (Toddler)  
**Manufacturer:** Russell Leisure Ltd

**Finding:** The paintwork on this item has been damaged or worn exposing the metal underneath which is rusting  
**Action:** Treat any rusting components and repaint

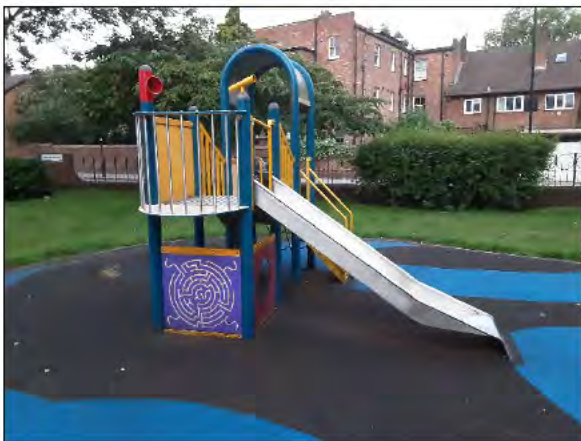
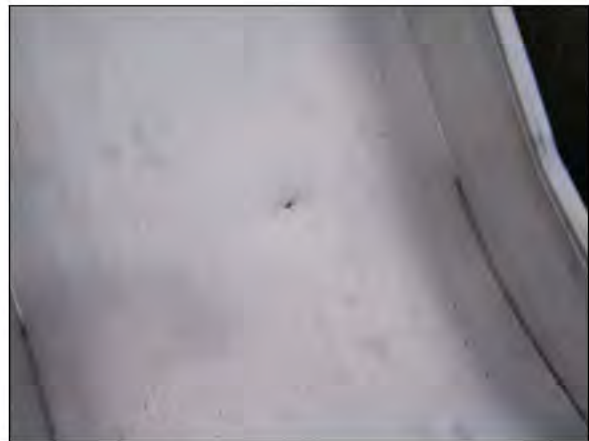
**Item:** Activity Equipment - Multi Play (Toddler)  
**Manufacturer:** Russell Leisure Ltd

**Finding:** There are a number of dents in the slide surface, sharp surface  
**Action:** Arrange to sand down any burrs on surface

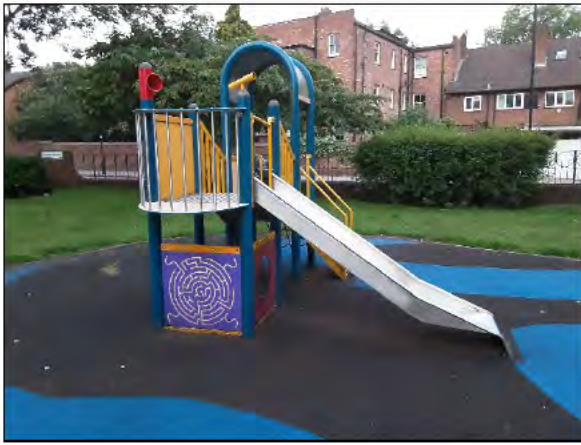
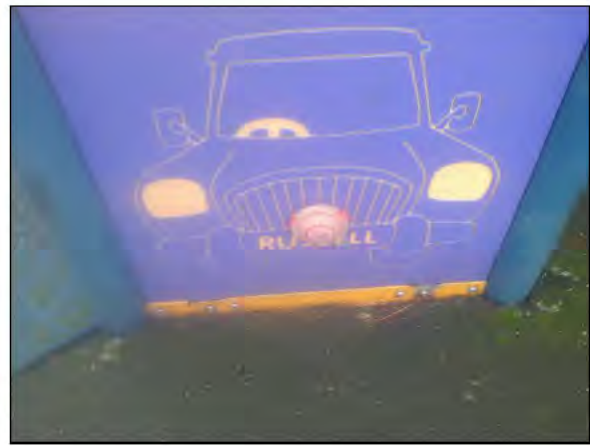
<b>Item:</b>	Activity Equipment - Multi Play (Toddler)	<b>Risk Level:</b>	6 - Low Risk
<b>Manufacturer:</b>	Russell Leisure Ltd	<b>Surface:</b>	Wet Pour

**Finding:** Steering wheel is damaged  
**Action:** Replace

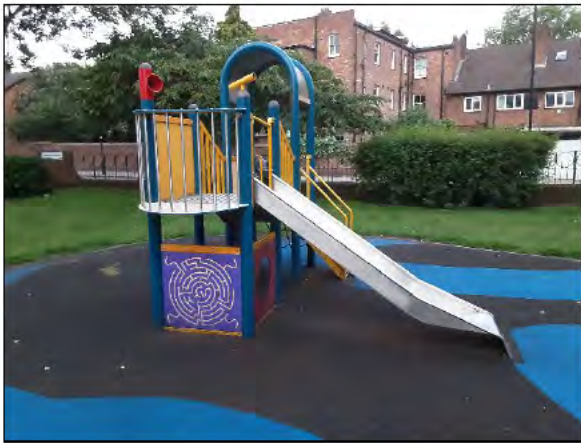
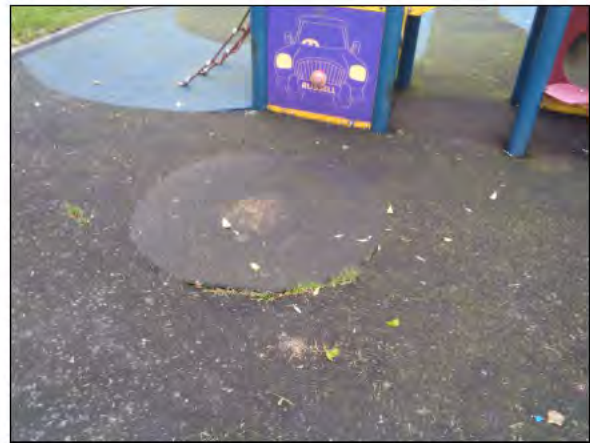
**Item:** Activity Equipment - Multi Play (Toddler)  
**Manufacturer:** Russell Leisure Ltd

**Finding:** There are gaps opening between the surfacing and the edging surround or between the joints in the surfacing  
**Action:** Monitor for any further deterioration and repair as required, 2 Lm

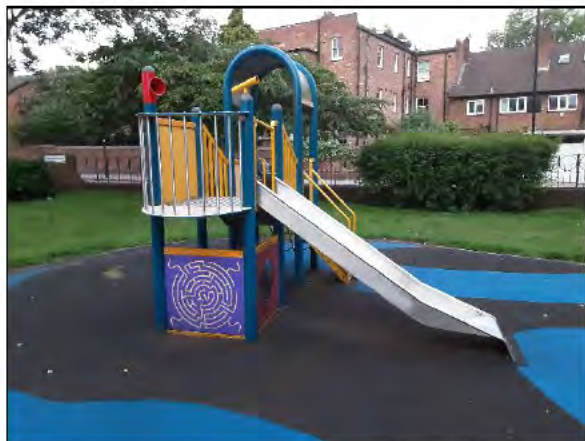
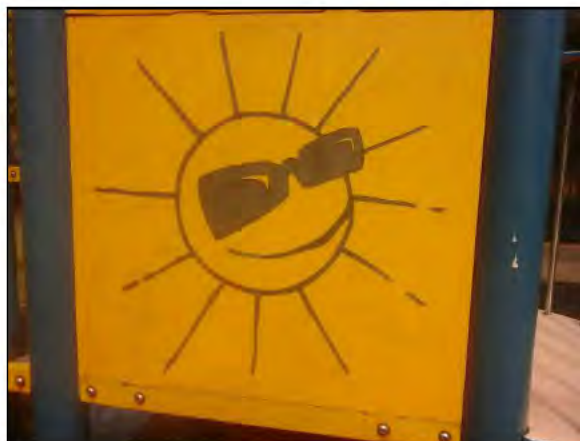
**Item:** Activity Equipment - Multi Play (Toddler)  
**Manufacturer:** Russell Leisure Ltd

**Finding:** There is some graffiti present  
**Action:** Remove the graffiti
