The works include external and communal upgrade works to Ponton House, Chalner House, Ducavel House and 130-139 Coburg Crescent, circa 86 flats across 4 separate blocks, any nominated contractor should be able to deliver works to this scale and works as listed. The planned works include but are not limited to; the replacement of the existing flat roof coverings, associated flashings and any rooflights/ lightning protection as required and where applicable. The existing windows will be replaced with new PVCu double glazed equivalents, along with fire rated screens to the front communal balconies. The external walls will be repaired as necessary, including repairs to brickwork, repointing and the replacement of any existing defective timber cladding prior to redecoration works. Any concrete surfaces will be tested once access is available and areas repaired as required. All previously painted surfaces are to be redecorated to both external and communal parts of the building, along with upgrade works to the existing balconies. This will include repairs to the existing timber and glass balcony balustrading and any repairs/ re coating of the existing private or communal asphalt walkways

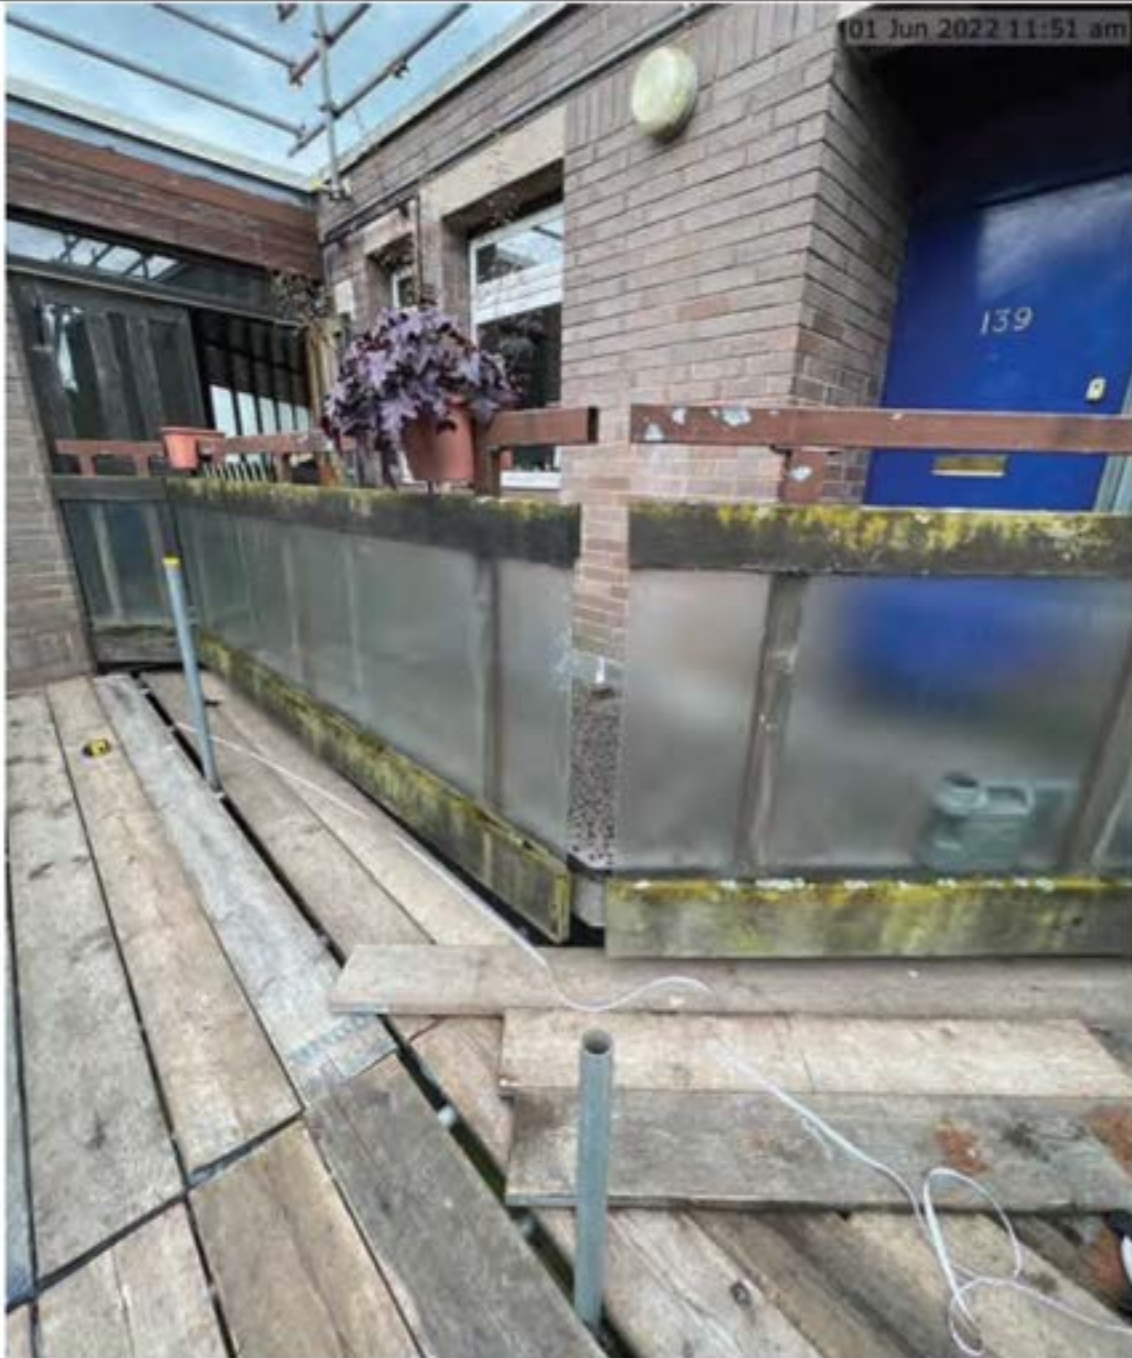
Pic.1

Glass is in good condition – However would advise change to laminated glass for safety reasons.

Horizontal wood sections – Rebates where glass sits, are in poor condition and are cracking. Would advise to change the top and bottom wood sections in full – 6 LM in total.

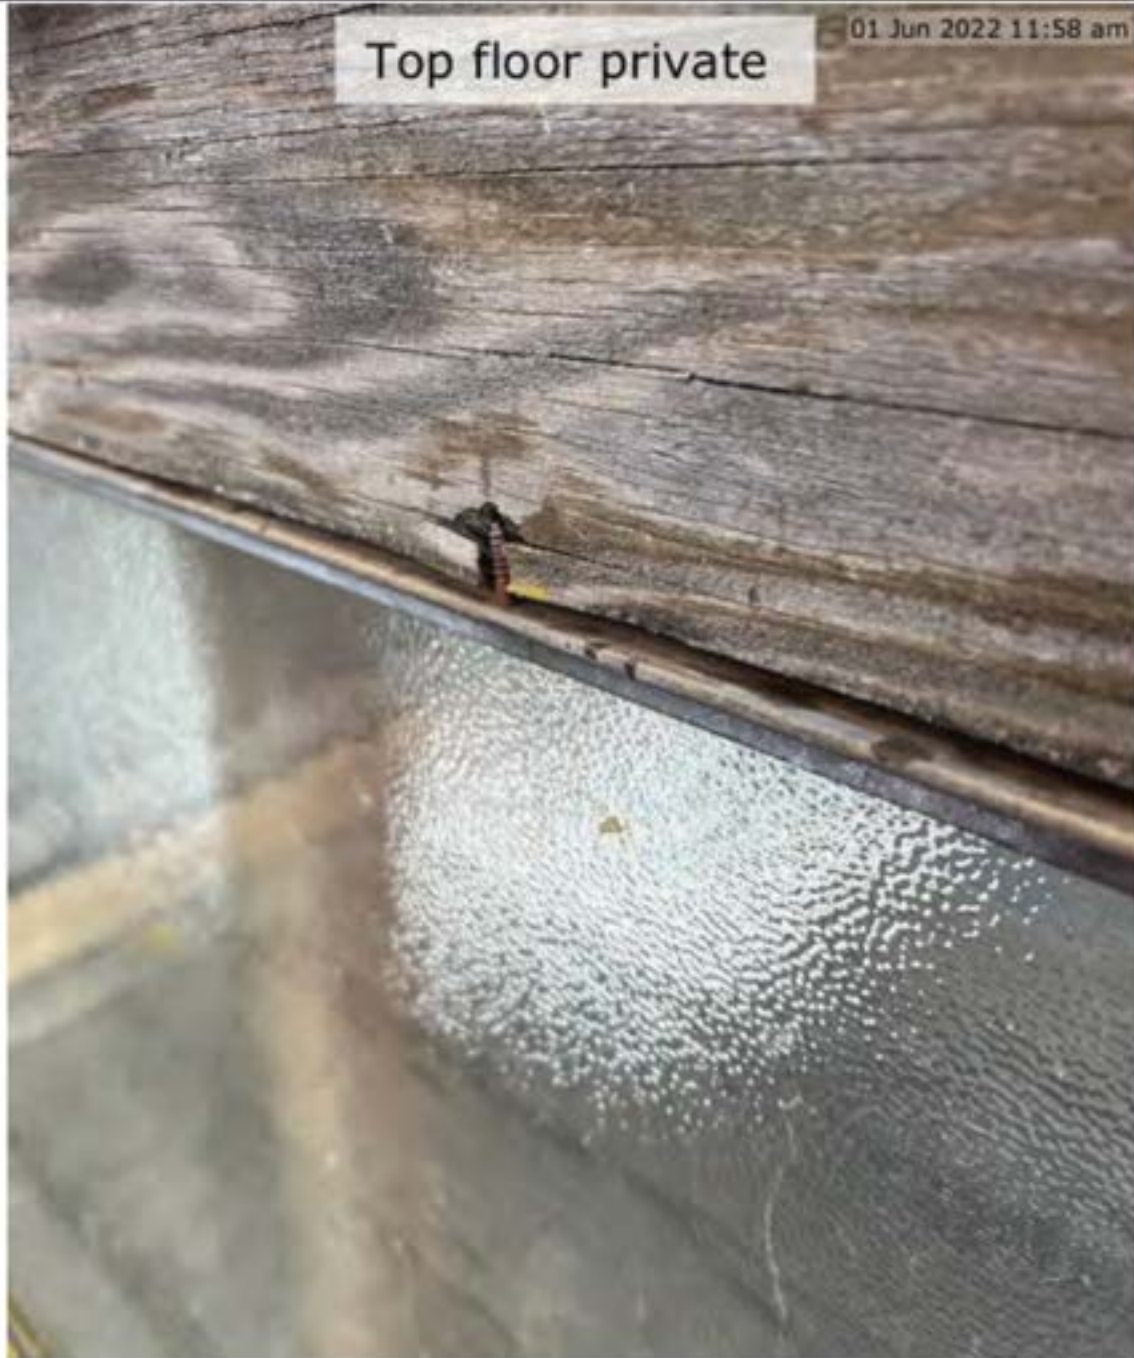
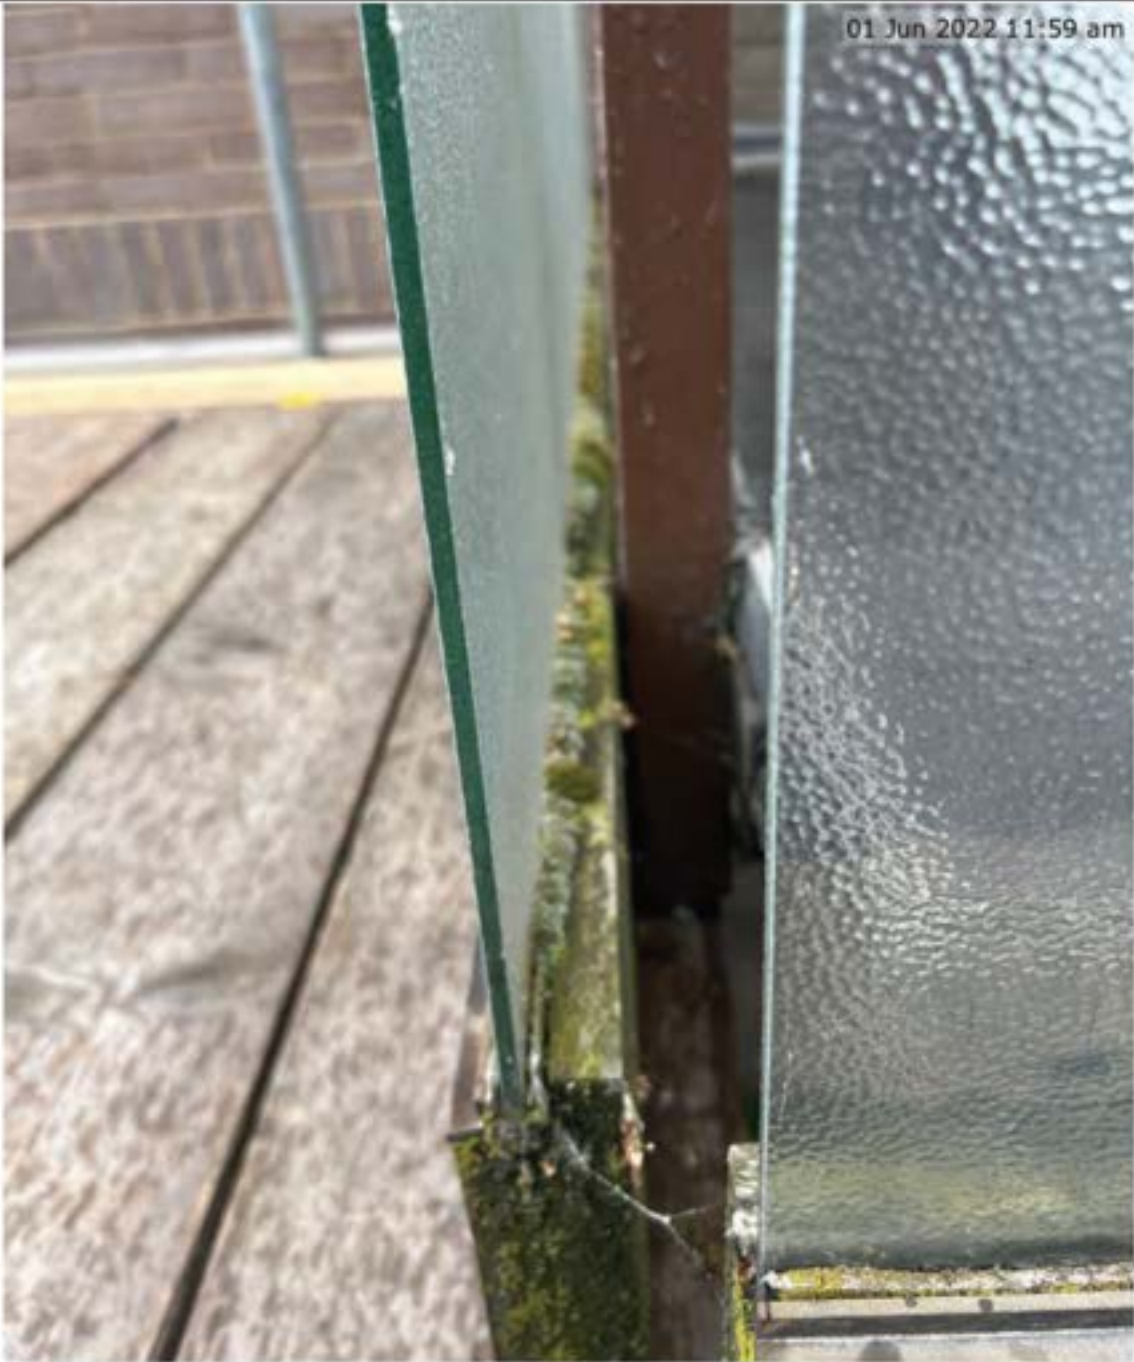
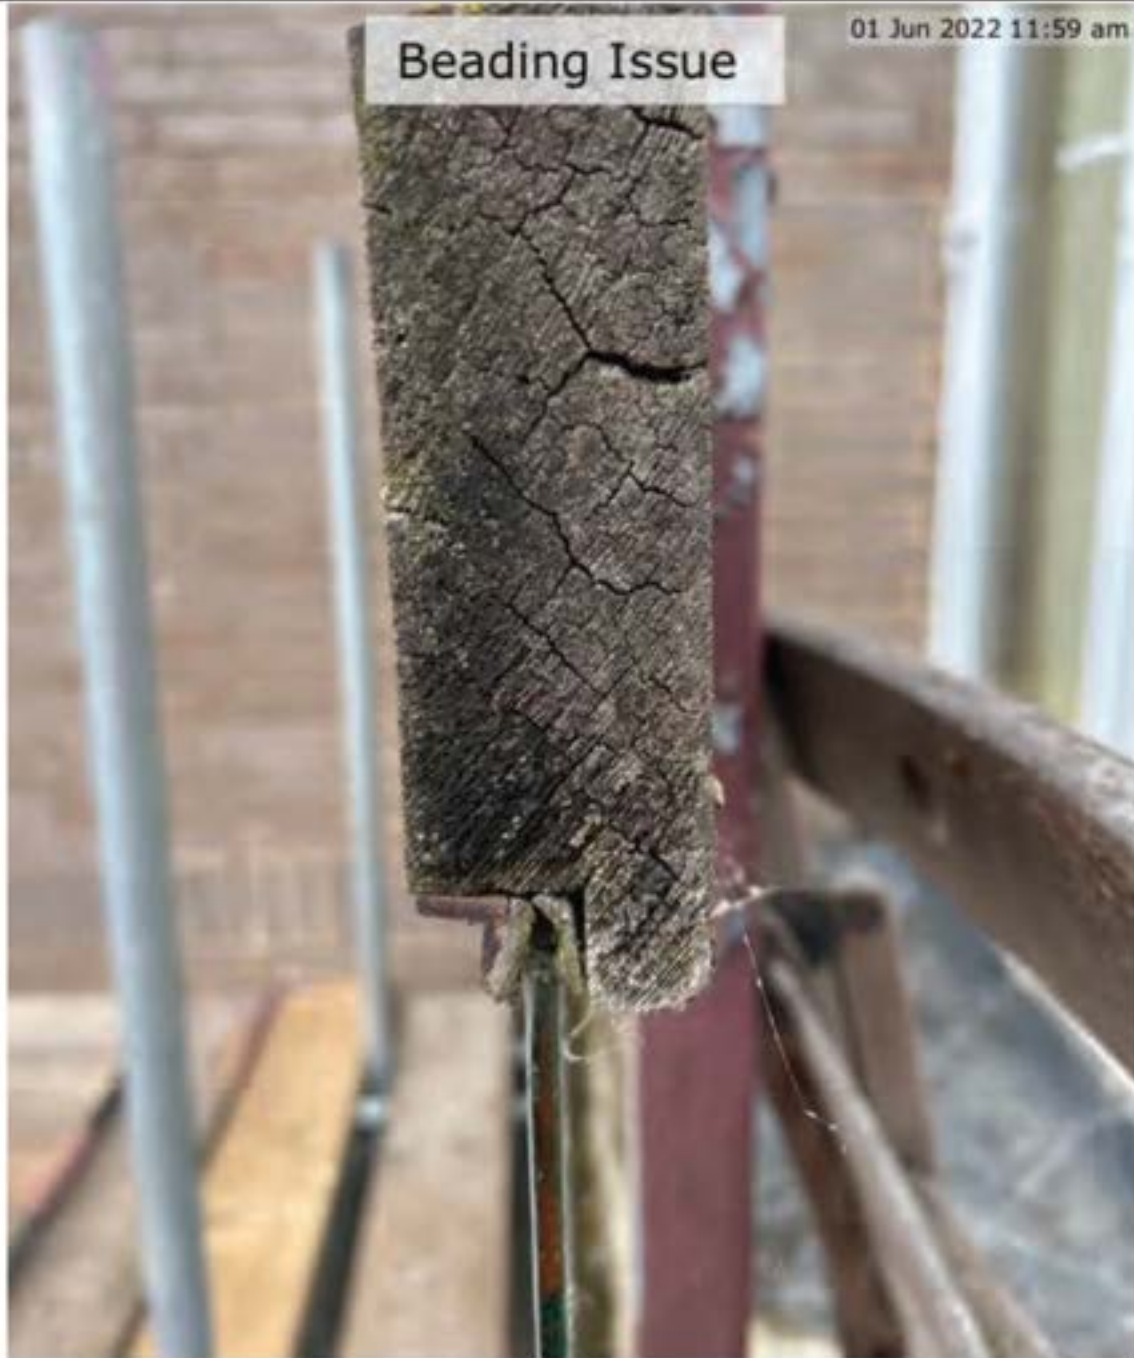
Top Floor – Rear Private Balconies – 2 No in total:

As pictures 4, 5 & 6 below:

Advise wood to be changed to have the beads internal.

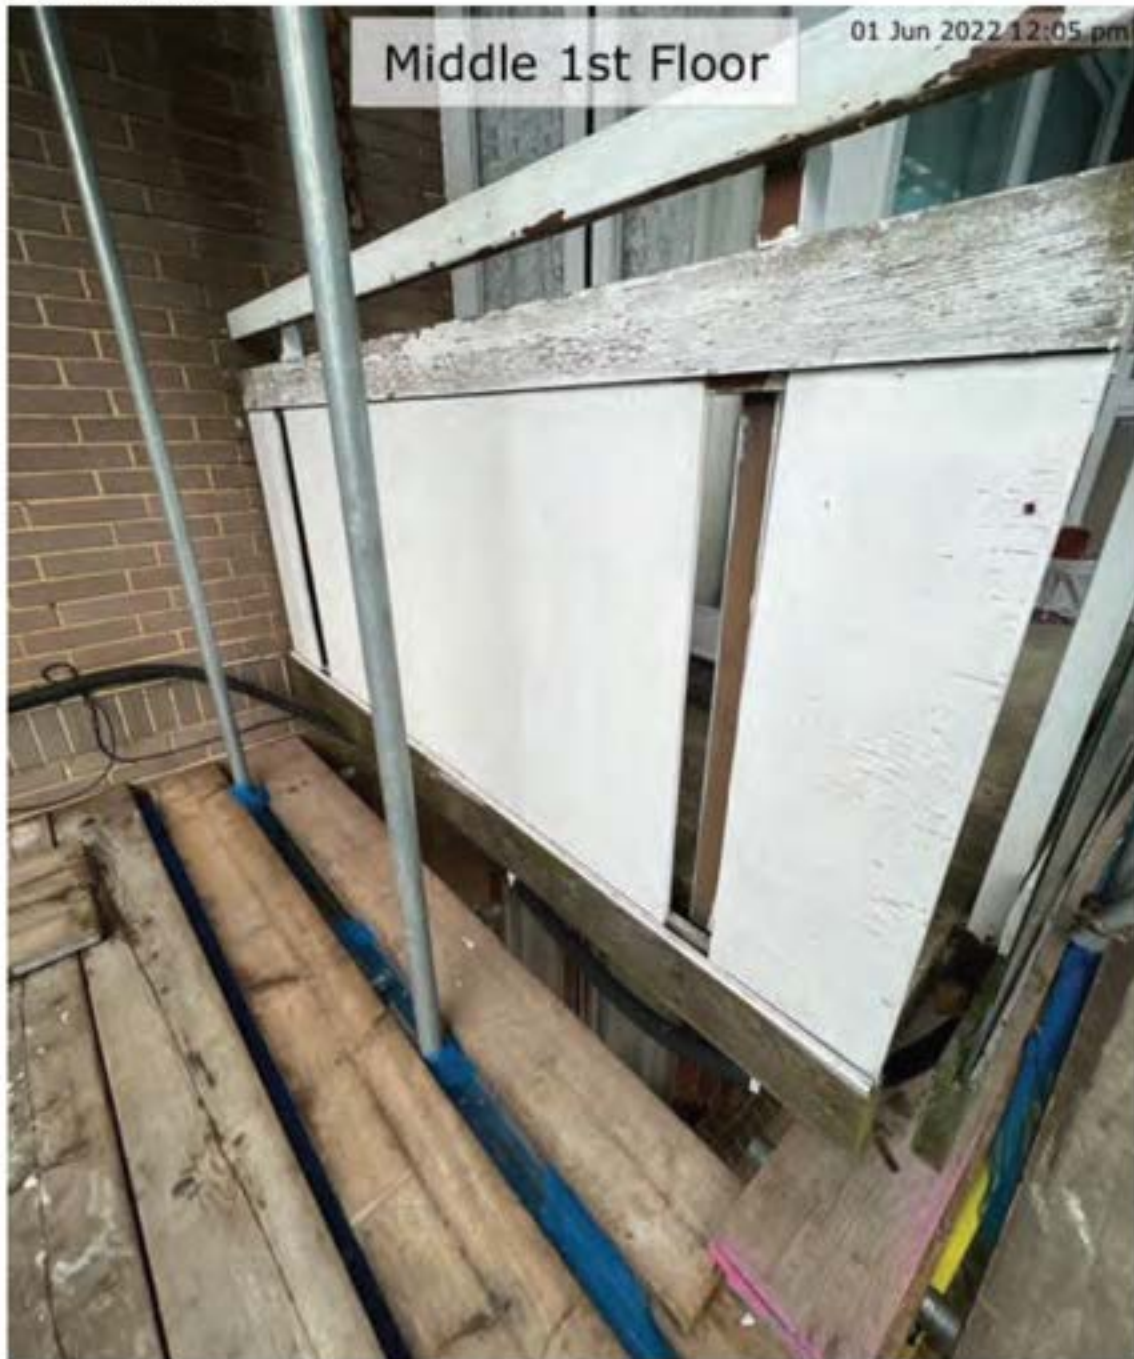
Middle Balcony – 1 damaged glass panel to be changed – Size 1360 x 850mm – Total side of the 2250mm length – Glass is missing – need full replacement – as picture below:

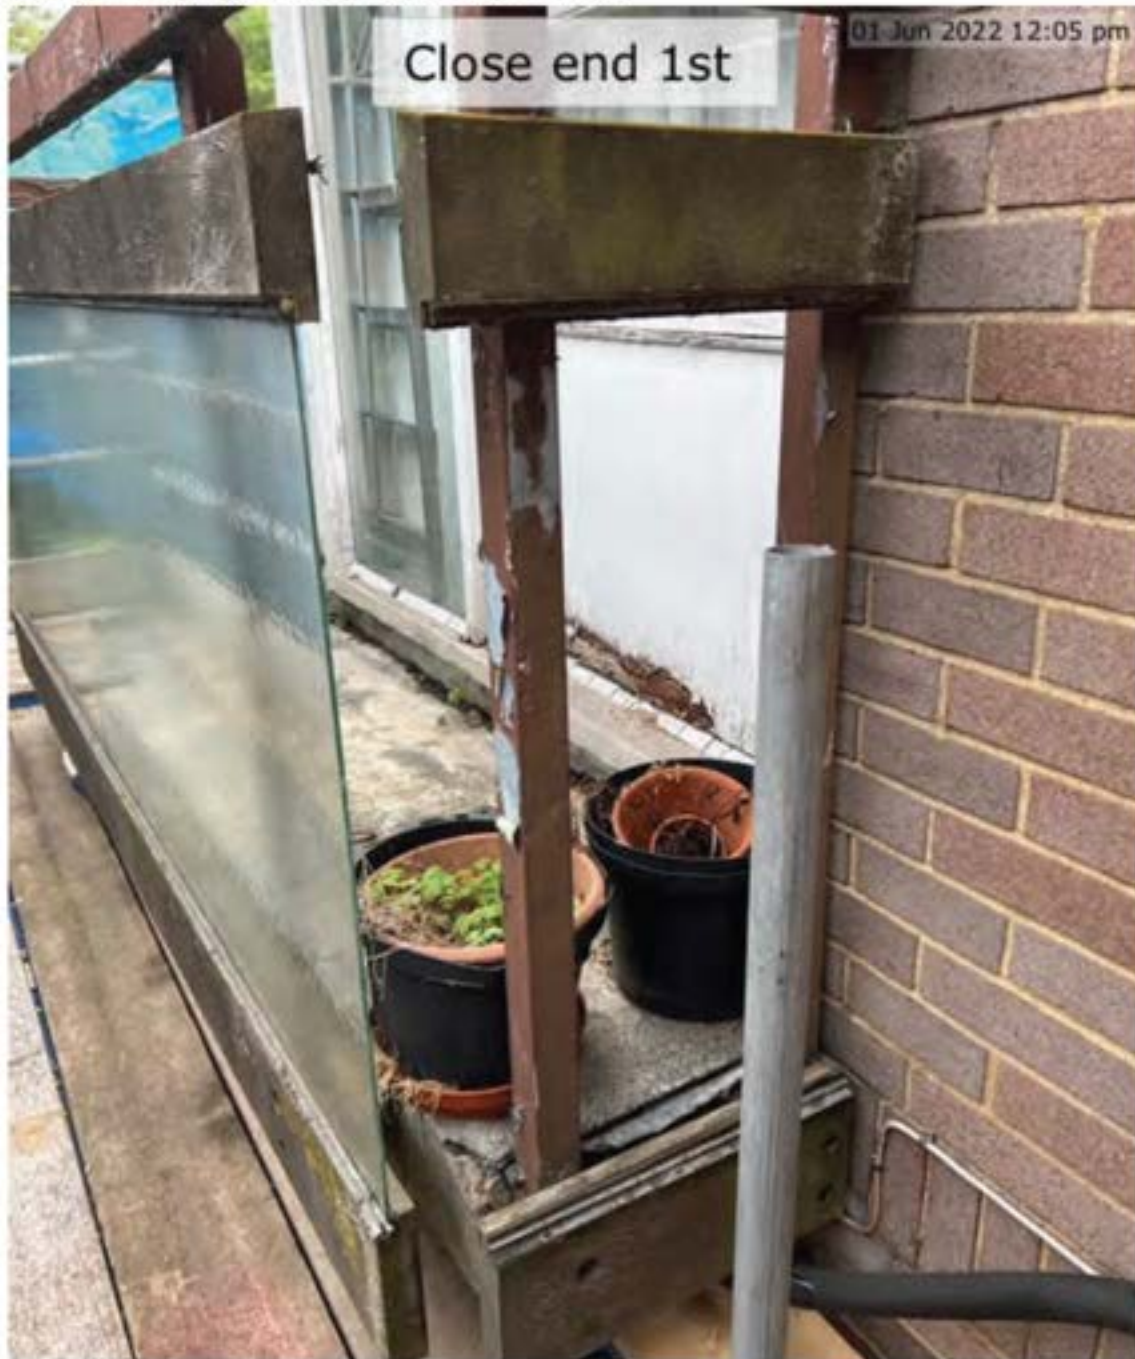
End Private balcony – Closest to site compound – Small end glass panel missing as picture below – 450mm wide – Same issues with beading to be external, advise changing this as previous comments.

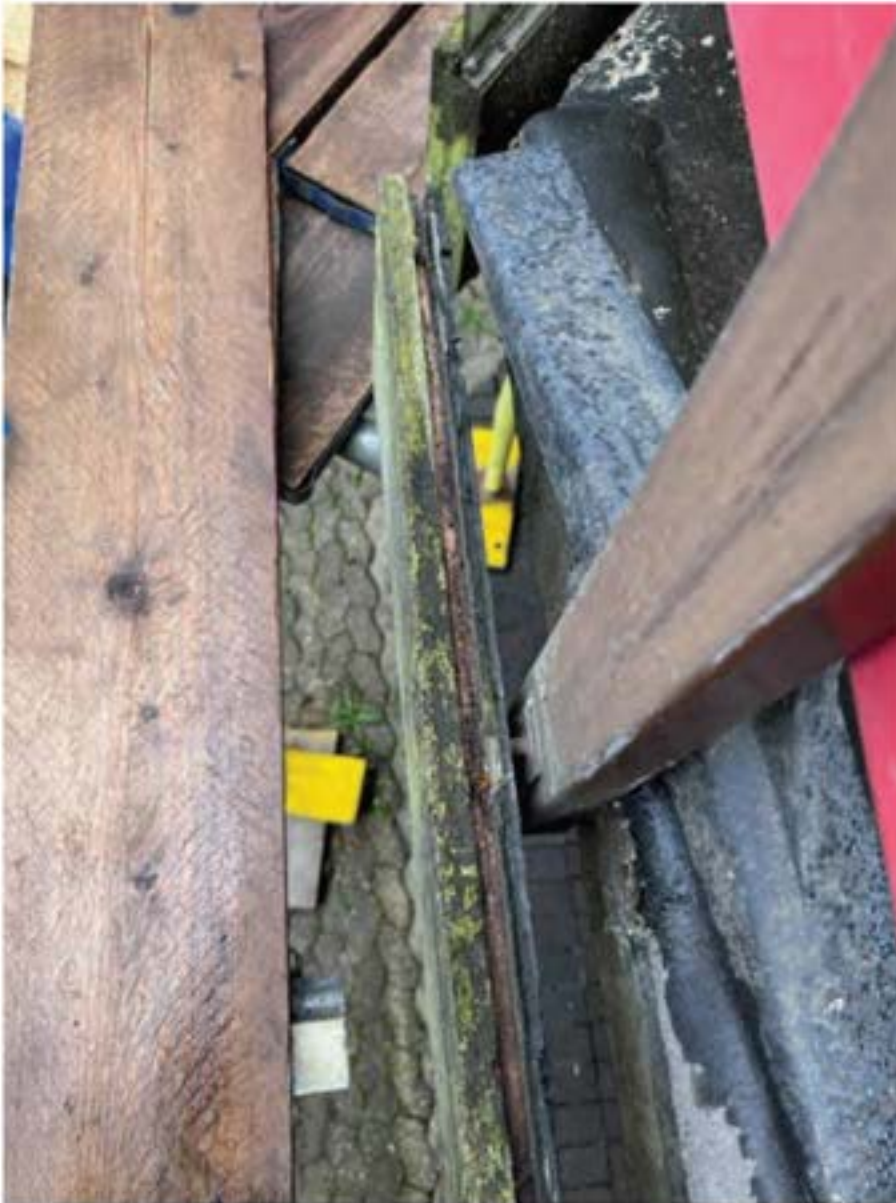
1st Floor Private balcony to front elevation – Glass panels missing from all side apart from the 2640mm length, where only half the glass is still in place. Wooden section in very poor condition – Advise full replacement. As picture below:

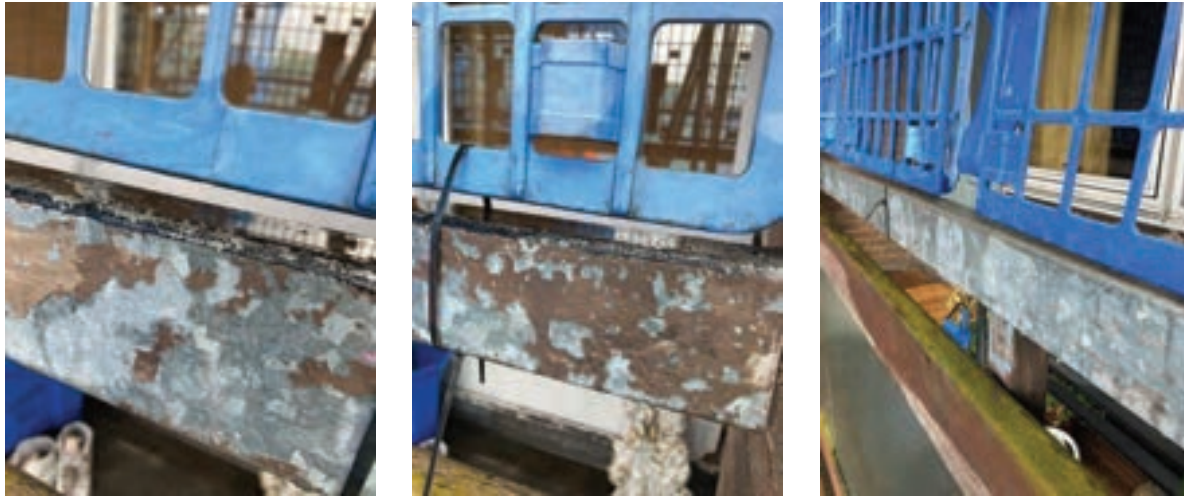
Fig 1 – Various degrees of paint failure showing loss of adhesion back to the galvanized steel.

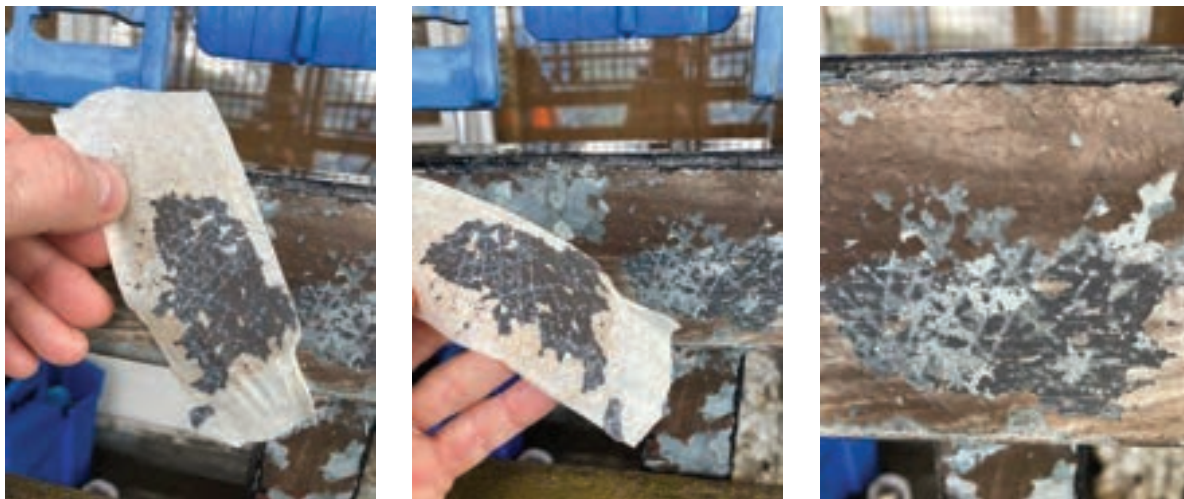
Fig 2 – Adhesion tests reveals total loss of adhesion back to the substrate.

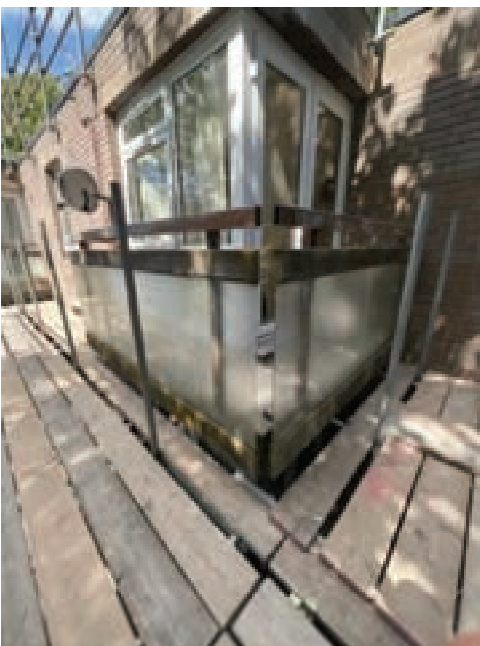
Beads - external - in poor condition, rebate in wood is too thin and corroding.

Repair Option – Replace both rails of wood – Add new aluminium angle bead.

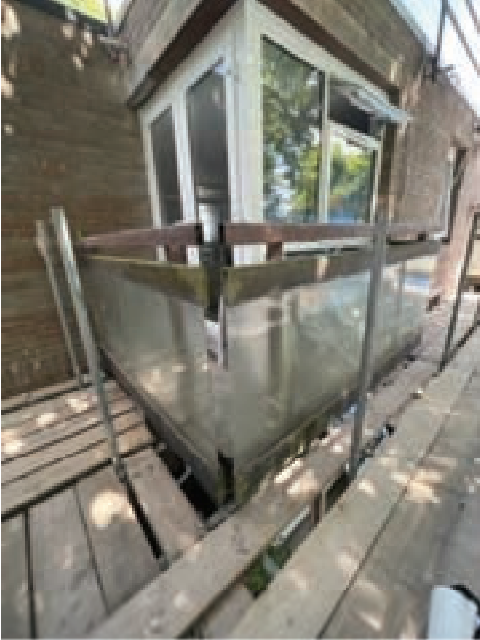
Balc 2 - Size as 1
Glass - OK
Wood - Poor
Beads - Same issues as B1

Repair Option – Replace both rails of wood – Add new aluminium angle bead.

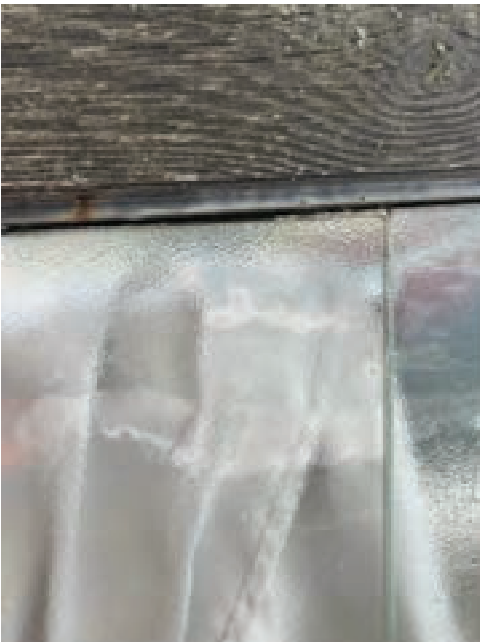
Balc 3 - 2250 x 2780 x 450
Glass - Ok
Wood - Poor
Beads – Poor

Repair Option – Replace both rails of wood – Add new aluminium angle bead.

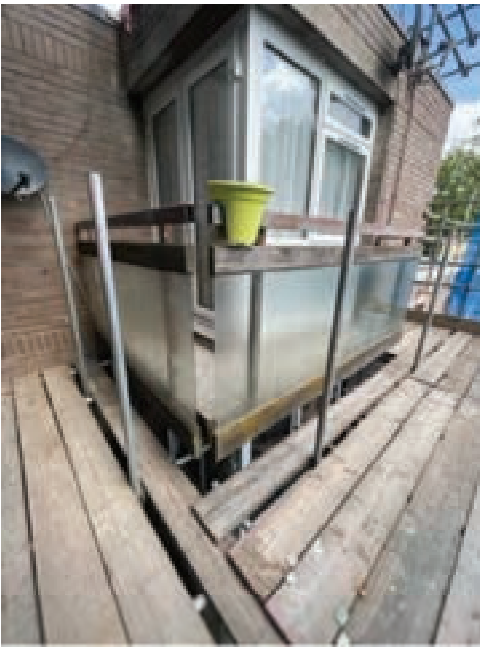
Glass has dropped -

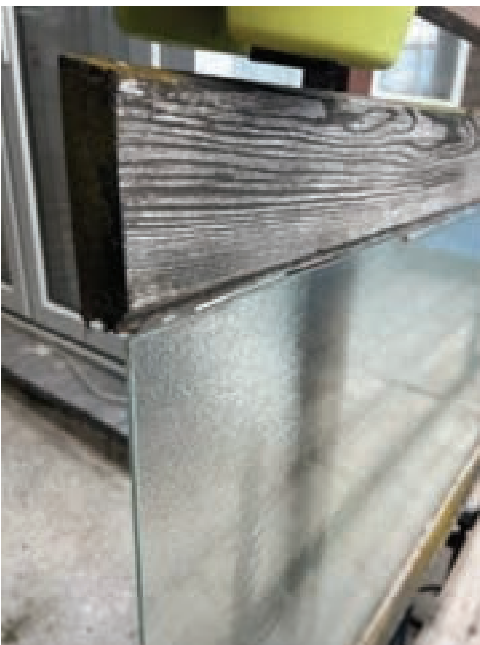
Balc 4 - Size as 3
Glass - OK
Wood - Poor
Beads - glass has dropped - Poor Condition

Repair Option – Replace both rails of wood – Add new aluminium angle bead.

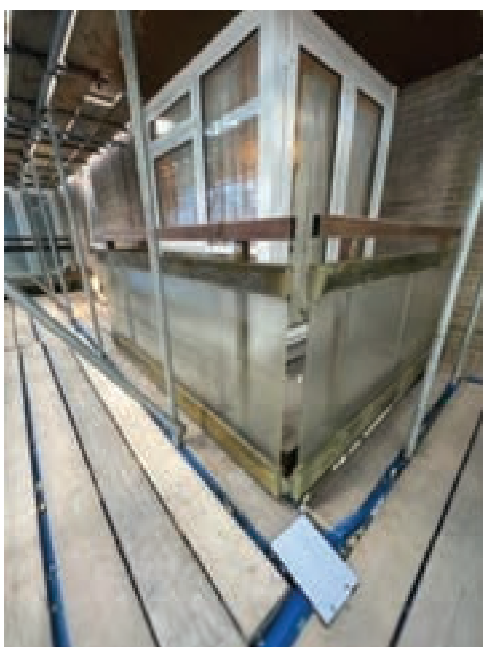
Beads - External - failing again as wooden rebate is causing issues. Rebate needs to be thicker.

Repair Option – Replace both rails of wood – Add new aluminium angle bead.

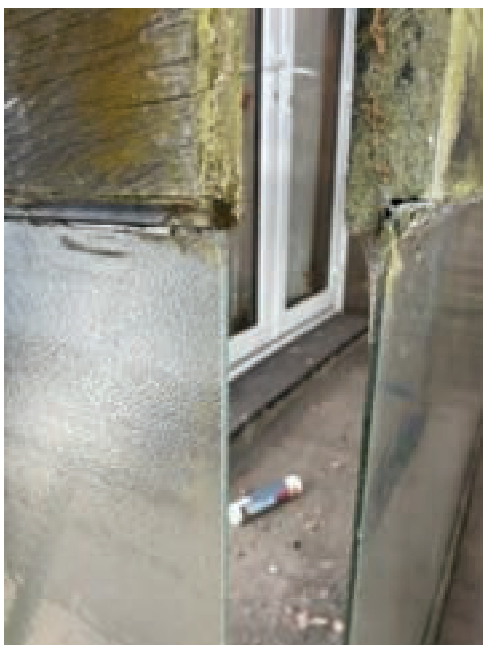
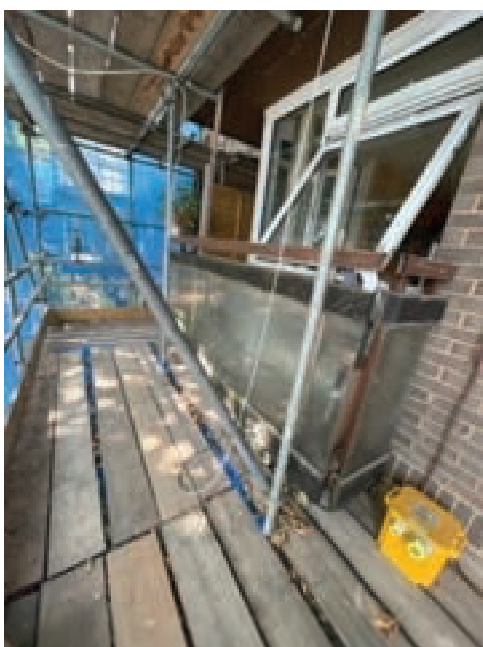
Beads - Failing and glass is now not sitting within them

Repair Option – Replace both rails of wood – Add new aluminium angle bead.

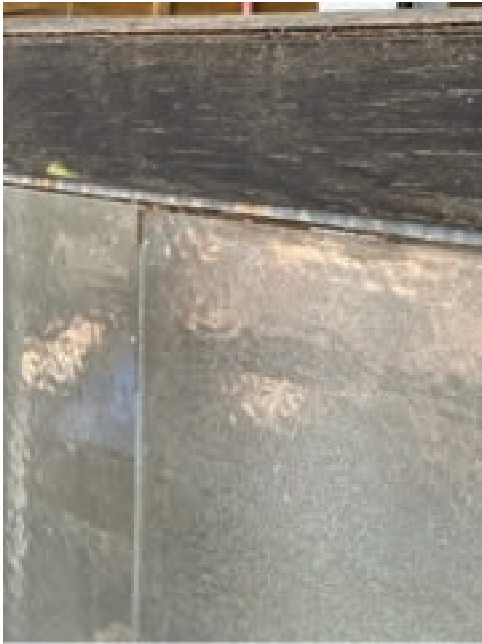
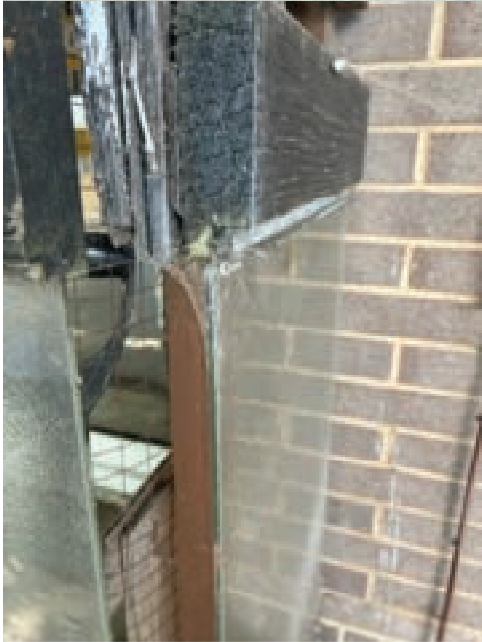
Balc 3 - size as Balc 3 top floor
Glass - Ok
Wood - Poor
Beads - failing - glass dropped

Repair Option – Replace both rails of wood – Add new aluminium angle bead.

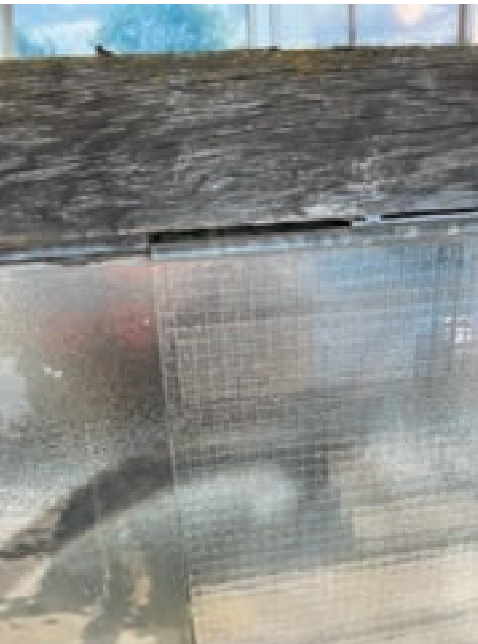
Beads - same issues as previous balc

Repair Option – Due to beads failing - Replace both rails of wood – Add new aluminium angle bead.

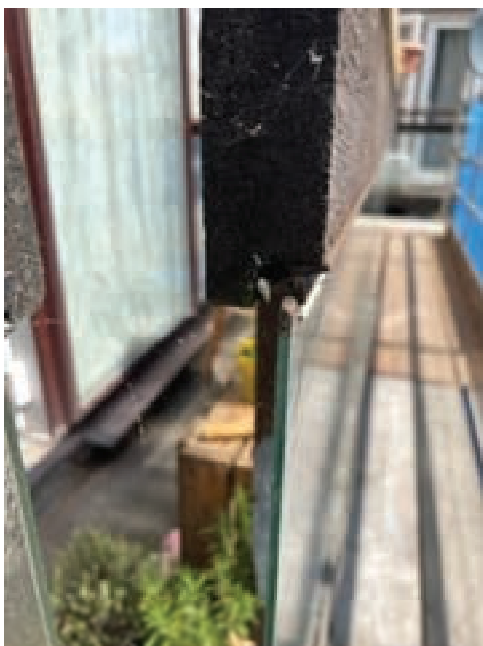
Beads - rebate issues - Poor condition

Repair Option – Replace both rails of wood – Add new aluminium angle bead.

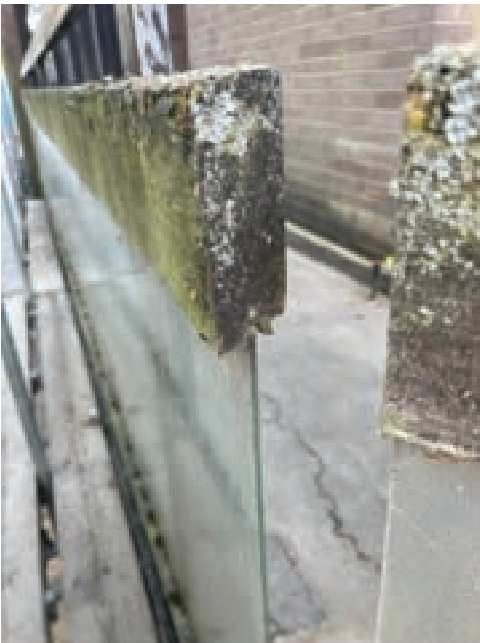
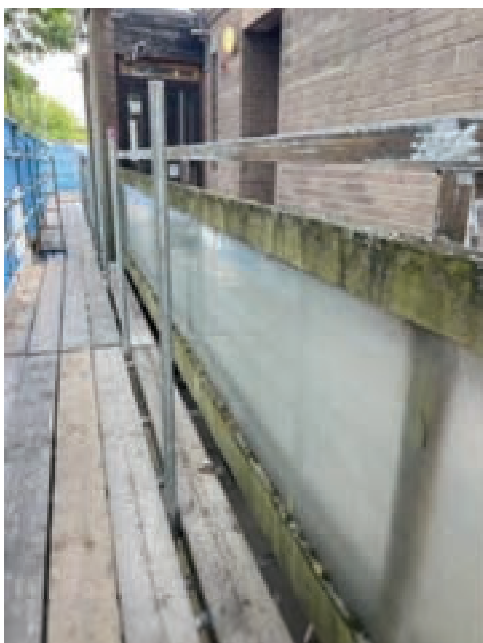
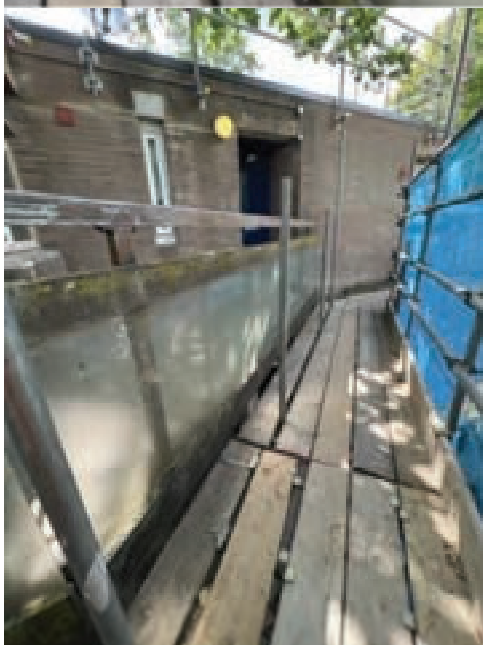
Chanler - Walkway
Top floor :
Right side
Length - 4950 & 6898
Glass all ok
Wood - Generally poor
Beads - internal - Poor condition

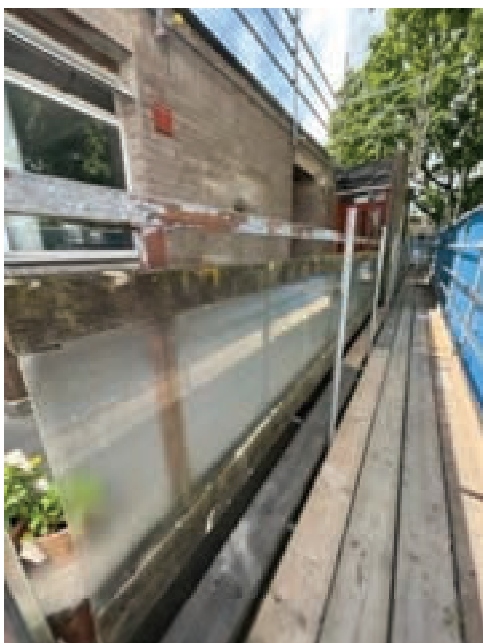
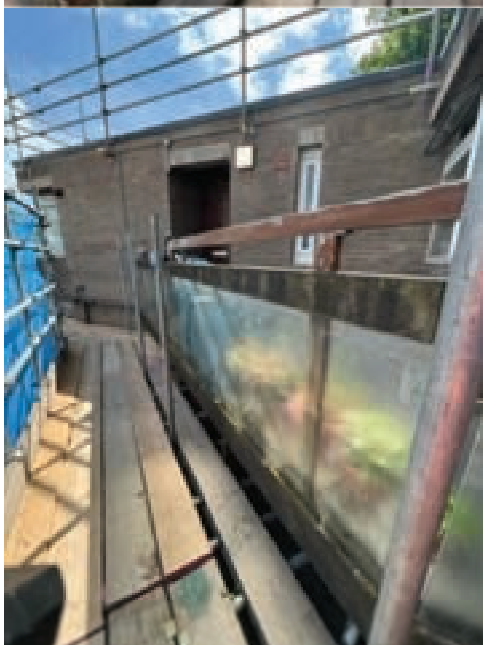
Beads - Poor - Same issues as all previous.

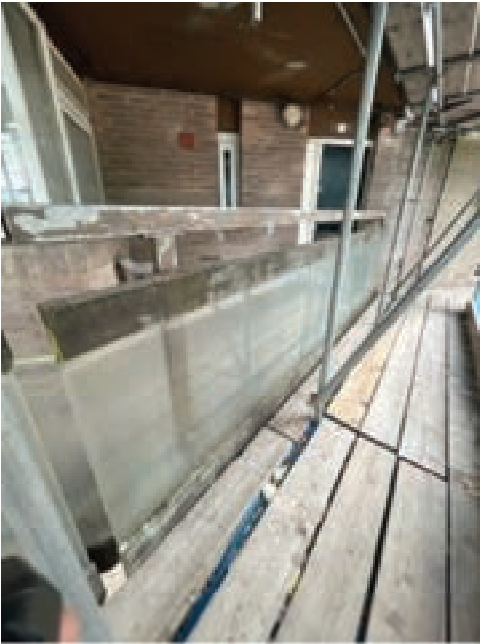
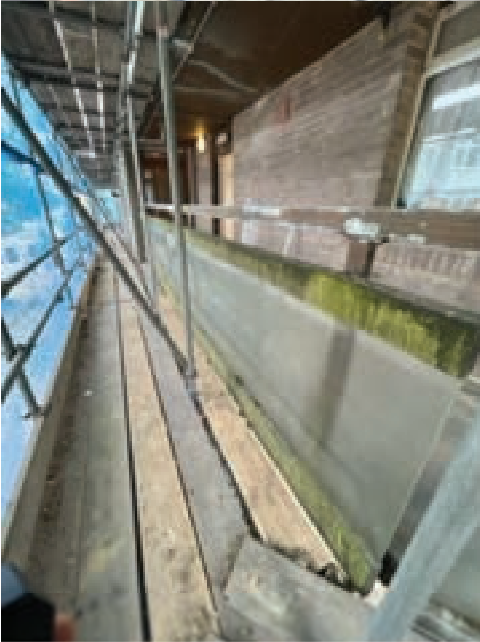
1st floor walkway:
Right side - 6928 & 4731
Glass - Ok
Wood - Poor - Rebates are failing.
Beads - Internal - Same issues.

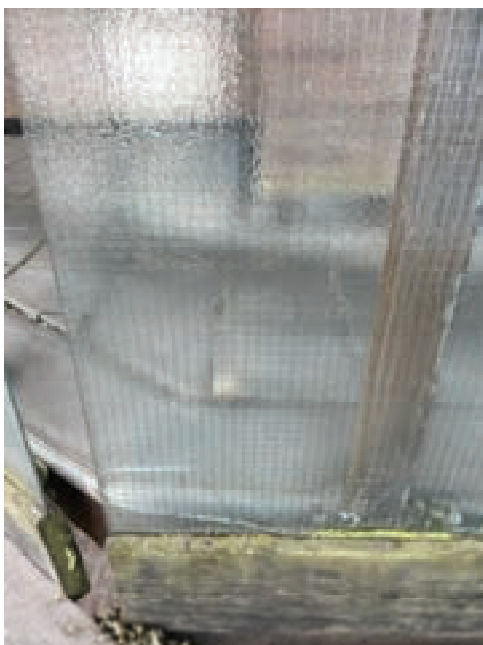
Left side:
6886 & 2907 & 5021 & 2950 & 5100 & 4900
Glass - 4th panel to be replaced - Cracked
Repair Option – Replace Glass panel

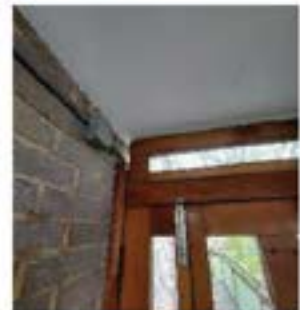
Gaps around doors in common area (150x60)

Remedial work required. Ensure the gaps are sealed with intumescent Batt & mastic installed to manufacturer's tested detail.

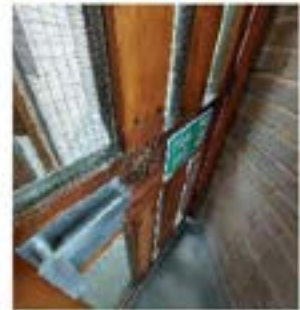
Damage to doors

Replace with FD60 doors

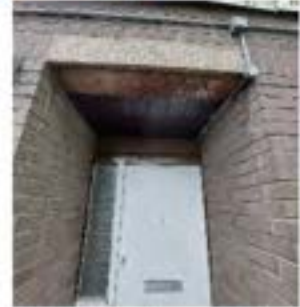
Non fire rated Wooden soffit board over flat doors (900 x 1120)

Replace with a suitable fire resistant material in line with manufacturer's tested detail.

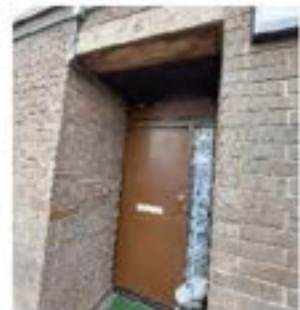
Flat entry doors

Front entr. doors are ear compliant. An additional FD survey is recommended as it was not possible to thoroughly examine the FED.

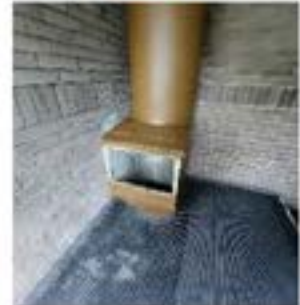
Non fire rated Access door on bin shoot (600x400)

Replace with a suitable fire resistant door in line with manufacturer's tested detail.

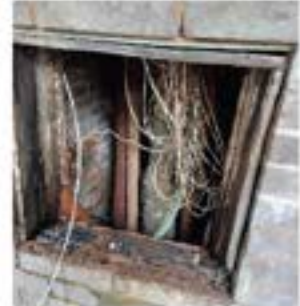
Non fire rated Wooden
Access panel (630x610)

Replace with a suitable fire
resistant material in line
with manufacturer's tested
detail.

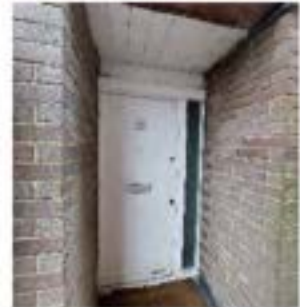
Non fire rated Wooden
soffit board over flat doors
(900 x 1120)

Replace with a suitable fire
resistant material in line
with manufacturer's tested
detail.

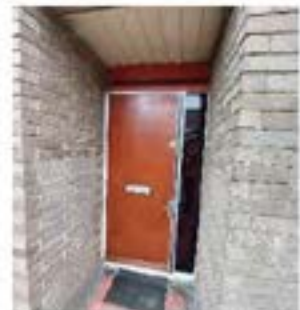
Flat entry doors

Front entr. doors are ear
compliant. An additional
FD survey is
recommended as it was
not possible to thoroughly
examine the FED.

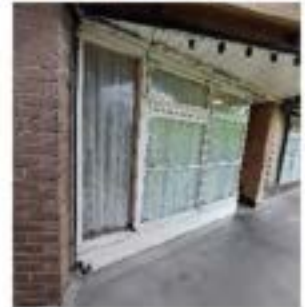
Non fire rated Wooden board under window with gas pipe penetration (4m x 230)per flat

Replace with a suitable fire resistant material in line with manufacturer's tested detail.

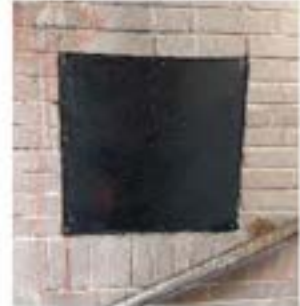
Non fire rated Wooden
Access panel (630x610)

Replace with a suitable fire
resistant material in line
with manufacturer's tested
detail.

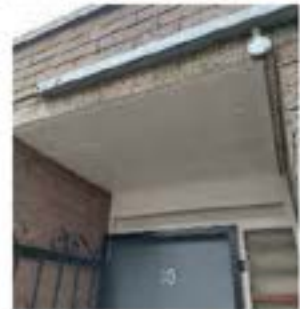
Non fire rated Wooden
soffit board over flat doors
(900 x 1120)

Replace with a suitable fire
resistant material in line
with manufacturer's tested
detail.

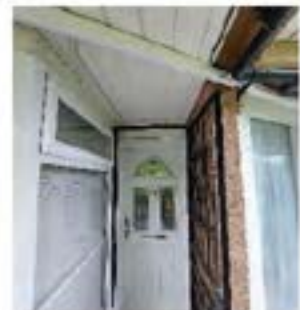
Flat entry doors

Front entr. doors are ear
compliant. An additional
FD survey is
recommended as it was
not possible to thoroughly
examine the FED.

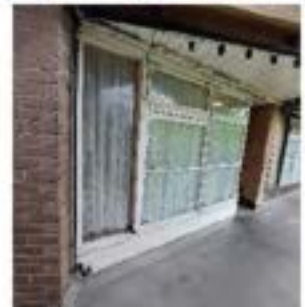
Non fire rated Wooden board under window with gas pipe penetration (4m x 230)per flat

Replace with a suitable fire resistant material in line with manufacturer's tested detail.

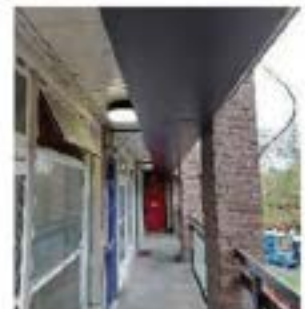
Level 2 Non fire rated Wooden boxing over flat doors (12m x 550 x 300)

Replace with a suitable fire resistant material in line with manufacturer's tested detail.

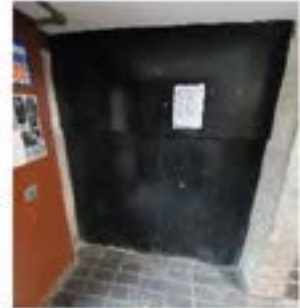
Non fire rated Wooden
Access panel
(1320x1730)

Replace with a suitable fire
resistant material in line
with manufacturer's tested
detail.

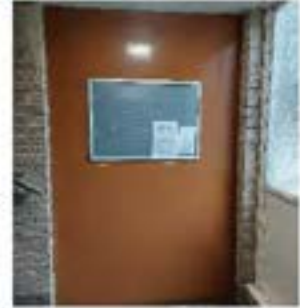
Non fire rated Wooden
Access panel
(2380x1500)

Replace with a suitable fire
resistant material in line
with manufacturer's tested
detail.
