## Annual Inspection

### Kildoran Road

Inspection Ref: 1737494

Inspected: 21 August 2022 at 14:02 Inspector: [REDACTED]

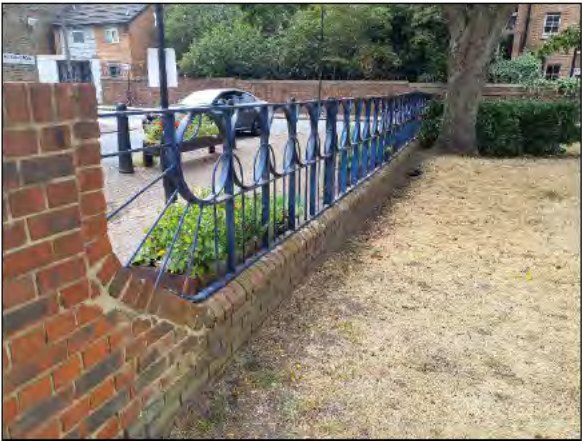
This item is satisfactory - no work required

**Risk Assessment:** 4 - Very Low Risk

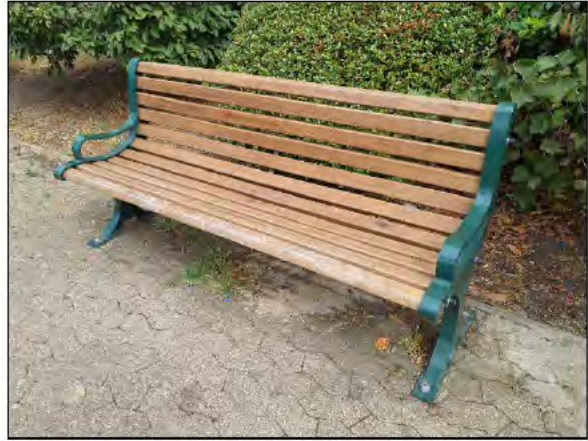
**Item:** Ancillary Items - Bench  
**Manufacturer:** Unknown  
**Comments**

This item is satisfactory - no work required

**Risk Assessment:** 4 - Very Low Risk

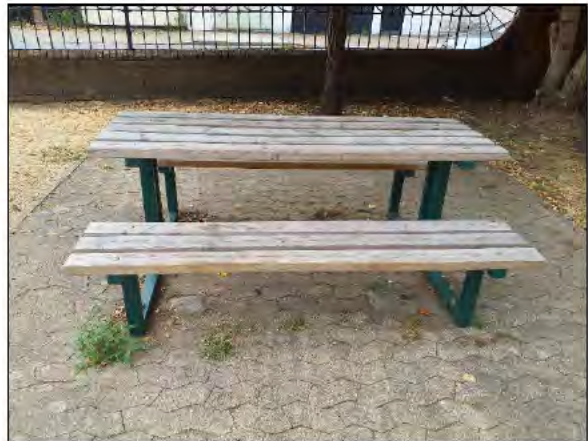
**Item:** Ancillary Items - Picnic Table  
**Manufacturer:** Unknown  
**Comments**

This item is satisfactory - no work required

**Risk Assessment:** 4 - Very Low Risk

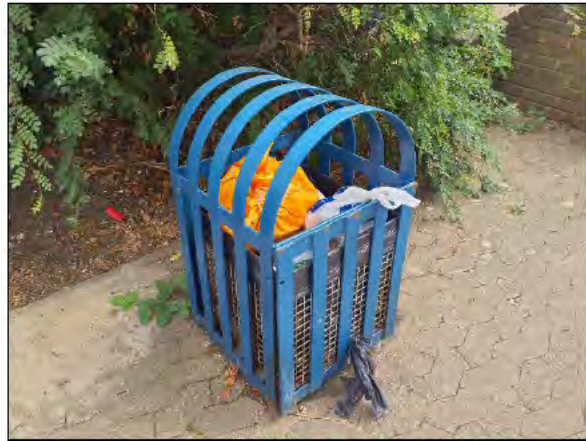
**Item:** Ancillary Items - Litter Bin  
**Manufacturer:** Unknown  
**Comments**

This item is satisfactory - no work required

**Risk Assessment:** 4 - Very Low Risk
