123 Knights Hill, West Norwood,  
London, SE27 0SP

## Structural Engineer's Report

**Prepared for:**  
**Lambeth Housing Management**  
**on the Instruction of Savills (UK) Ltd**

July 2022

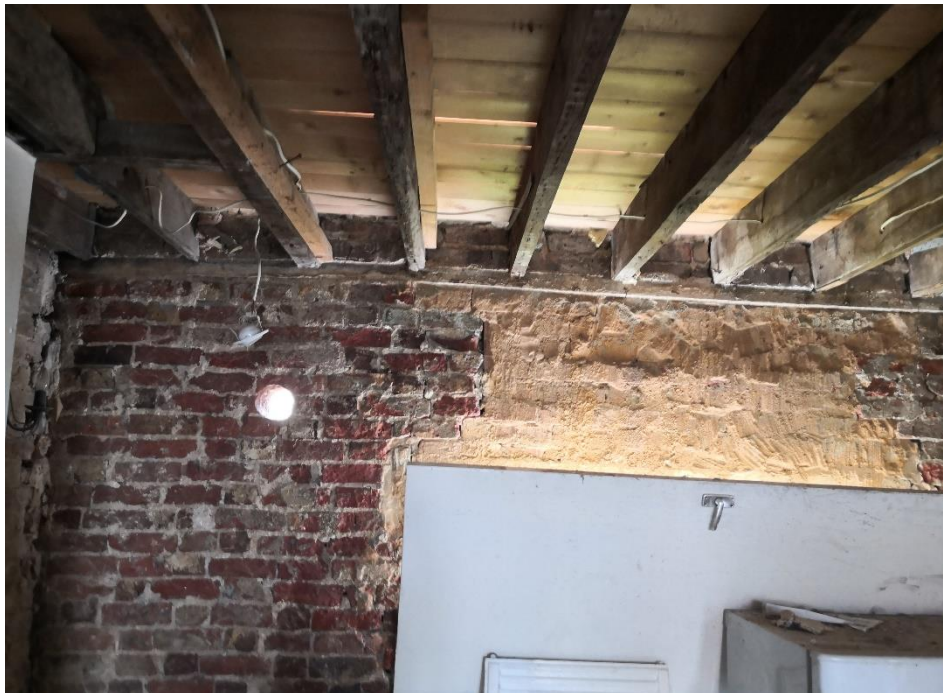
6.34 Rear elevation wall above the rear door opening in the ground floor right-hand room that is distorted

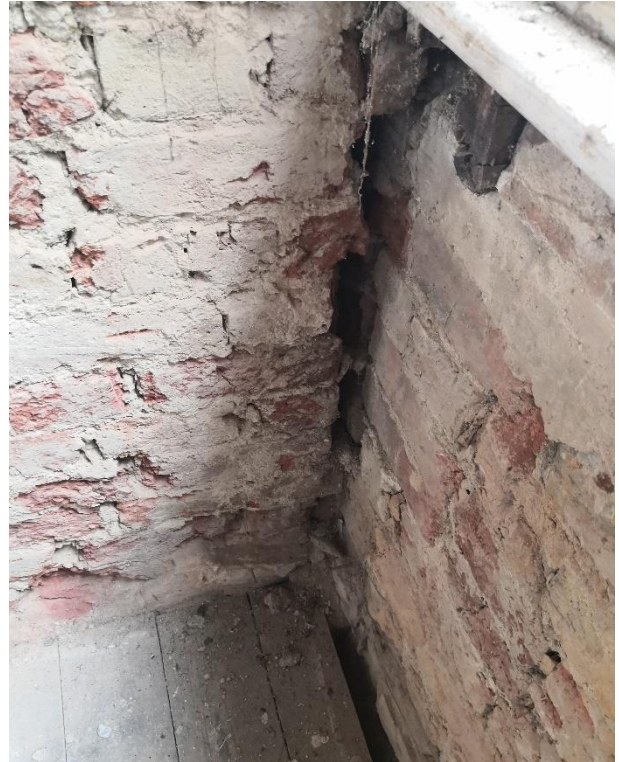
6.41 10-20mm wide gap in the corner of the stair landing between the rear elevation wall and internal wall with the large ground floor room (right)
