## Operational Inspection

### Kildoran Road

Inspection Ref: 1564240

Inspected: 21 January 2022 at 10:09 Inspector: [REDACTED]

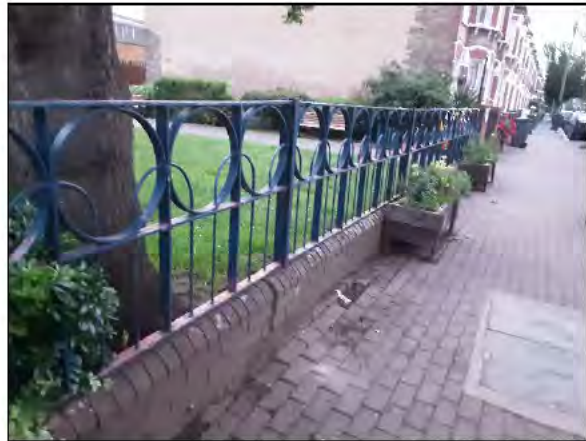
**Item:** Fences - Fencing - Flat Top  
**Manufacturer:** Unknown  
**Comments**

There is surface corrosion present on the item Consider treating and repainting the item

There is some graffiti present Remove the graffiti

Section of railing is missing Replace as required

**Risk Assessment:** 6 - Low Risk

**Finding:** There is surface corrosion present on the item  
**Action:** Consider treating and repainting the item

**Finding:** Section of railing is missing  
**Action:** Replace as required
