Operational Inspection

Kildoran Road

Inspection Ref: 1932010

Inspected: 30 January 2023 at 12:05 Inspector: [REDACTED]

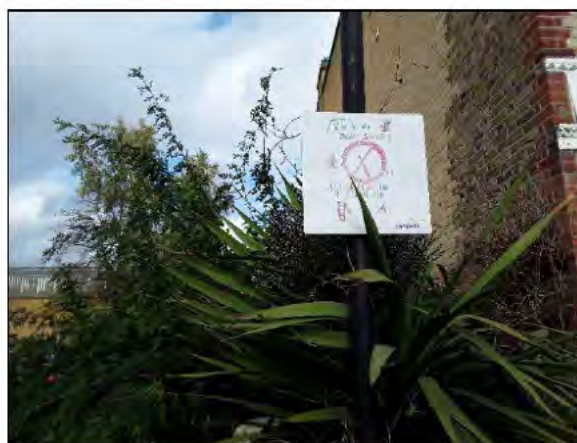
Item: Ancillary Items - Sign
Manufacturer: Not Applicable
Comments

This item is satisfactory - no work required

Risk Assessment: 3 - Very Low Risk

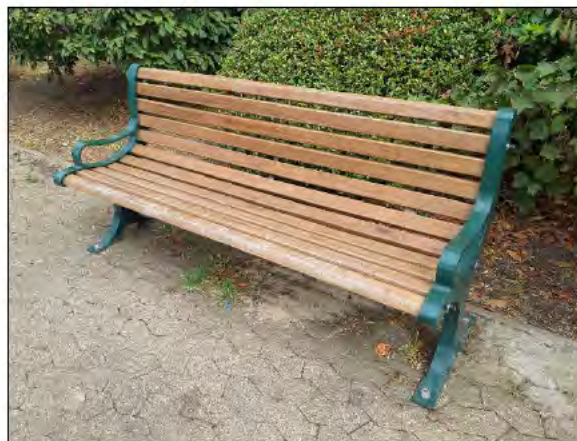
Item: Ancillary Items - Bench
Manufacturer: Unknown
Comments

This item is satisfactory - no work required

Risk Assessment: 3 - Very Low Risk

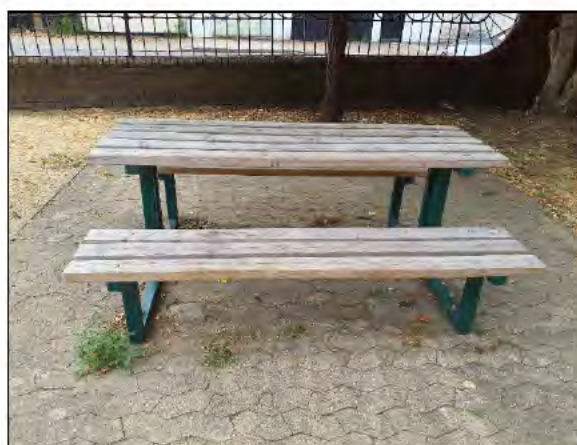
Item: Ancillary Items - Picnic Table
Manufacturer: Unknown
Comments

This item is satisfactory - no work required

Risk Assessment: 3 - Very Low Risk
