Annual Inspection  
Kildoran Road

Inspection Ref: 1406328

Site Ref: 63714

Inspected: 01 July 2021 at 04:36 Inspector: [REDACTED]

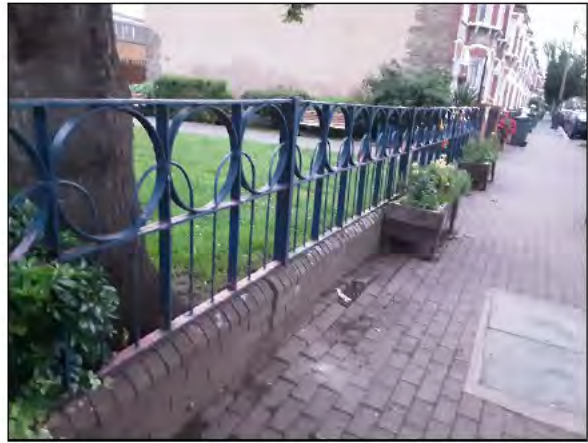
**Item:** Fences - Fencing - Flat Top

This item is satisfactory - no work required

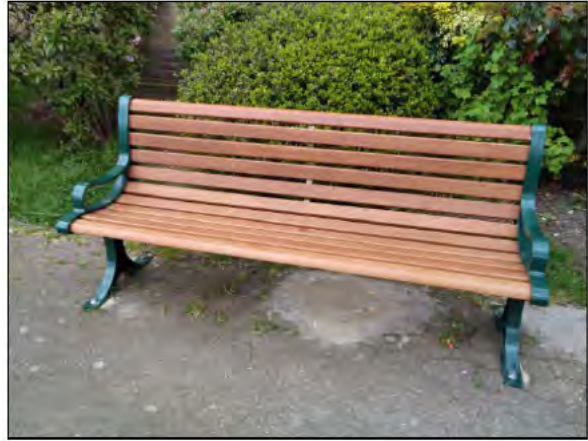
**Item:** Ancillary Items - Bench  
**Manufacturer:** Unknown  
**Comments**

This item is satisfactory - no work required

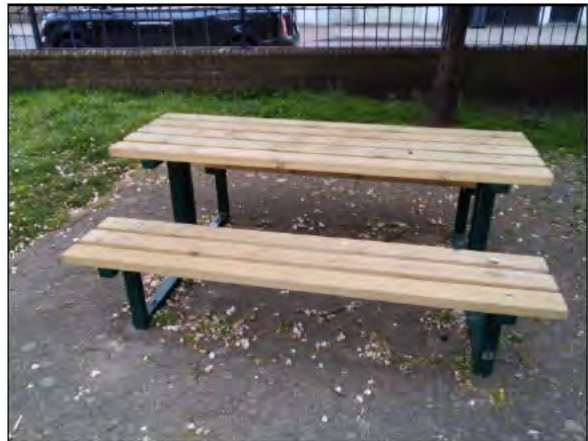
**Item:** Ancillary Items - Picnic Table  
**Manufacturer:** Unknown  
**Comments**

This item is satisfactory - no work required

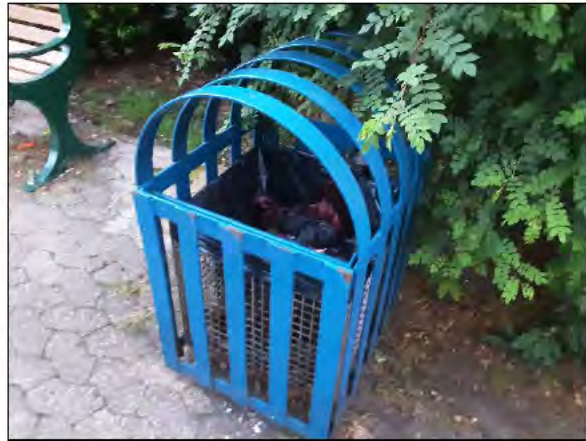
**Item:** Ancillary Items - Litter Bin  
**Manufacturer:** Unknown  
**Comments**

The adjacent foliage is overhanging the bin Cut back and maintain
