## Operational Inspection

### Kildoran Road

Inspection Ref: 1498660

Inspected: 28 October 2021 at 09:01 Inspector: [REDACTED]

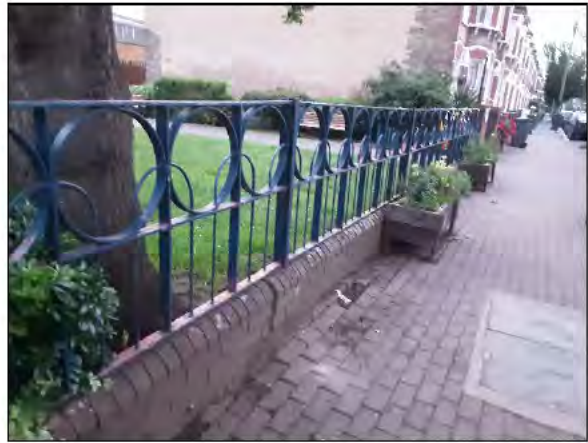
**Item:** Fences - Fencing - Flat Top  
**Manufacturer:** Unknown  
**Comments**

There is surface corrosion present on the item Consider treating and repainting the item

There is some graffiti present Remove the graffiti

Section of railing is missing Replace as required

**Risk Assessment:** 6 - Low Risk

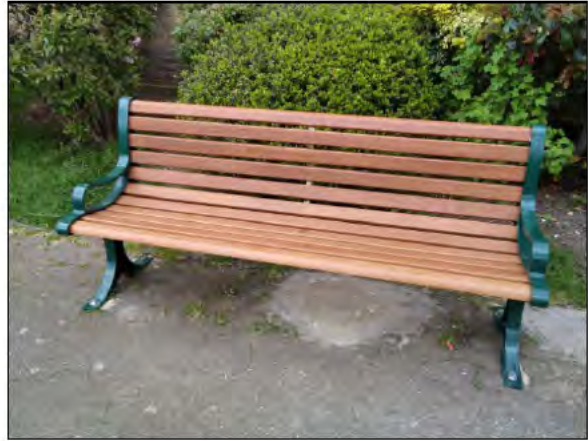
**Item:** Ancillary Items - Bench  
**Manufacturer:** Unknown  
**Comments**

This item is satisfactory - no work required

**Risk Assessment:** 3 - Very Low Risk

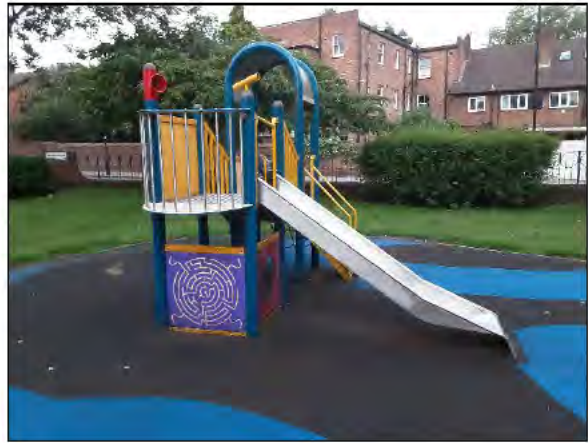
**Item:** Activity Equipment - Multi Play (Toddler)  
**Manufacturer:** Russell Leisure Ltd  
**Comments**

There is some graffiti present Remove the graffiti

Steering wheel is damaged Replace

There are gaps opening between the surfacing and the edging surround or between the joints in the surfacing Monitor for any further deterioration and repair as required, 2 Lm

The paintwork on this item has been damaged or worn exposing the metal underneath which is rusting Treat any rusting components and repaint

There are a number of dents in the slide surface, sharp surface Arrange to sand down any burrs on surface

**Risk Assessment:** 10 - Low Risk
