The works include external and communal upgrade works to Ponton House, Chalner House, Ducavel House and 130-139 Coburg Crescent, circa 86 flats across 4 separate blocks, any nominated contractor should be able to deliver works to this scale and works as listed. The planned works include but are not limited to; the replacement of the existing flat roof coverings, associated flashings and any rooflights/ lightning protection as required and where applicable. The existing windows will be replaced with new PVCu double glazed equivalents, along with fire rated screens to the front communal balconies. The external walls will be repaired as necessary, including repairs to brickwork, repointing and the replacement of any existing defective timber cladding prior to redecoration works. Any concrete surfaces will be tested once access is available and areas repaired as required. All previously painted surfaces are to be redecorated to both external and communal parts of the building, along with upgrade works to the existing balconies. This will include repairs to the existing timber and glass balcony balustrading and any repairs/ re coating of the existing private or communal asphalt walkways

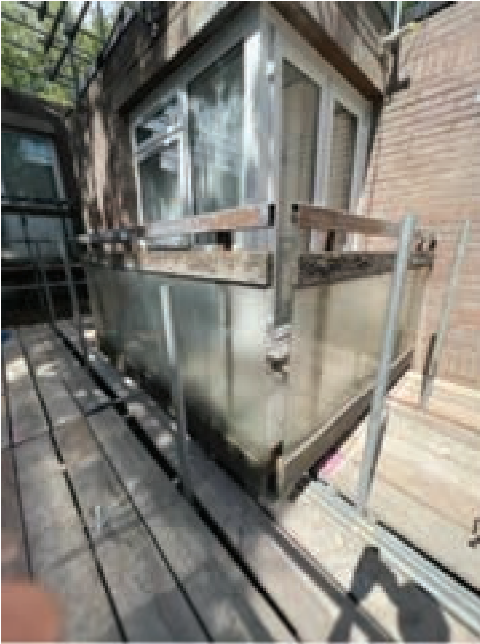
Top floor from Despard end.

Balc 1 - 480 x 2735 x 2285

Glass - Ok

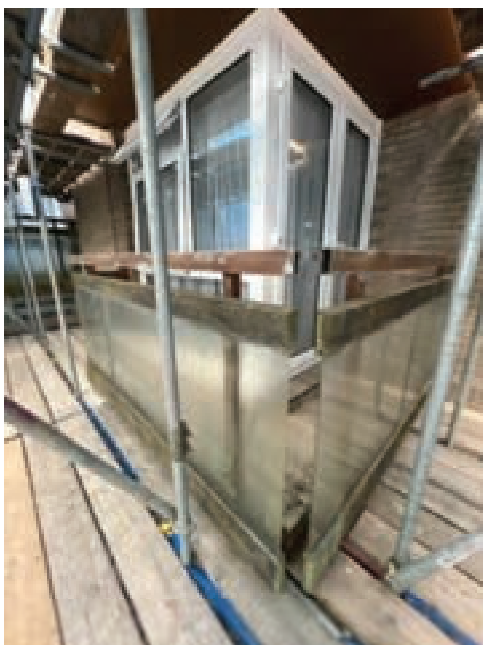
1st Floor - From Despard End.

Balc 1 - 480 x 2735 x 2290

Glass - Ok

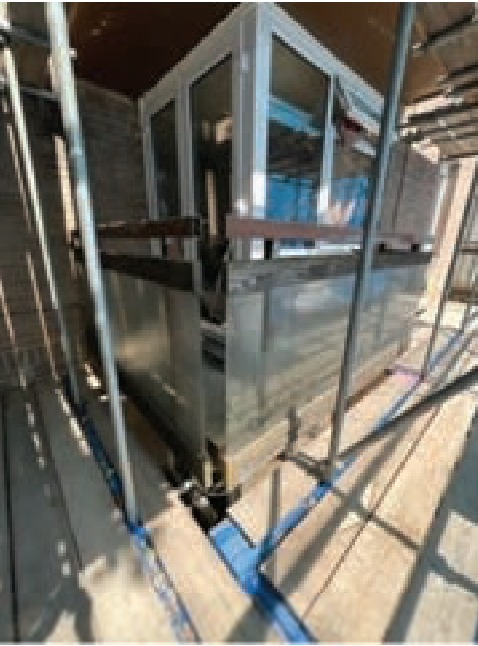
Balc 4 - size as 3

Glass - Ok

Repair Option – Due to beads failing - Replace both rails of wood – Add new aluminium angle bead.

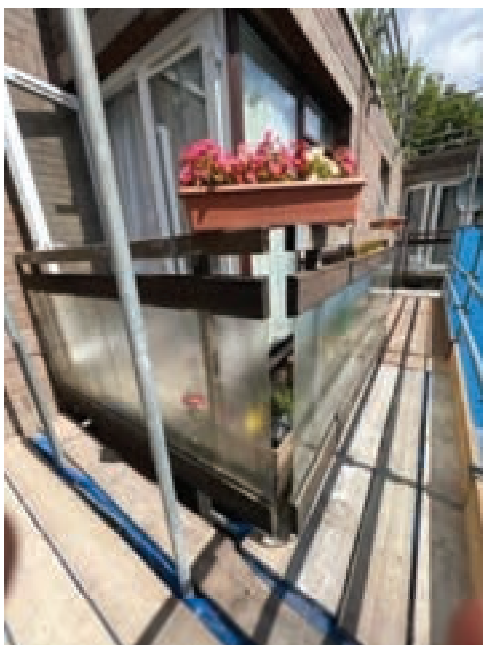
Balc 5 - size as previous

Glass - Ok

Repair Option – Replace both rails of wood – Add new aluminium angle bead.

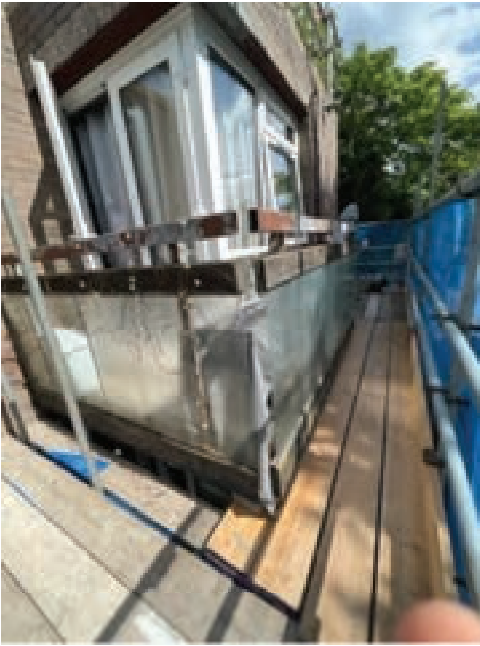
Balc 6 - size as previous
Glass - Ok
Wood – Poor - Rebate issues
Beads – Poor

Repair Option – Replace both rails of wood – Add new aluminium angle bead.

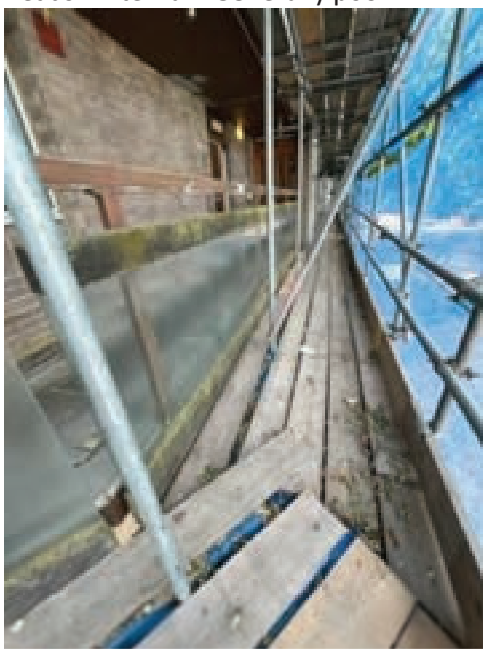
Wood - Poor
Beads - internal - Generally poor.

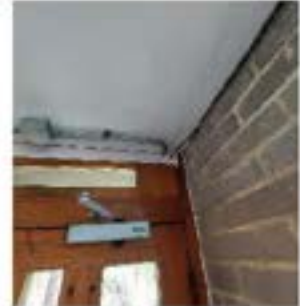
Gaps around services above doors in common area (20x20)

Remedial work required. Ensure the gaps are sealed with intumescent mastic installed to manufacturer's tested detail.

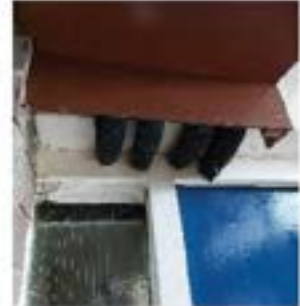
Gaps around services over doors in common area (40x40)

Remedial work required. Ensure the gaps are sealed with intumescent Batt & mastic installed to manufacturer's tested detail.

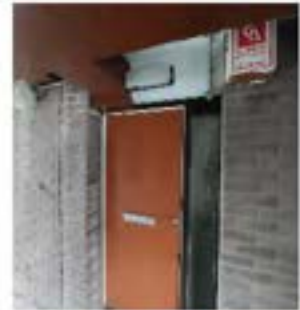
Ground floor Non fire rating boxing in common area (10m x 550x270)

Boxing with a suitable fire resistant material in line with manufacturer's tested detail.

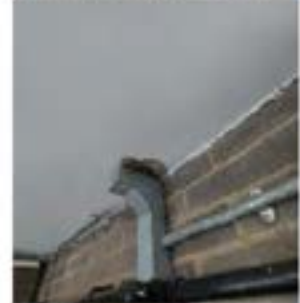
Gaps around services in common area (120x20)

Remedial work required. Ensure the gaps are sealed with intumescent mastic installed to manufacturer's tested detail.

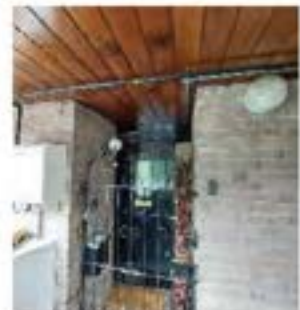
Flat entry doors

Front entr. doors are ear compliant. An additional FD survey is recommended as it was not possible to thoroughly examine the FED.

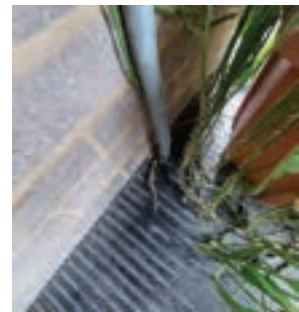
level1 Gaps around services in common area floor (40x40)

Remedial work required. Ensure the gaps are sealed with intumescent Batt & mastic installed to manufacturer's tested detail.

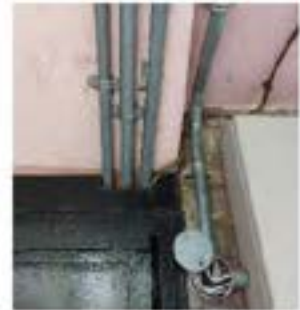
Gaps around doors in
common area (100x40)

Remedial work required.
Ensure the gaps are
sealed with intumescent
Batt & mastic installed to
manufacturer's tested
detail.

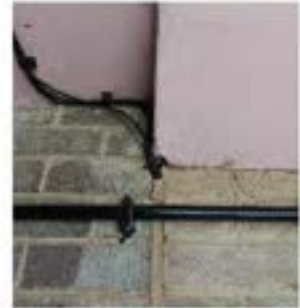
Gaps around services
above doors in common
area (20x20)

Remedial work required.
Ensure the gaps are
sealed with intumescent
mastic installed to
manufacturer's tested
detail.

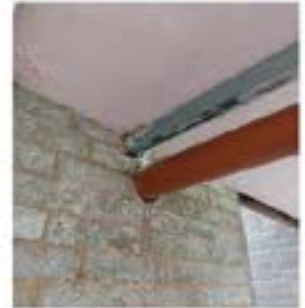
Gaps around services above doors in common area (120x20)

Remedial work required. Ensure the gaps are sealed with intumescent mastic installed to manufacturer's tested detail.

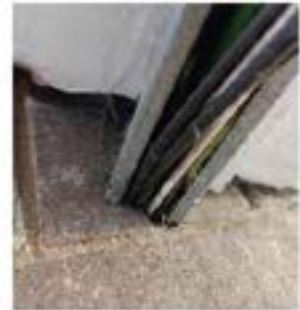
Gaps around doors in
common area (50x50)

Remedial work required.
Ensure the gaps are
sealed with intumescent
Batt & mastic installed to
manufacturer's tested
detail.

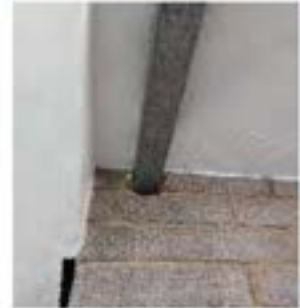
Gaps around services
above doors in common
area (20x20)

Remedial work required.
Ensure the gaps are
sealed with intumescent
mastic installed to
manufacturer's tested
detail.

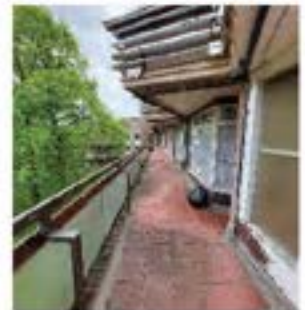
Exposed pipe work above common area (6m x 1500x300) per flat

Boxing with a suitable fire resistant material in line with manufacturer's tested detail.

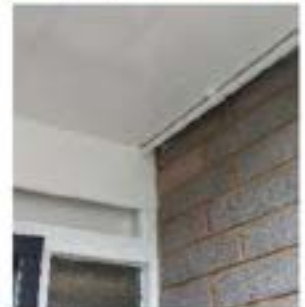
Gaps around services above doors in common area (20x20)

Remedial work required. Ensure the gaps are sealed with intumescent mastic installed to manufacturer's tested detail.

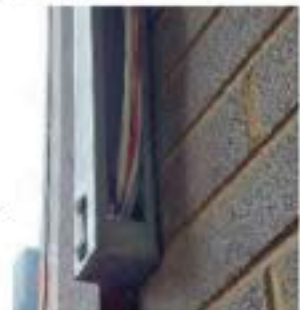
Gaps around doors in
common area (50x50)

Remedial work required.
Ensure the gaps are
sealed with intumescent
Batt & mastic installed to
manufacturer's tested
detail.
